RE: Rule 34 Variance Request –Produced Water Impoundment Construction on Unstable Area

Cave and Karst Resource Inventory Report WaterBridge Parkway Pond Eddy County, New Mexico

July 20, 2022

PW-083B-20220512

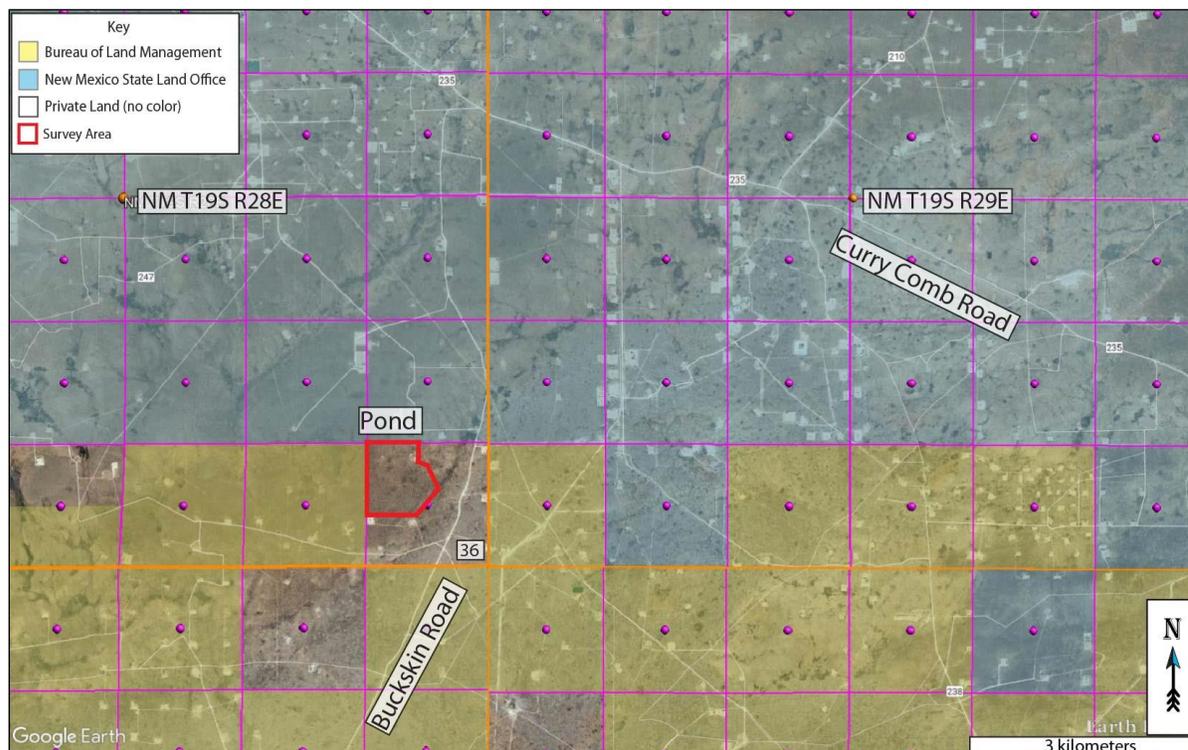
Figure 2: Land ownership overview^[3,6]. Background image credit: Google Earth. Image date: December 21, 2019. Datum: WGS-84.

The WBP project site is located in Eddy County, New Mexico, 26.1 kilometers (16.2 miles) northeast of Carlsbad, New Mexico, south of Curry Comb Road. The site is located west of Buckskin Road and south of Curry Comb Road within the NW ¼ of section 36, NM T19S R28E^[3] (**Figure 1** and **Figure 2**). The region is semi-arid with an average annual precipitation of approximately 13 inches, of which about two-thirds falls as rain during summer thunderstorms from June to October. Summers are hot and sunny while winters are generally mild, with an average maximum temperature of 96°F in July and an average minimum temperature of 28°F in January^[4]. This area is within the Chihuahuan Desert Thornscrub as defined by the Southwestern Regional ReGAP Vegetation map^[5] and the vegetation consists mostly of areas of grass, sparse creosote, and sparse yucca, with very good visibility in most locations. See section **2.2 Local Geology** for the geology of the area. Both project sites are located entirely within an HKOZ^[1] (**Figure 1**). The pond project site is located entirely within privately managed (fee surface) land and the parkway project site is located entirely within NMSLO managed land^[6] (**Figure 2**).
