SUBJECT: Liner Inspection and Closure Report for Aleutian 10 CTB 2 – April 23, 2025 Site Visit

Incident ID: nAPP2509923225
Facility ID (Name): fAPP2300331384 (ALEUTIAN 10 CTB 2)
Facility Location: Unit J, 10, T23S, R31E,
Facility GPS Coordinates: 32.315443, -103.762228
Eddy County, New Mexico

Environmental Liner Inspection Field Notes & Photolog Report

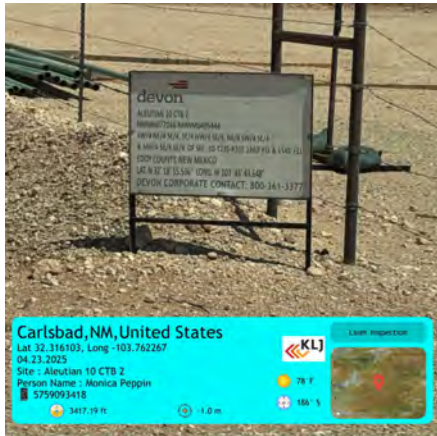
<p>Photo of Lease Sign</p>	
Client Contact:			
Land Status:	BLM		
County:	Eddy		
Lease ID:	NMNM077045, NMNM0405444		
Facility ID/API #:	fAPP2300331384

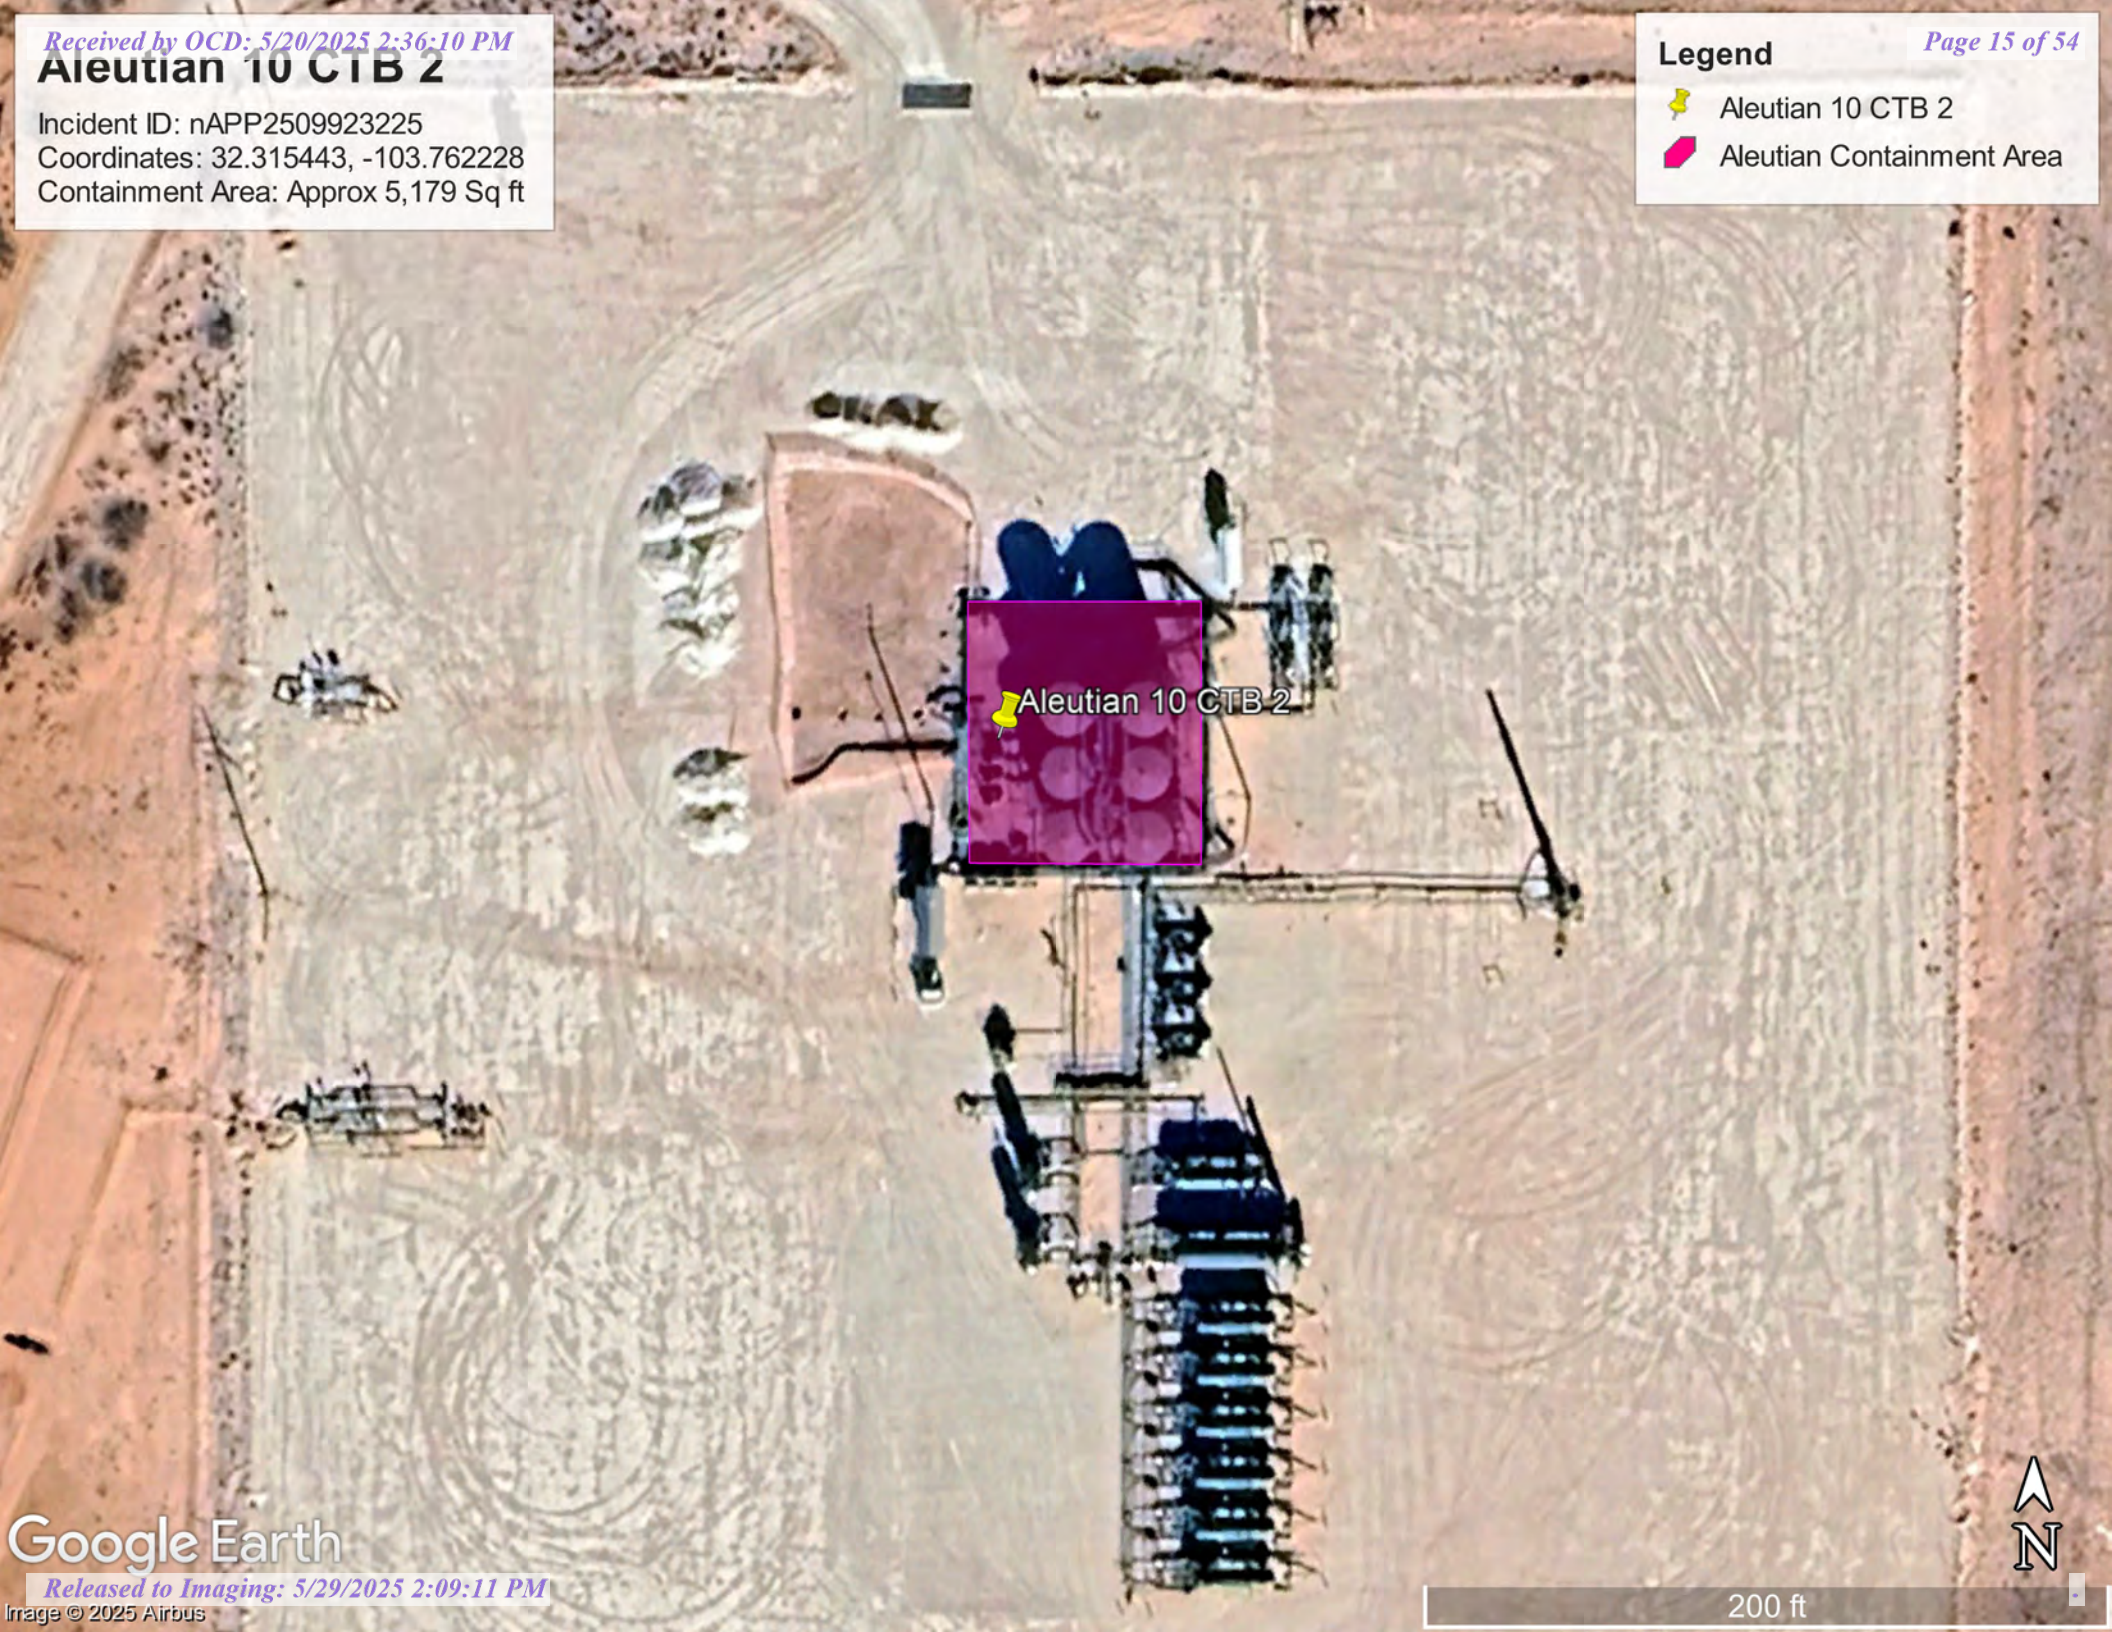
Aleutian Containment Area

- Upload documents to folder
- Compile data and start drafting closure report
- Submit report for approval
- Liner integrity is confirmed. No signs of degrading or wear and tear of liner.
- Liner is capable of containing fluids from going onto the ground.
