# INITIAL C-141 AND REMEDIATION WORK PLAN

## Report Type: Work Plan

**Re: Work Plan for the COG Operating LLC., Hercules Federal Com #1,  
Unit E, Section 15, Township 15 South, Range 31 East, Chaves  
County, New Mexico.**

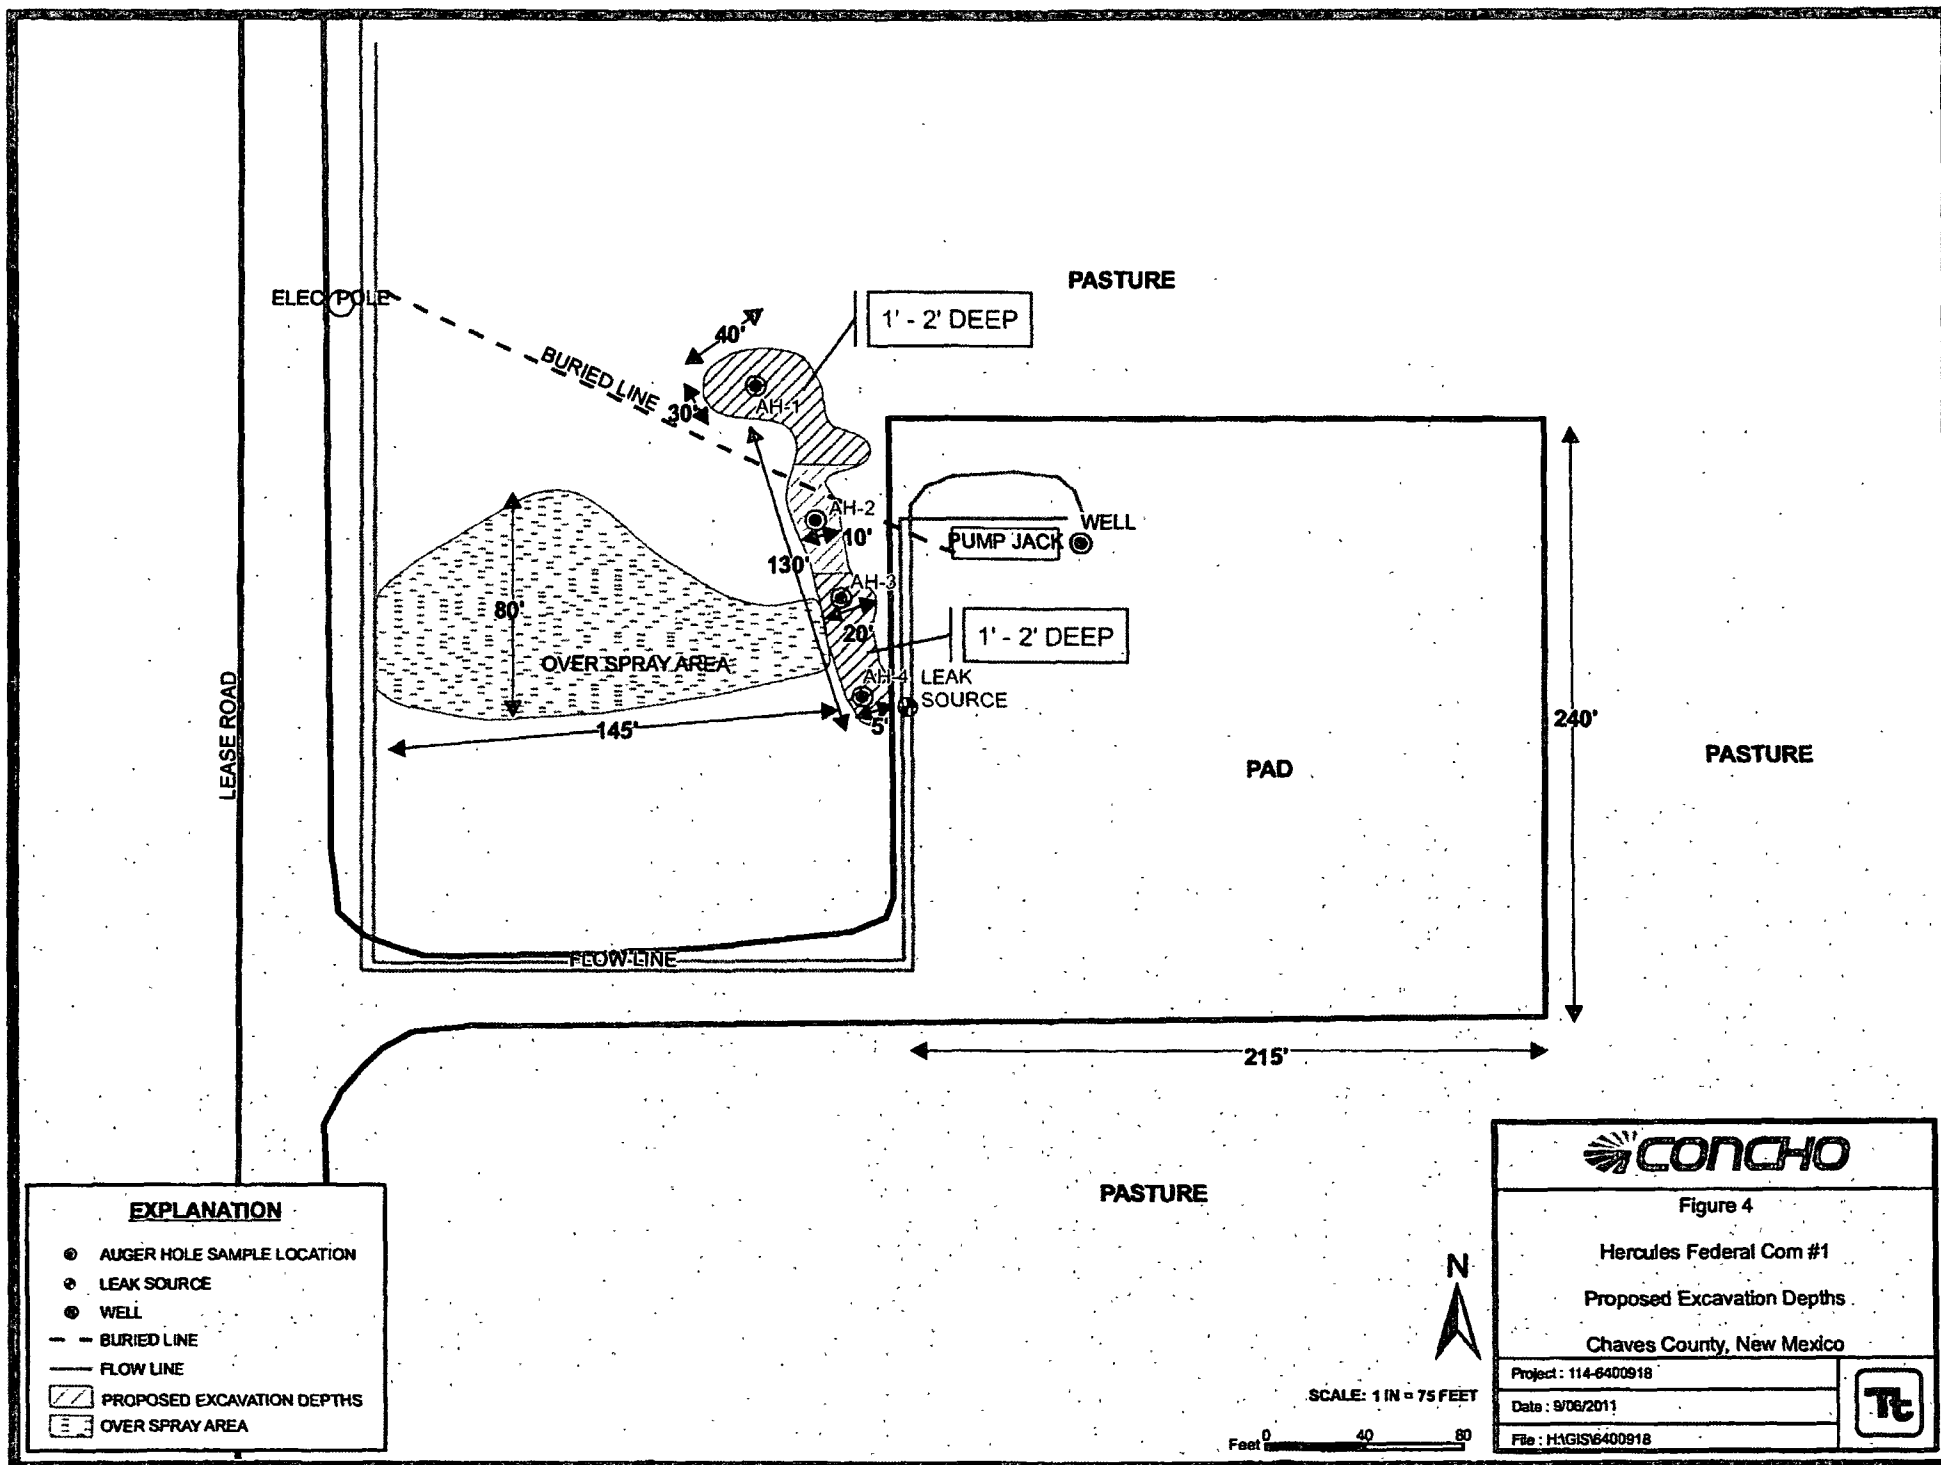
On May 24, 2011, Tetra Tech personnel inspected and sampled the spill area. Four (4) auger holes (AH-1 and AH-4) were installed using a stainless steel hand auger to assess the impacted soils. Select samples were analyzed for TPH analysis by EPA method 8015 modified, BTEX by EPA Method 8021B and chloride by EPA method 300.0. Copies of laboratory analysis and chain-of-custody documentation are included in Appendix B. The results of the sampling are summarized in Table 1. The auger hole locations are shown on Figure 3.
