Inconsistencies regarding reported cement top:

### Main Points Addressing Wellbore Integrity

### NMOCD CASE NO. 15397: OXY-442

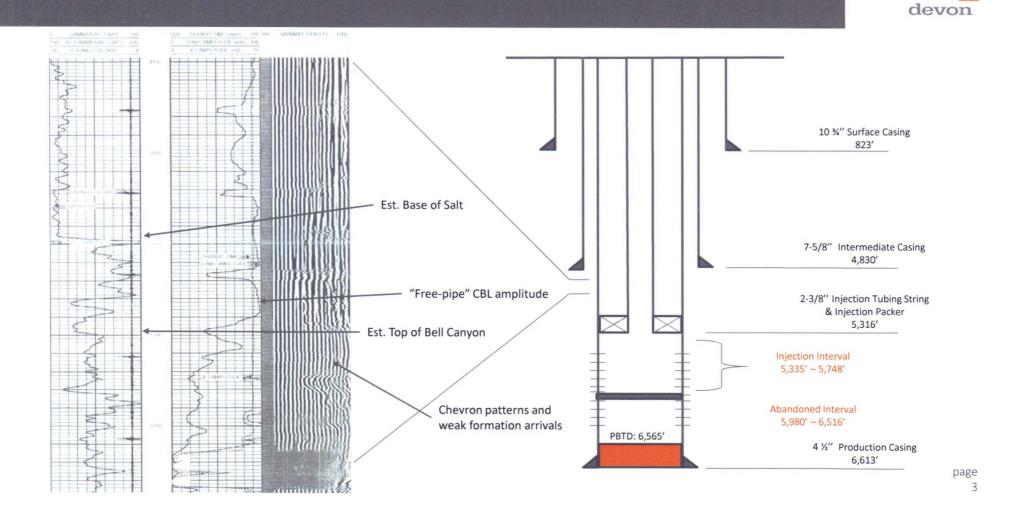
3

#### Facts:

- Overpressure compliance violation cited in December, where reported volumes were similar to average volumes injected throughout the year (NMOCD record)
- Reported monthly injection volumes in 2004 greatly exceeded average injection volumes of any other year since 2002
- As late as September 2015, Oxy continued to inject above permitted pressures (ref: Oxy-257)

### **Based on these facts:**

- Fracture gradient likely was exceeded, which could have established a vertical path into the production casing annulus
- This far-wellbore path would be unidentifiable by RA-tracer survey data if communication was established beyond the tool's depth of investigation
