Subject: Chevron/Anadarko West Hugh Lease Railroad Conduit Remediation

OCD Case #: 1R0296

### REMEDIATION WORK PLAN AND CLOSURE REPORT

### WEST HUGH LEASE RAILROAD CONDUIT

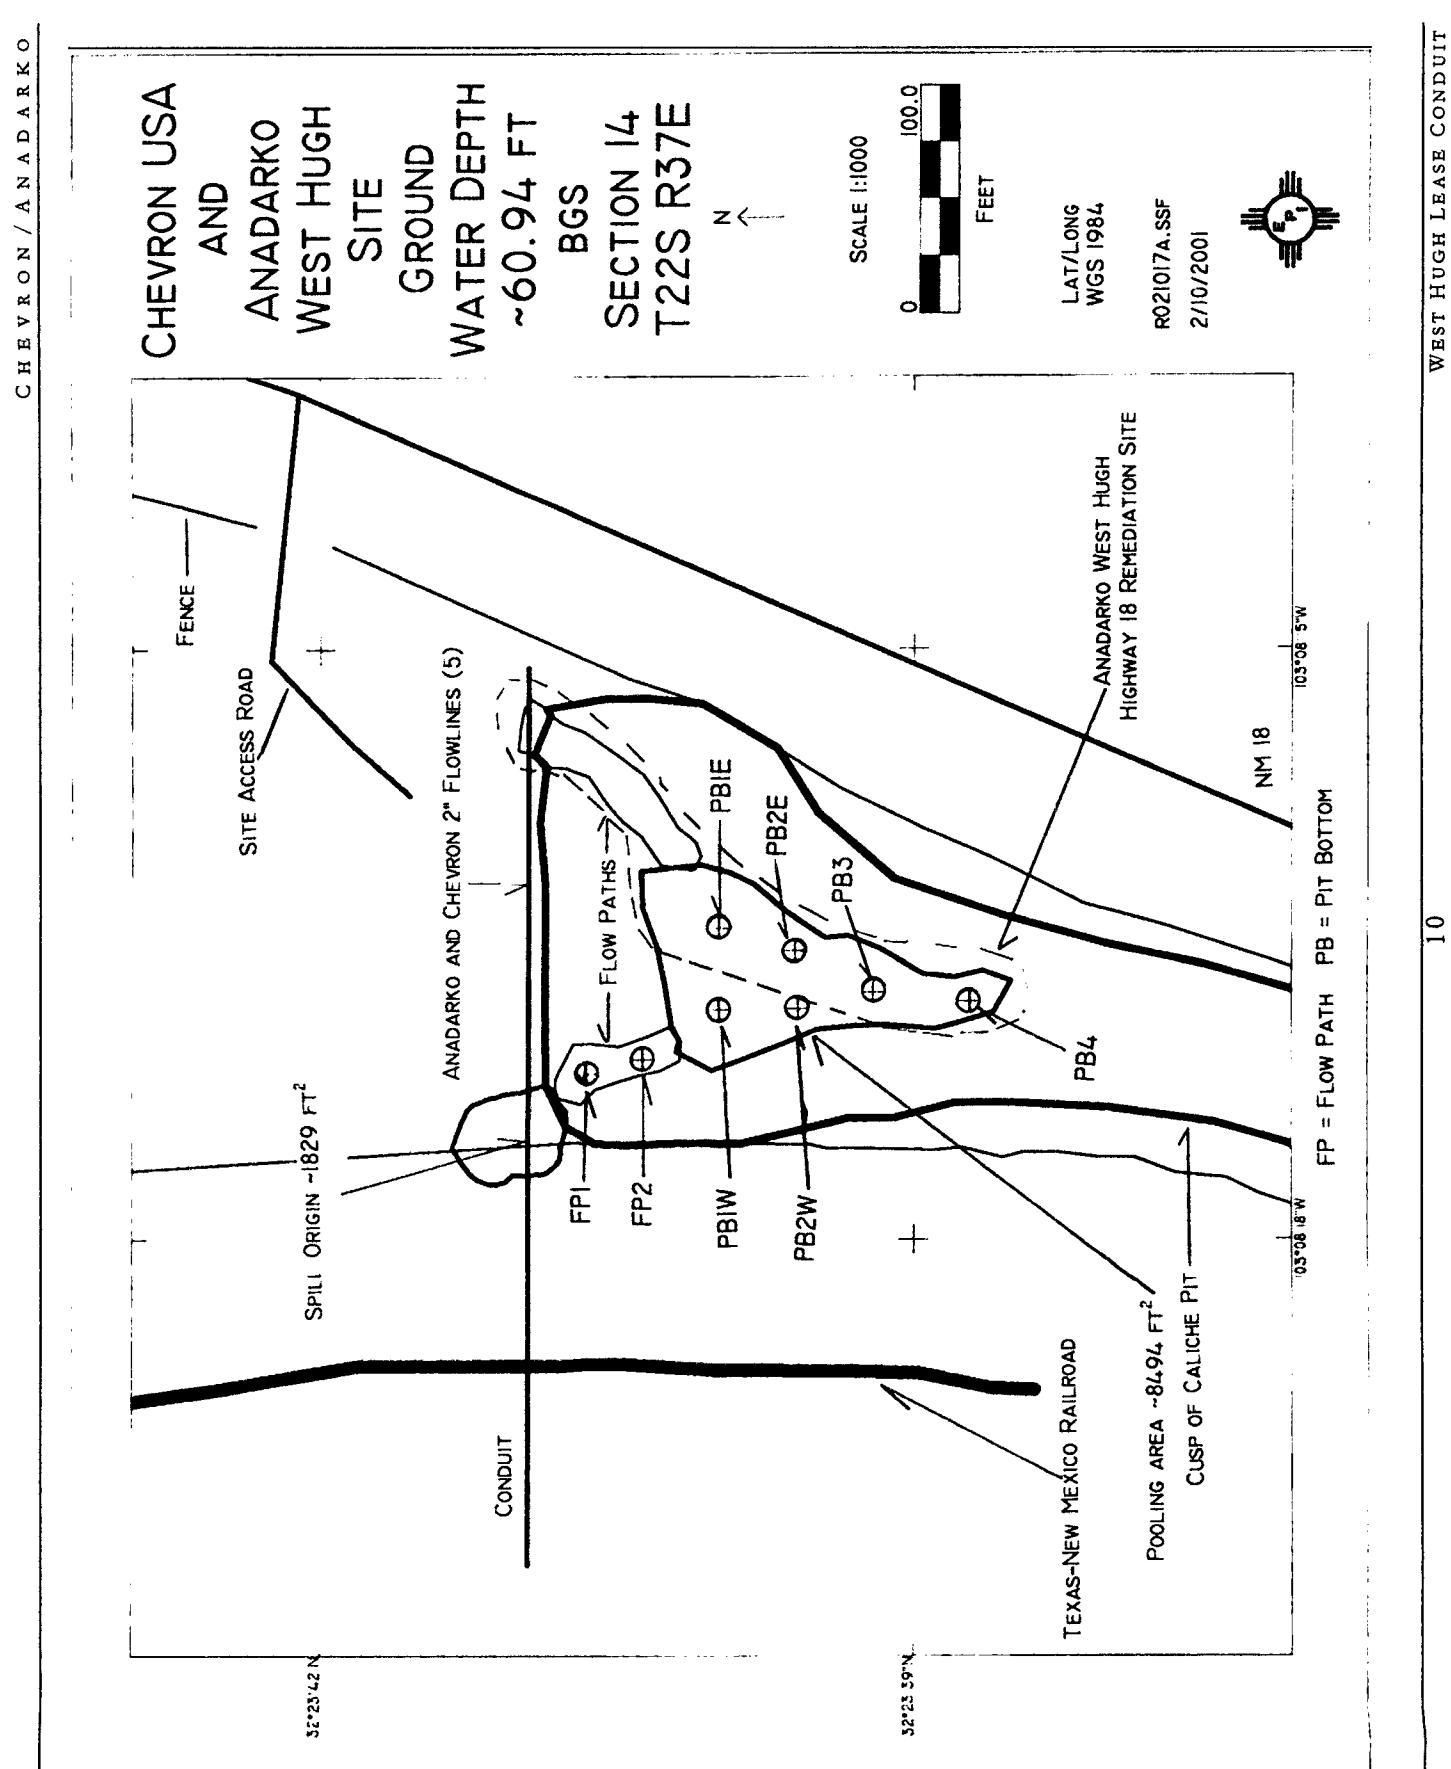
### Attachment I: Site Map

This site is associated with a gallery of five 2" diameter production flow lines owned by Chevron USA and Anadarko Petroleum Corporation that carries production fluid from the Hugh Lease wells east of Highway 18 and the Texas-New Mexico Railroad to the tank batteries on the west via a common conduit under the Texas-New Mexico Railroad right of way. The leak occurred inside the conduit where one or more of the flow lines failed, resulting in production fluid being released to the surface via the east end of the conduit. The decision was made by Chevron and Anadarko managers to first replace or repair the flow lines inside the conduit and then proceed with site remediation. The leak origin lies on the northwest corner of a caliche barrow pit that also received historic run-in from the location. Discovery of the Hugh Lease Top West Conduit site occurred in July 2000, when contractors involved in remediating the Anadarko Top East site located on the northeast corner of the caliche barrow pit, observed crude oil pooling on the surface near the east end of the railroad conduit. Both leaks developed respective flow paths that end in a common pooling area in the bottom of the 25' deep caliche pit. The Top East Anadarko site, flow path, and half the pooling area were remediated to NMOCD standards in August 2000. Details are presented in the "Anadarko West Hugh Highway 18 Conduit Remediation Report, EPI, October 2000." Significant run-in during storm events from the open conduit excavation may have resulted in contaminated fluid recontaminating the pooling area in the bottom of the caliche pit. A site map is included as Attachment I.
