Release Notification

Chaco 2308 4P 149H Narrative

Enduring Resources, LLC Chaco 2308 4P 149H Photo Page

NRM2019555862

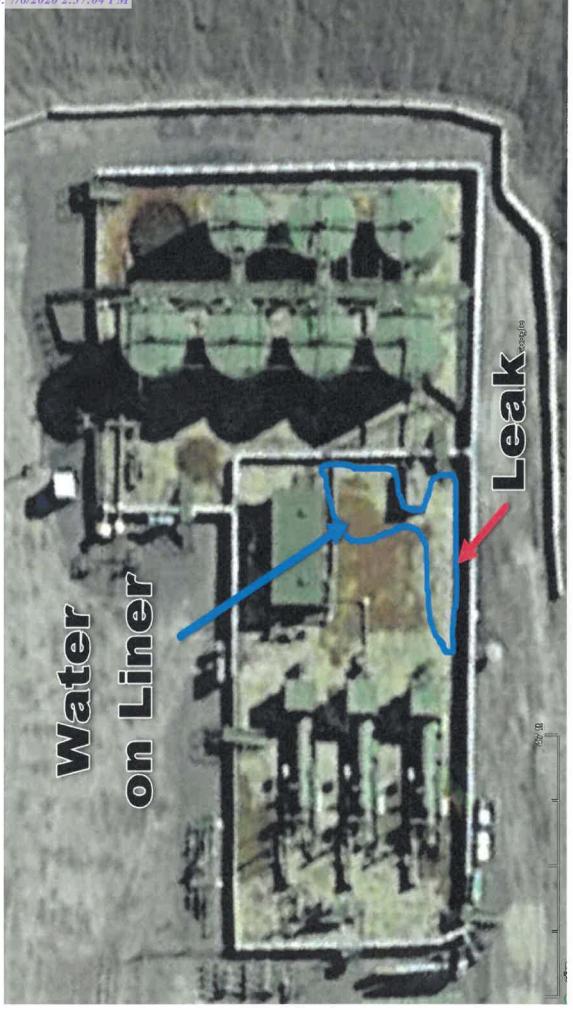
A waterline leak was discovered at the Chaco 2308 4P 149H wellsite. The line leak was due to internal corrosion on the above ground water dump line, leaking 7 bbls of produced water onto the lined secondary containment for this well facility. The leak was stopped and the line repaired.

Photo 1: View of Leaking Line
