MicroBind Case Study – Osage County, OK

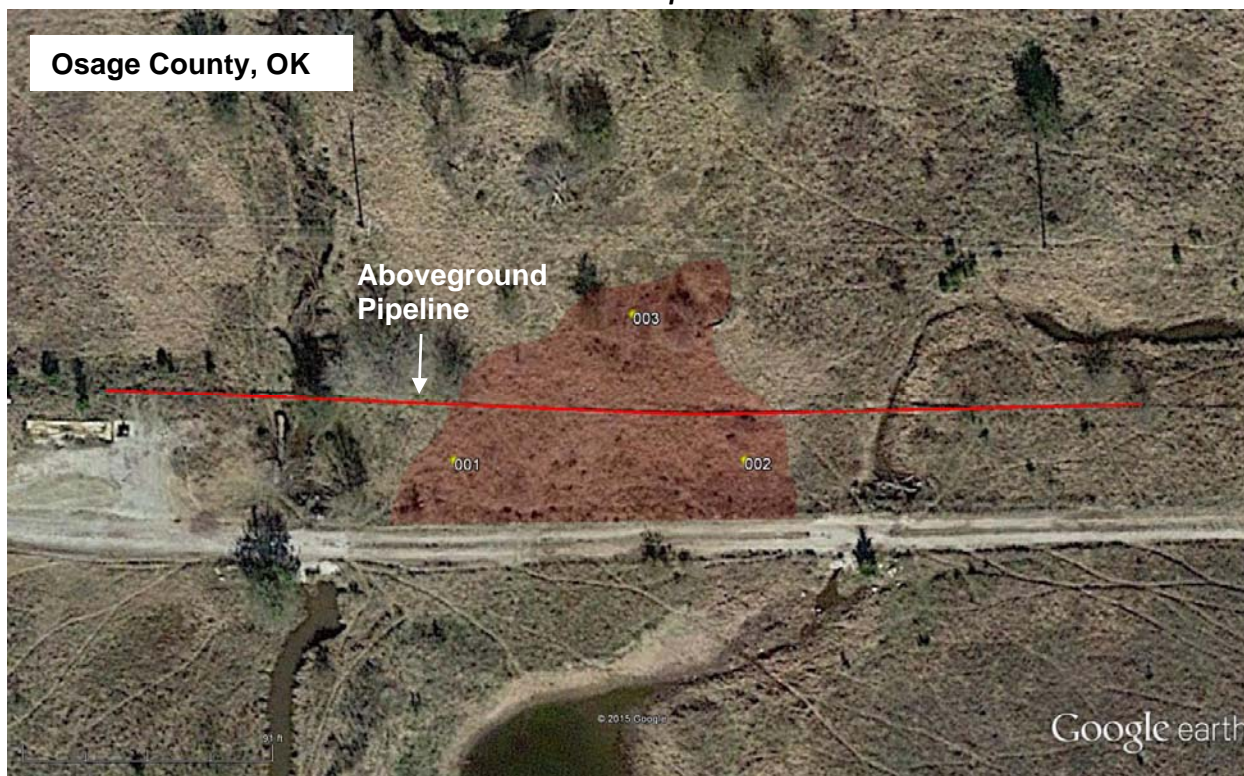
Site Map

1/29/13 Analytical Results		
Sample ID	Depth (ft. bgs)	Total Soluble Salts Results (ppm)
001	0	26,000
001A	1	2,040
002	0	5,140
002A	1	16,800
003	0	26,800
003A	1	12,600

Results indicated Total Soluble Salts (TSS) levels above the Oklahoma Corporation Commission (OCC's) action level of 2,640 ppm in Sample IDs 001, 002, 002A, 003, and 003A.

- Till the impacted area
- Treat the impacted area with an EnviroClean solution and a MicroBind solution
