MicroBind Case Study – Osage County, OK

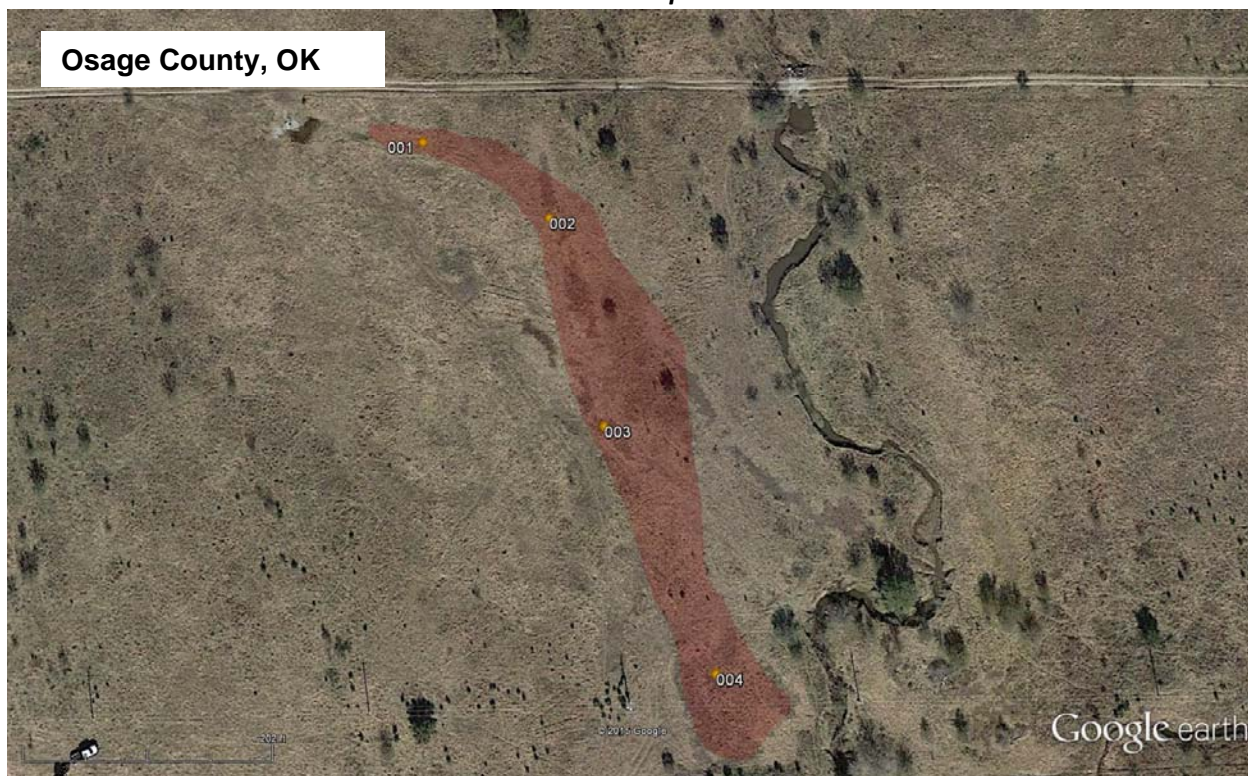
Site Map

Results indicated Total Soluble Salts (TSS) levels above the Oklahoma Corporation Commission (OCC's) action level of 2,640 ppm in Sample IDs 001, 001B, 002, 003, and 004.

5/24/12 – Perform remediation services:

- Till the impacted area
- Incorporate gypsum and manure into the surface of the impacted area
- Seed the impacted area
- Treat the impacted area with a MicroBind solution
