December 18, 2013

RE: NABORS HOBBS RECLAMATION PLANT INVESTIGATION, LEA COUNTY, NEW MEXICO – Address questions in Mr. Leking email of October 30, 2013.

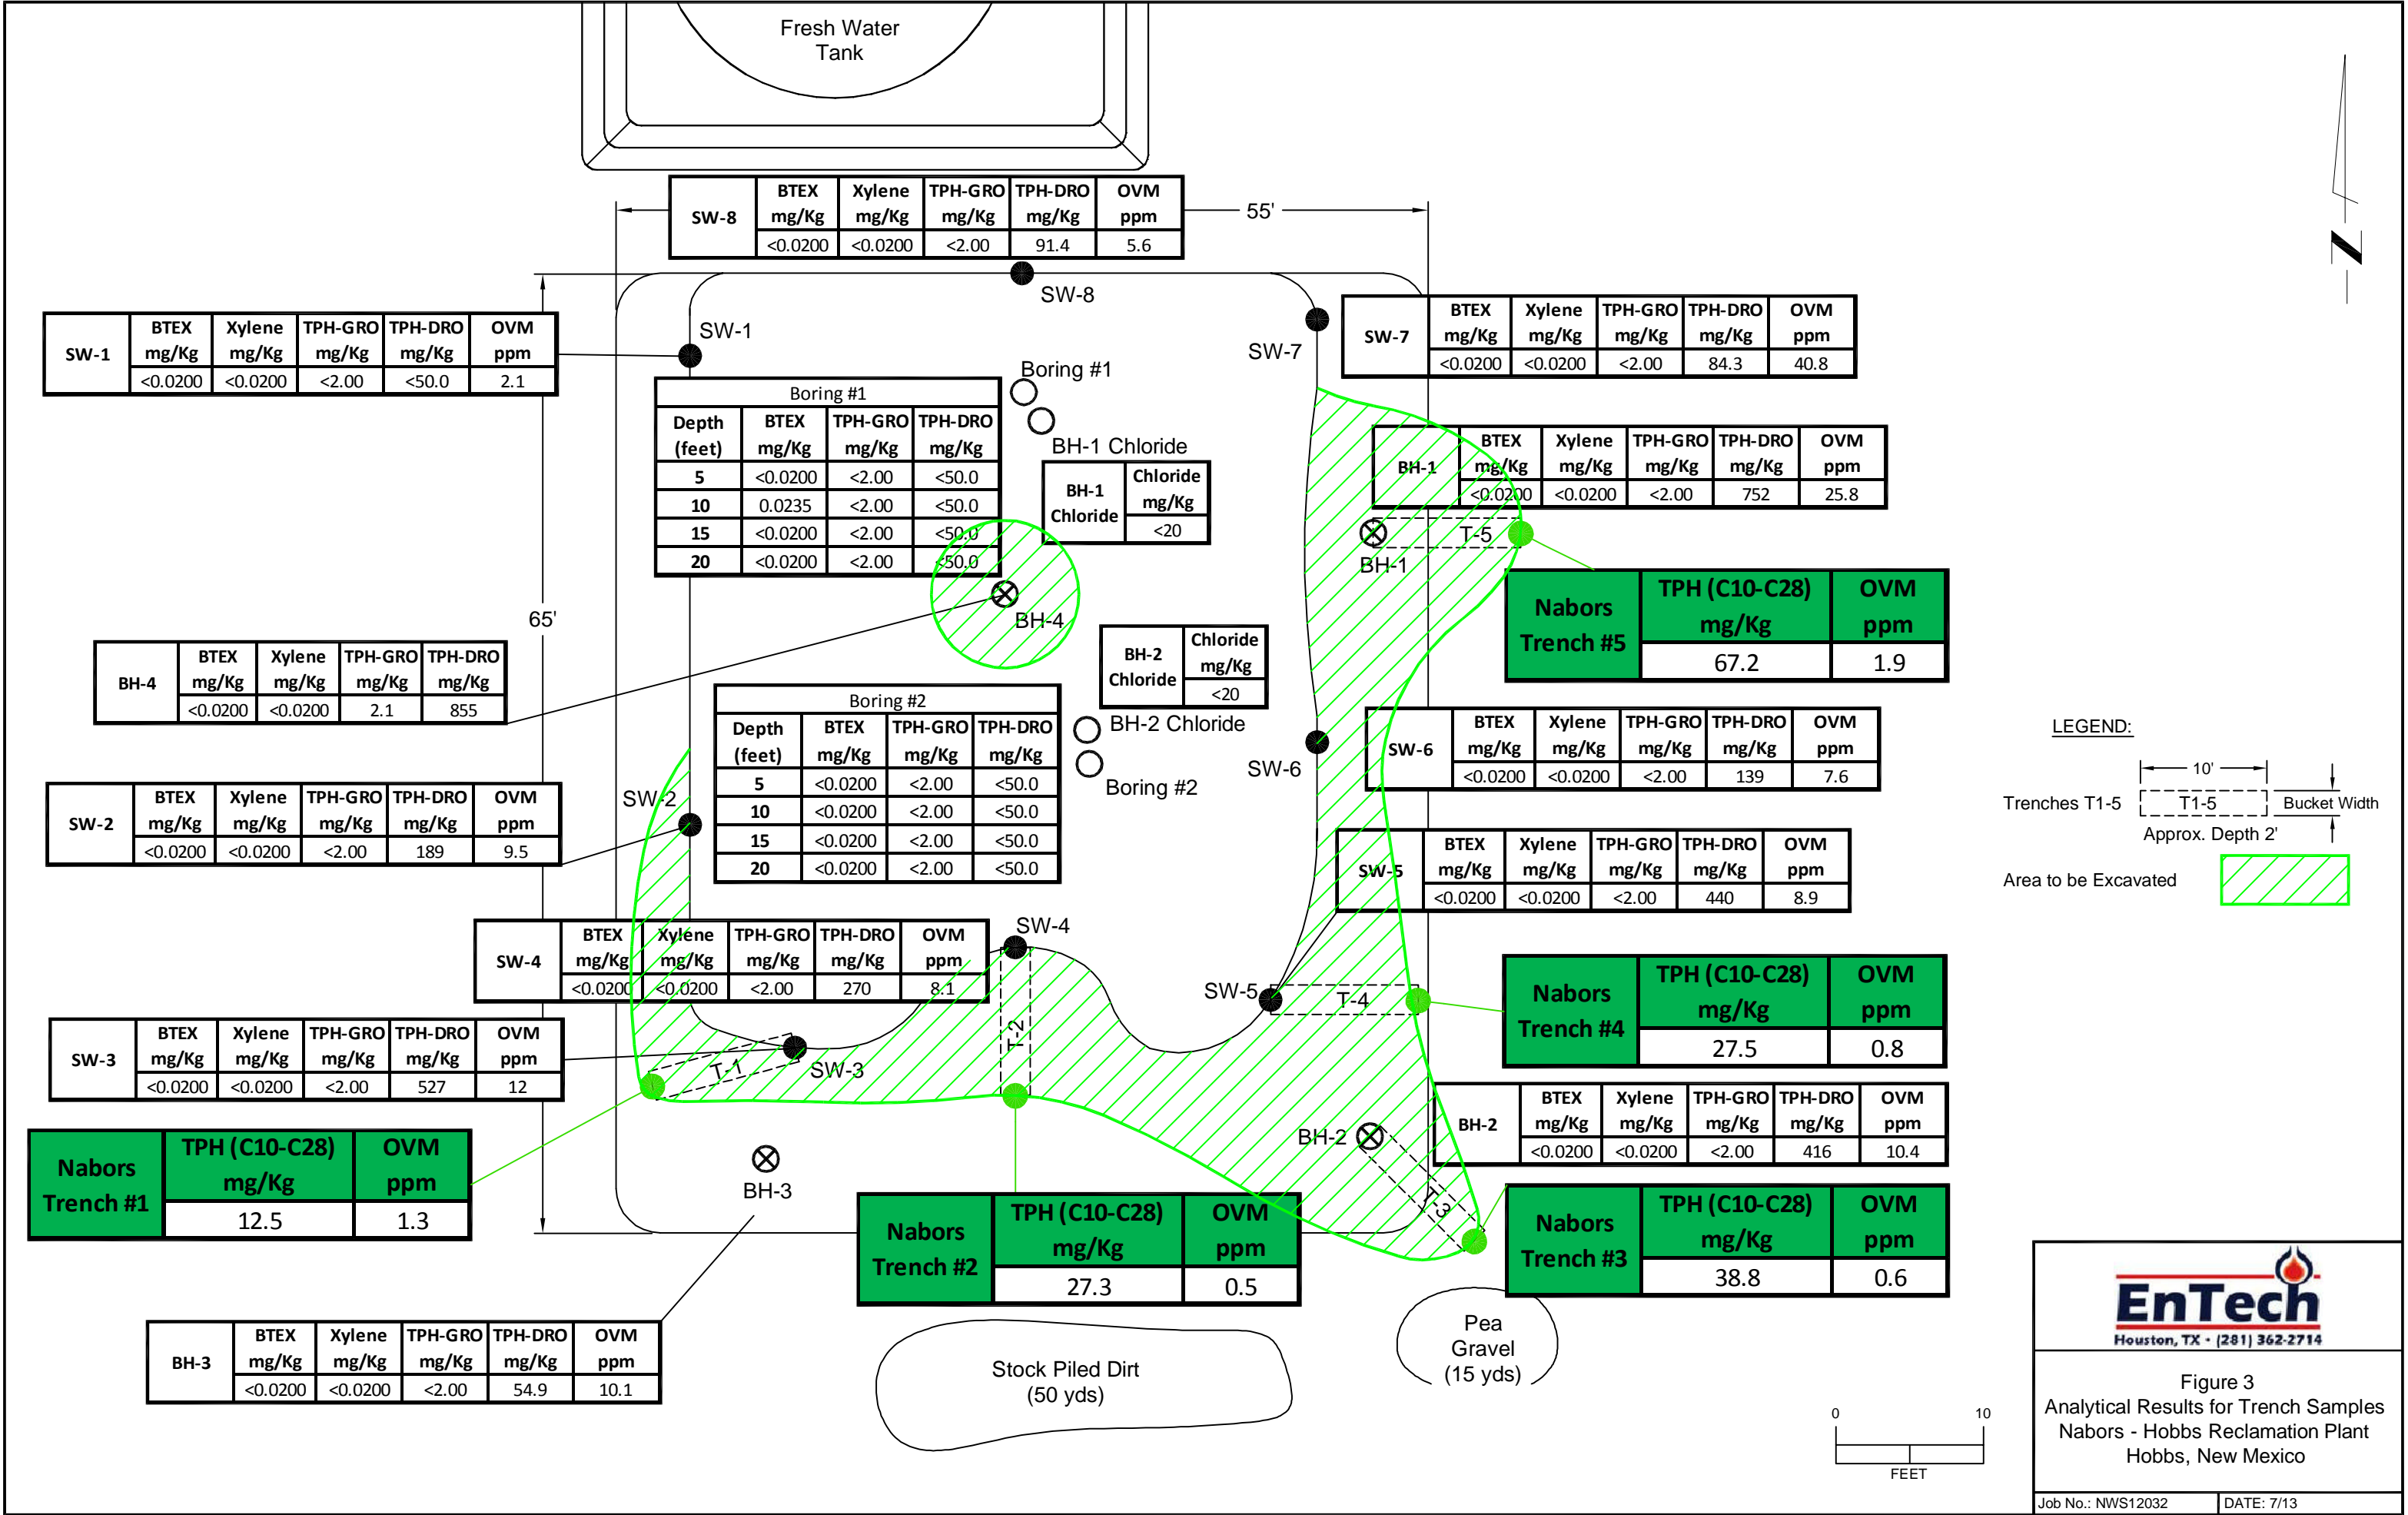
Photo 1 – Sample locations

The excavation was approximately 1-2 feet deep where the massive caliche cap rock was encountered. The boring log for Nabors water well report indicated this caliche layer is 16 feet thick. During the excavation photographs were taken. Photographs are enclosed in Attachment A. **Photo 1**, depicts the excavation and location of sidewall samples and shallow borings BH-1 through BH-3, which were

collected after removal of the surface pea gravel. These samples were scraped from the top of the hard caliche cap rock. The depth of BH-1 through BH-3 were 6-9 inches deep, as the pea gravel was thinner in outer section of the pea gravel base on which the tanks were originally located. All samples were collected following New Mexico Oil Conservation Division's (NMOCD) stated limit in their "Guidelines for Remediation of Spills, Leaks, and Releases", when screening with an OVM and removing affected soils with OVM readings above 100 ppm. These samples were initially collected to delineate the horizontal extent of contamination. As the OVM readings were well below 100 on the sidewall samples and BH-1 through BH-3 sample, we anticipated the analytical results would be below regulatory limits. Upon receipt of laboratory analytical results with TPH-DRO concentrations ranging from less than the detection limit to 752 mg/kg, we then dug the perpendicular trenches to further delineate horizontal limits of contamination away from the main excavation. The location of these trenches were specifically chosen to further delineate areas of contamination above 400 mg/kg TPH-DRO. The results of the samples collected at the end of these trenches were all below 100 mg/kg TPH-DRO. The green area in **Figure 3** is the extra excavation that we have proposed so that contamination identified in the initial samples can be remove to a point where TPH concentration are below 100 mg/kg at the end of the trenches. This should allay your fears that there are not more samples on the periphery besides BH-3.

BH-4 was taken in the middle of the excavation at a depth of approximately 2 feet. It too was a sample of the hard caliche cap rock. A photograph log of other pictures is enclosed in Attachment A. Initially a backhoe was used however, it was replaced with an excavator to complete the perpendicular trenches.

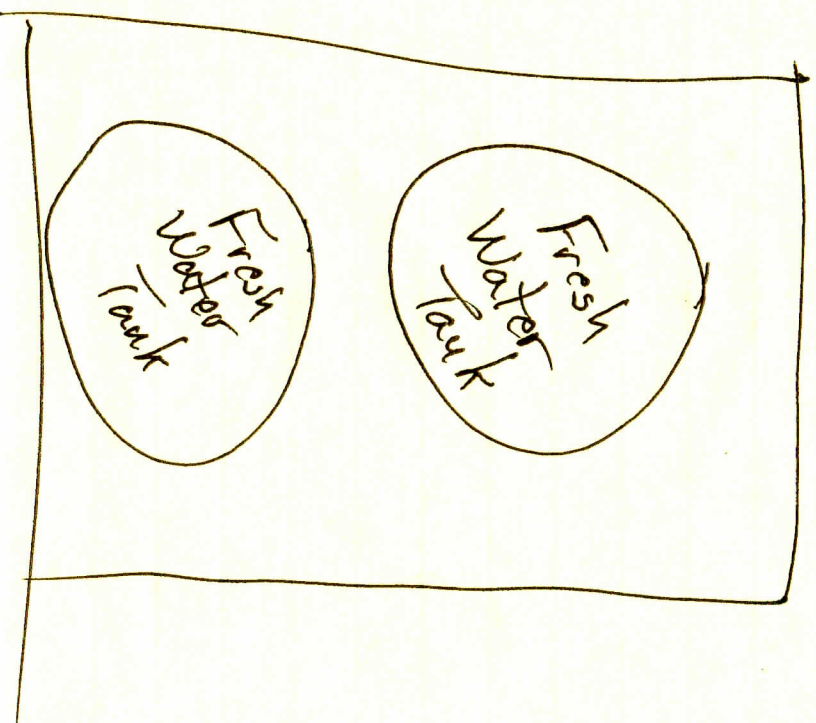
Photograph 1. Looking North at site before starting remediation. Tank in background is a fresh water tank.
