Gandy Corporation Nuckols 24 #1 Site Investigation Section 24, Township 7S, Range 31E Chaves County, New Mexico

April 12, 2016

SESI was contracted to perform a site investigation to determine the vertical extent of contamination at the Nuckols 24 #1 location. The subject area is located in Section 24, Township 7S, Range 31E in Chaves County, New Mexico.

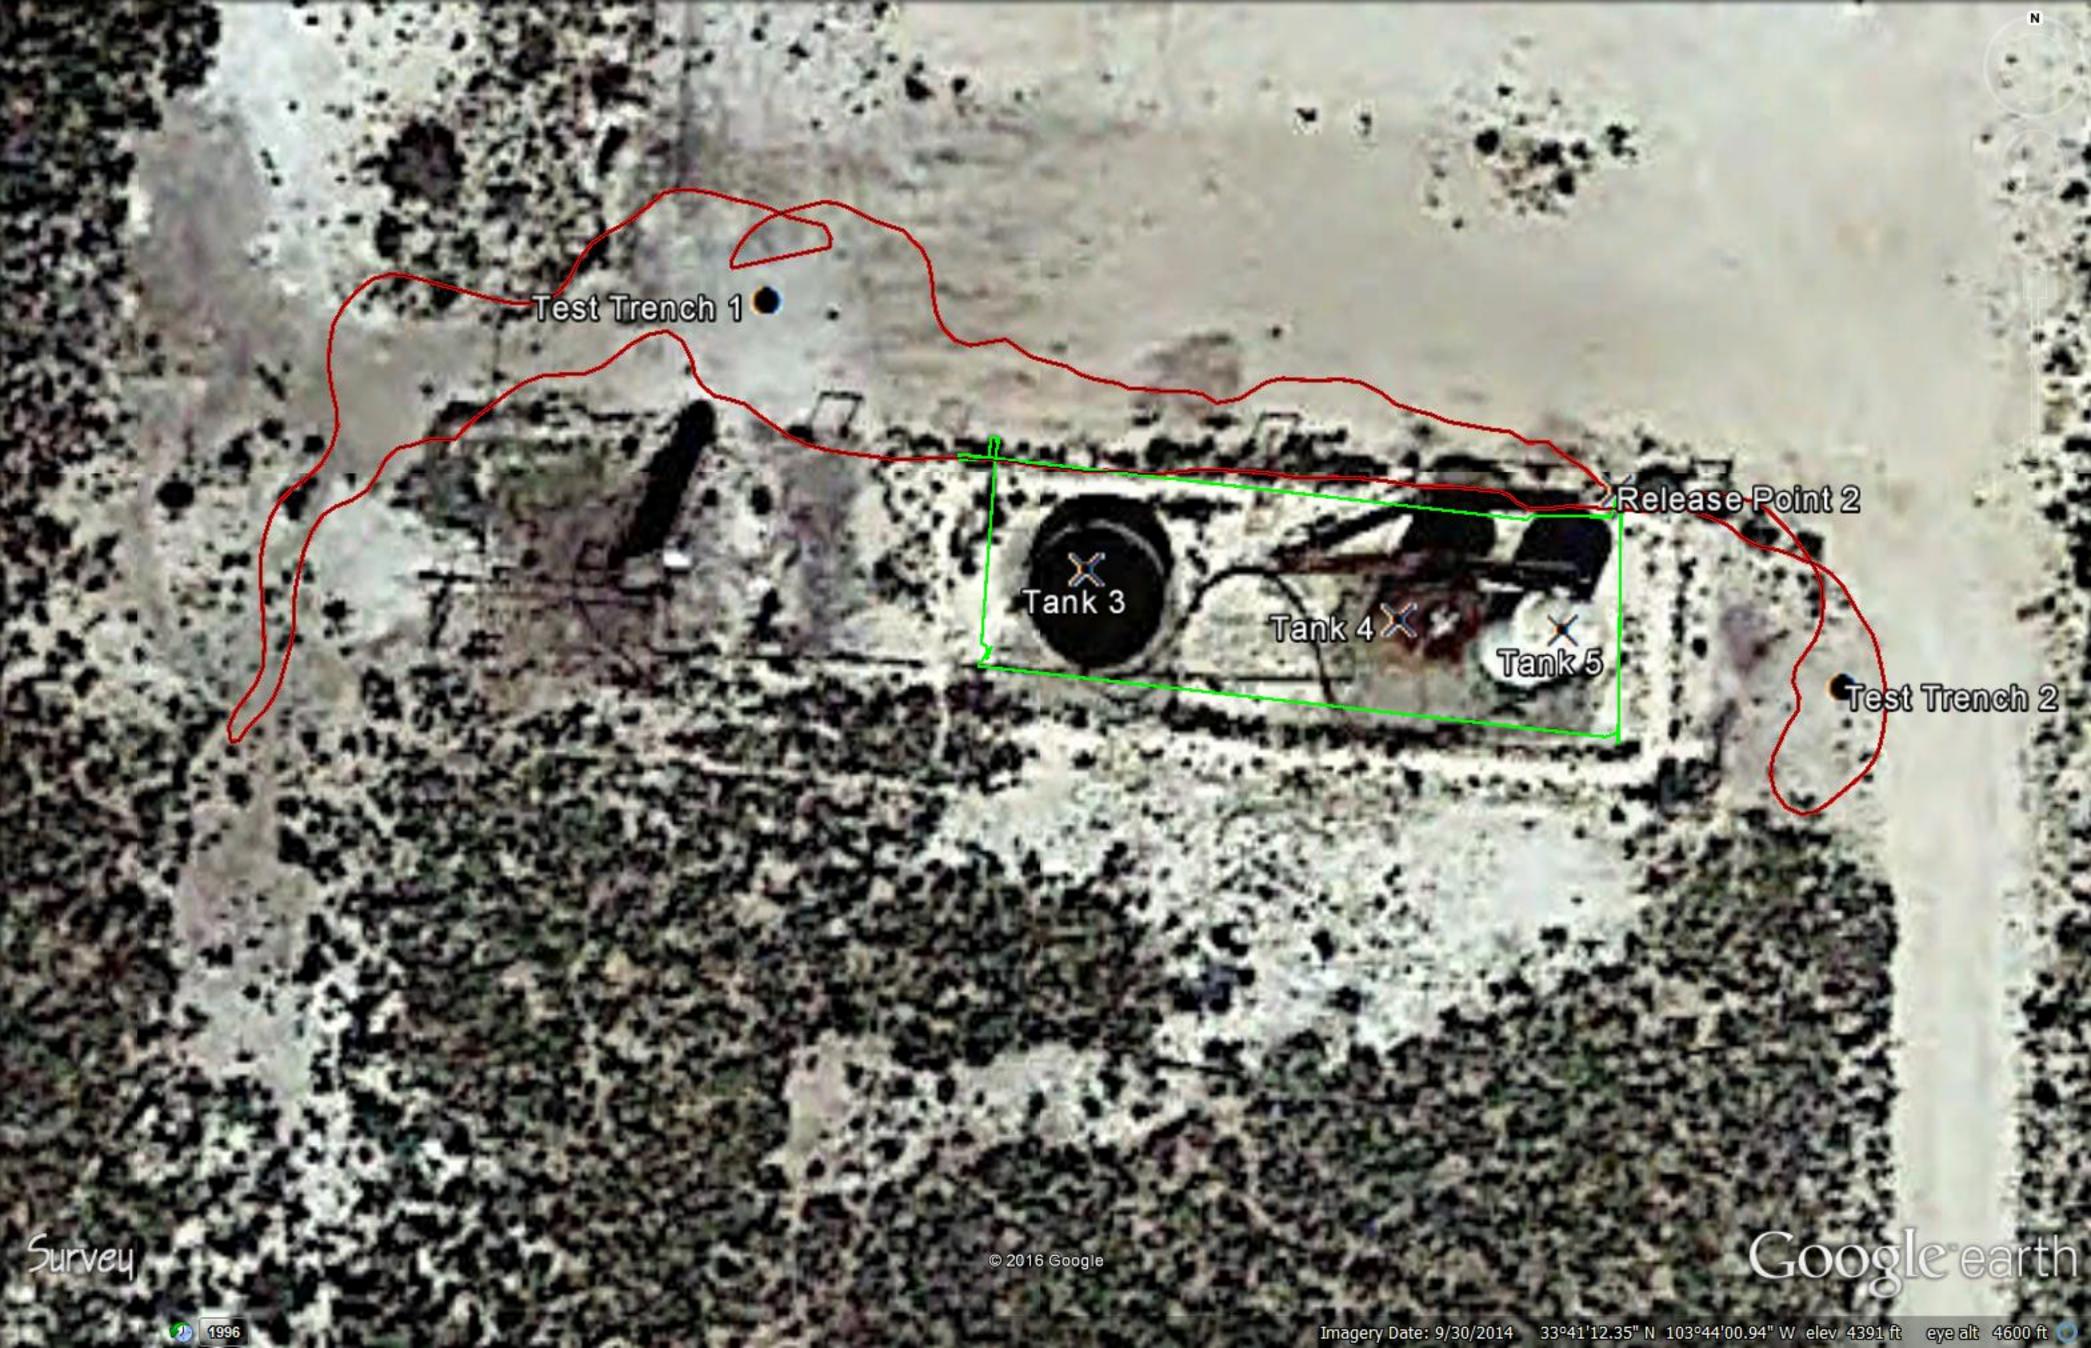
Figure 1 Site Plan

On April 11, 2016 SESI personnel, Gandy personnel together with a backhoe and operator, as well as a Rocky Mountain representative were on site to assess the spill area at this location. Heavy hydro carbon staining on the area were present (Figure 2). The location and spill area were mapped using a handheld Juno 3B (Figure 1). The spill area measured approximately 4,440.88 sq. ft. The backhoe operations included but were not limited to surface scraping of visual staining followed by the installation of test trenches. The results are recapped in the following table:

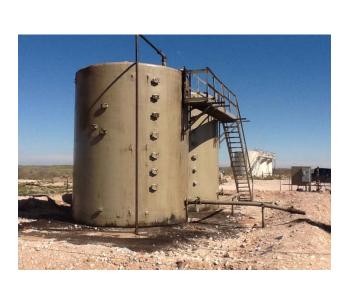
Standing fluid west of pad
