Pit, Below-Grade Tank, or Proposed Alternative Method Permit or Closure Plan Application

1.
Operator: **Burlington Resources** OGRID #: 14538
Address: PO BOX 4289, Farmington, NM 87499
Facility or well name: San Juan 29-7 Unit 106
API Number: 3003920645 OCD Permit Number:
U/L or Qtr/Qtr K (NESW) Section 36 Township 29N Range 7W County: Rio Arriba
Center of Proposed Design: Latitude 36.67949000 °N Longitude -107.52428000 °W NAD: ☒1927 ☐ 1983
Surface Owner: ☐ Federal ☒ State ☐ Private ☐ Tribal Trust or Indian Allotment

Burlington Resources Oil Gas Company, LP
San Juan Basin
Below Grade Tank Closure Report

RE: BELOW GRADE TANK CLOSURE DOCUMENTATION FOR THE SAN JUAN 29-7 UNIT 106 (HBR) WELL SITE, RIO ARRIBA COUNTY, NEW MEXICO

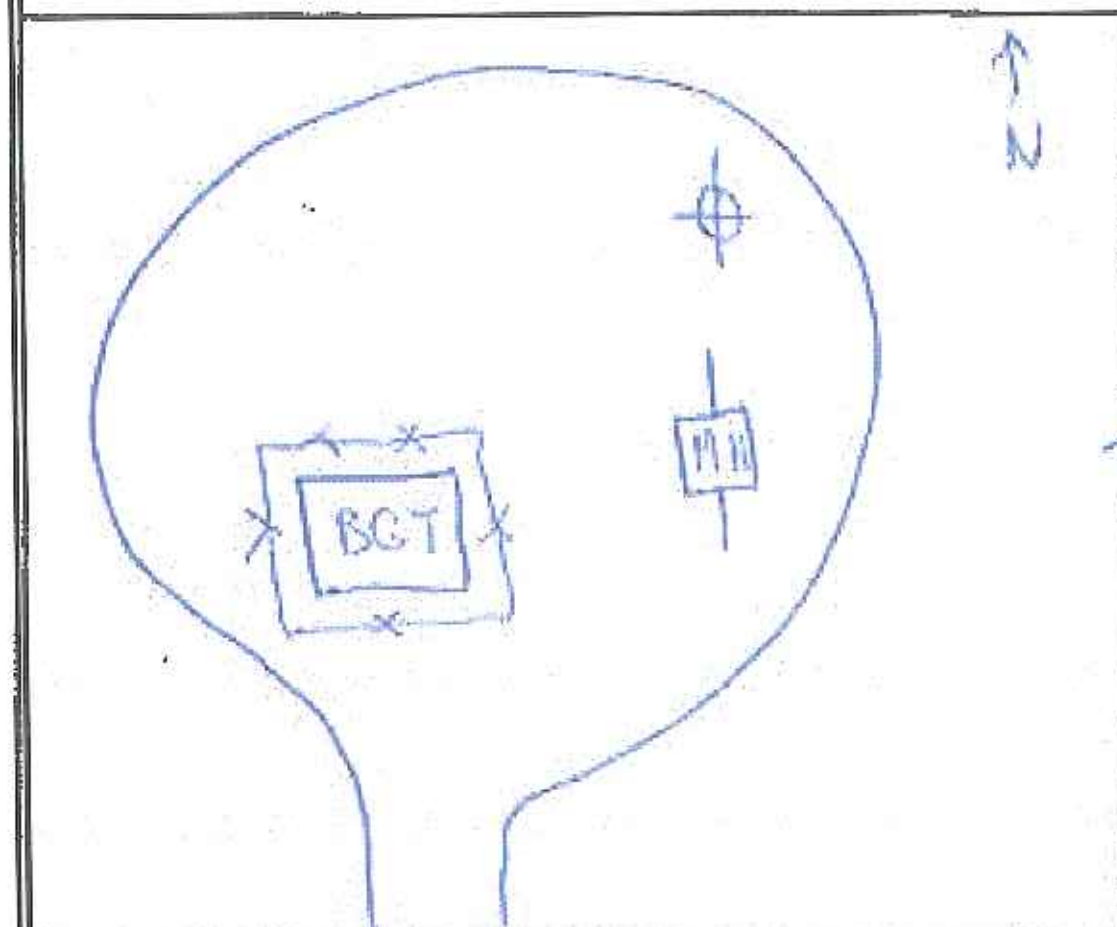
PERIMETER

TIME	SAMPLE I.D.	LAB NO.	WEIGHT (g)	mL FREON	DILUTION	READING	CALC. (mg/kg)
13:12	206 STD		-	-	-	185	
13:20	BGT Comp	1	5	20	4	9	36
	1	2					
		3					
		4					
		5					
		6

SAMPLE ID	READING	CALC. (mg/kg)
1	ND

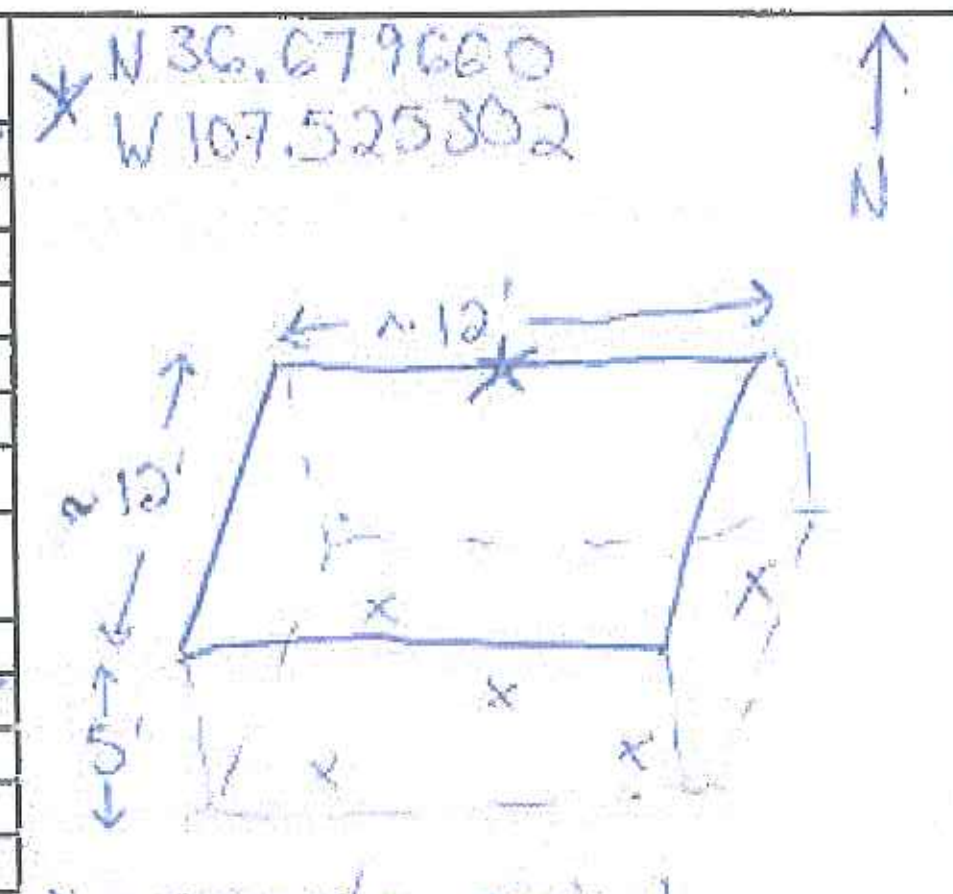
PROFILE

LAB SAMPLES		
SAMPLE ID	ANALYSIS	RESULTS
1	BENZENE	
1	BTEX	
	GRO & DRO	
1	CHLORIDES

NOTES: P&A Job. BGT removed prior. Liner removed upon arrival. Cribbing in place. Talked to Kelsi with field results. Kelley Oilfield onsite.
