Pit, Closed-Loop System, Below-Grade Tank, or Proposed Alternative Method Permit or Closure Plan Application

Operator WILLIAMS PRODUCTION COMPANY, LLC OGRID # 120782

Facility or well name: ROSA UNIT #080A

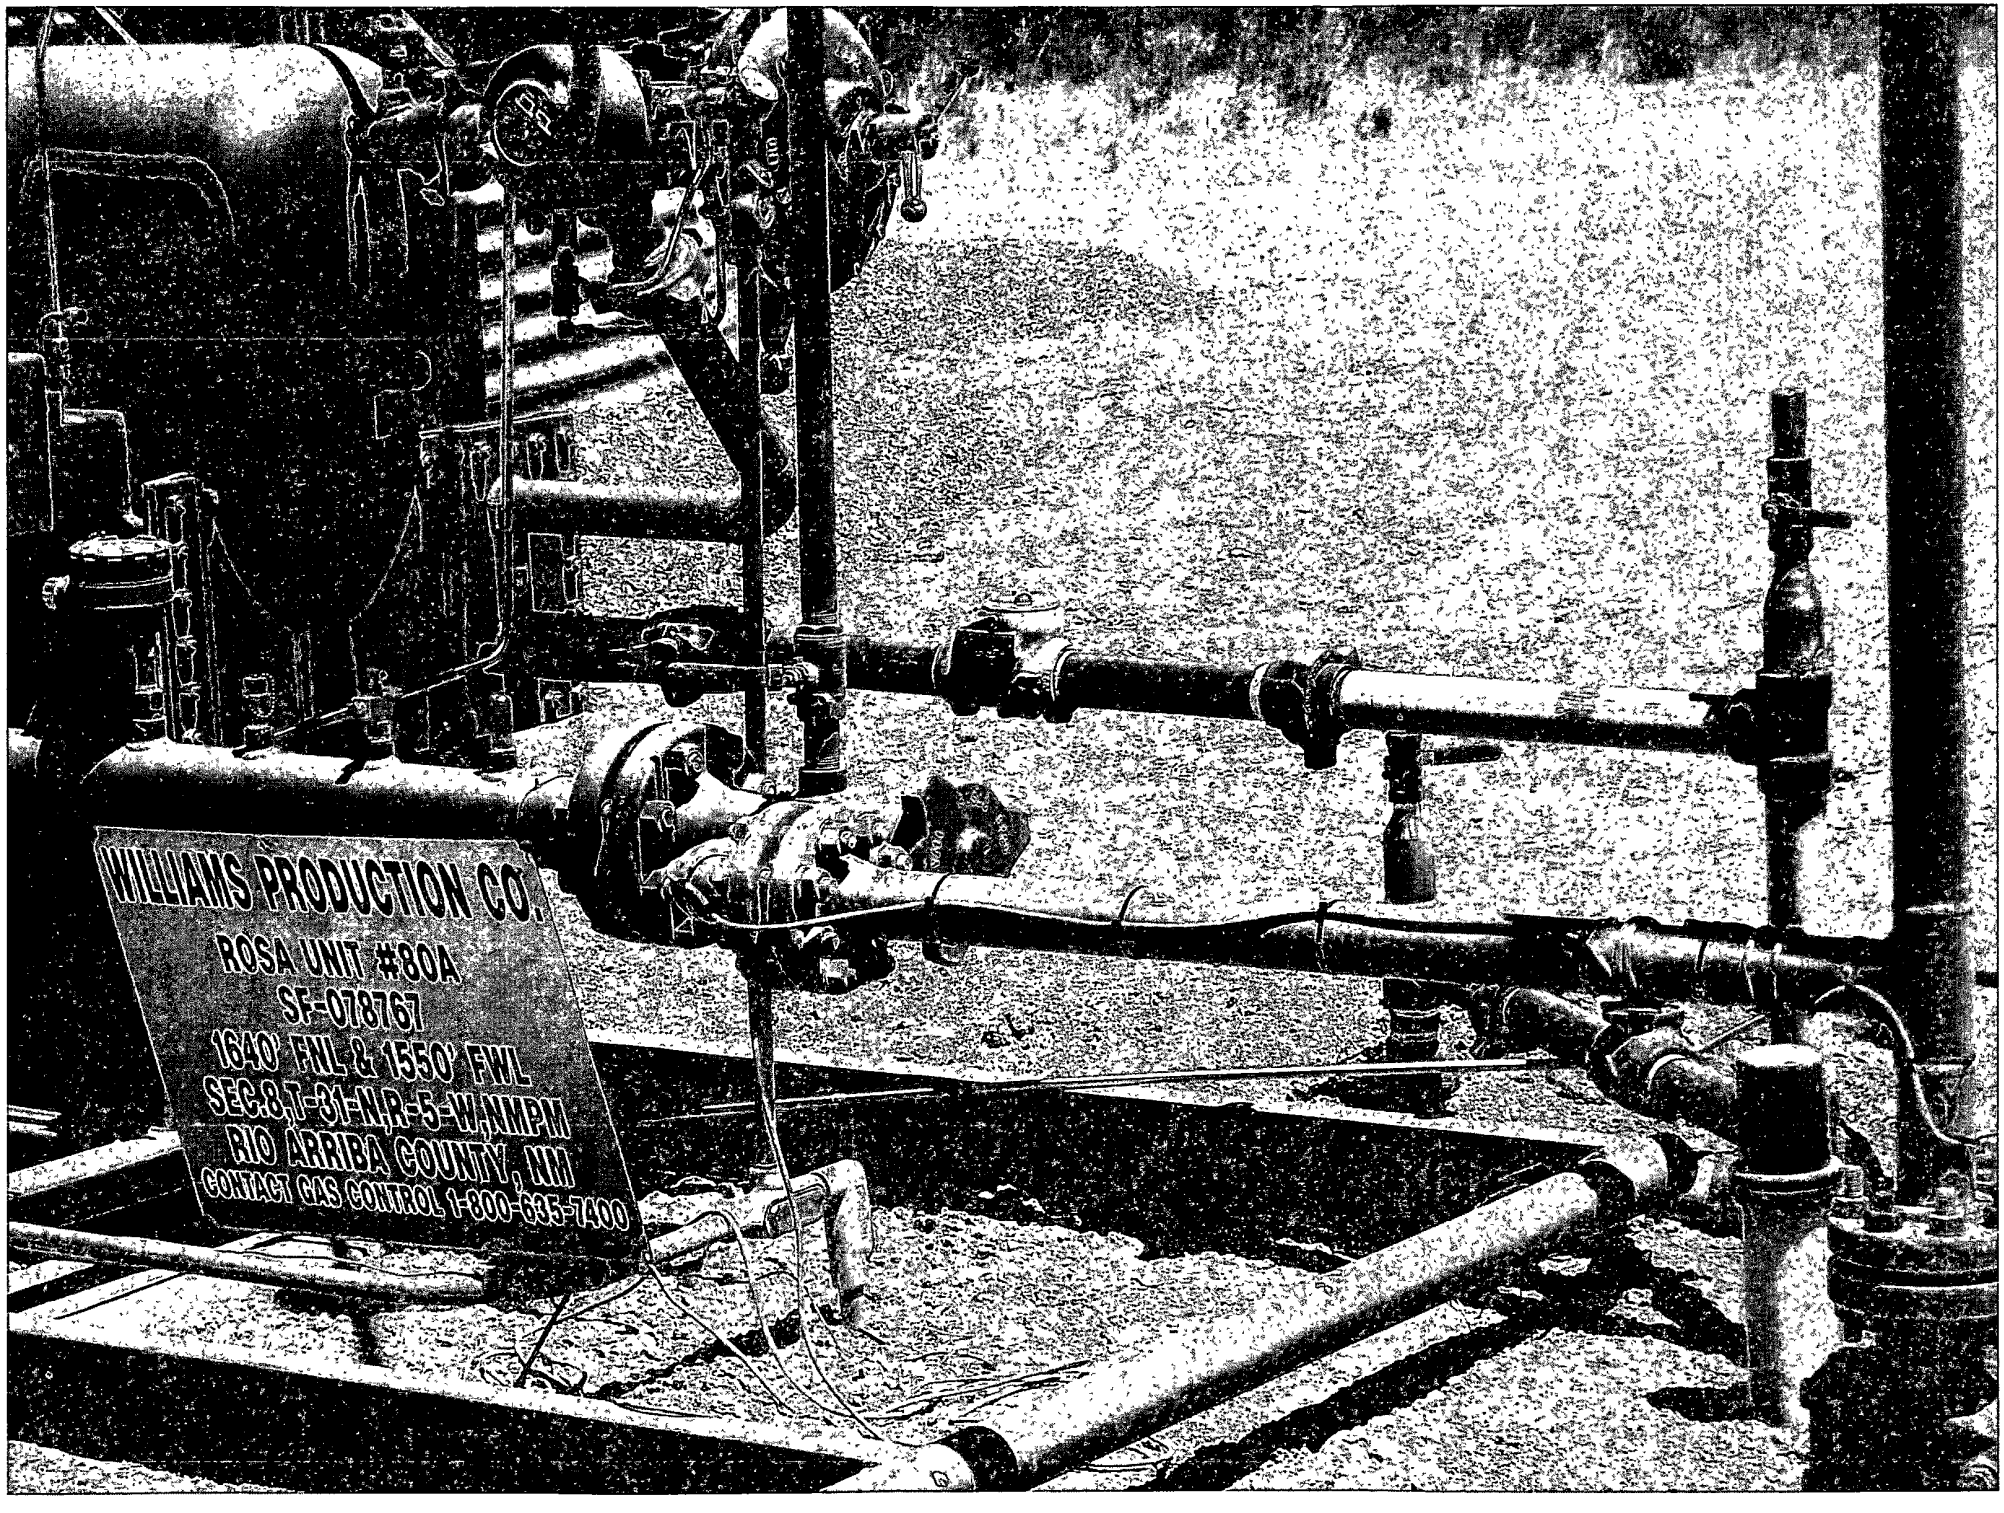
WILLIAMS PRODUCTION CO.
ROSA UNIT #80A
SF-078767
1640' FNL & 1550' FWL
SEC.8,T-31-N,R-5-W,NMPM
RIO ARRIBA COUNTY, NM
CONTACT GAS CONTROL 1-800-635-7400

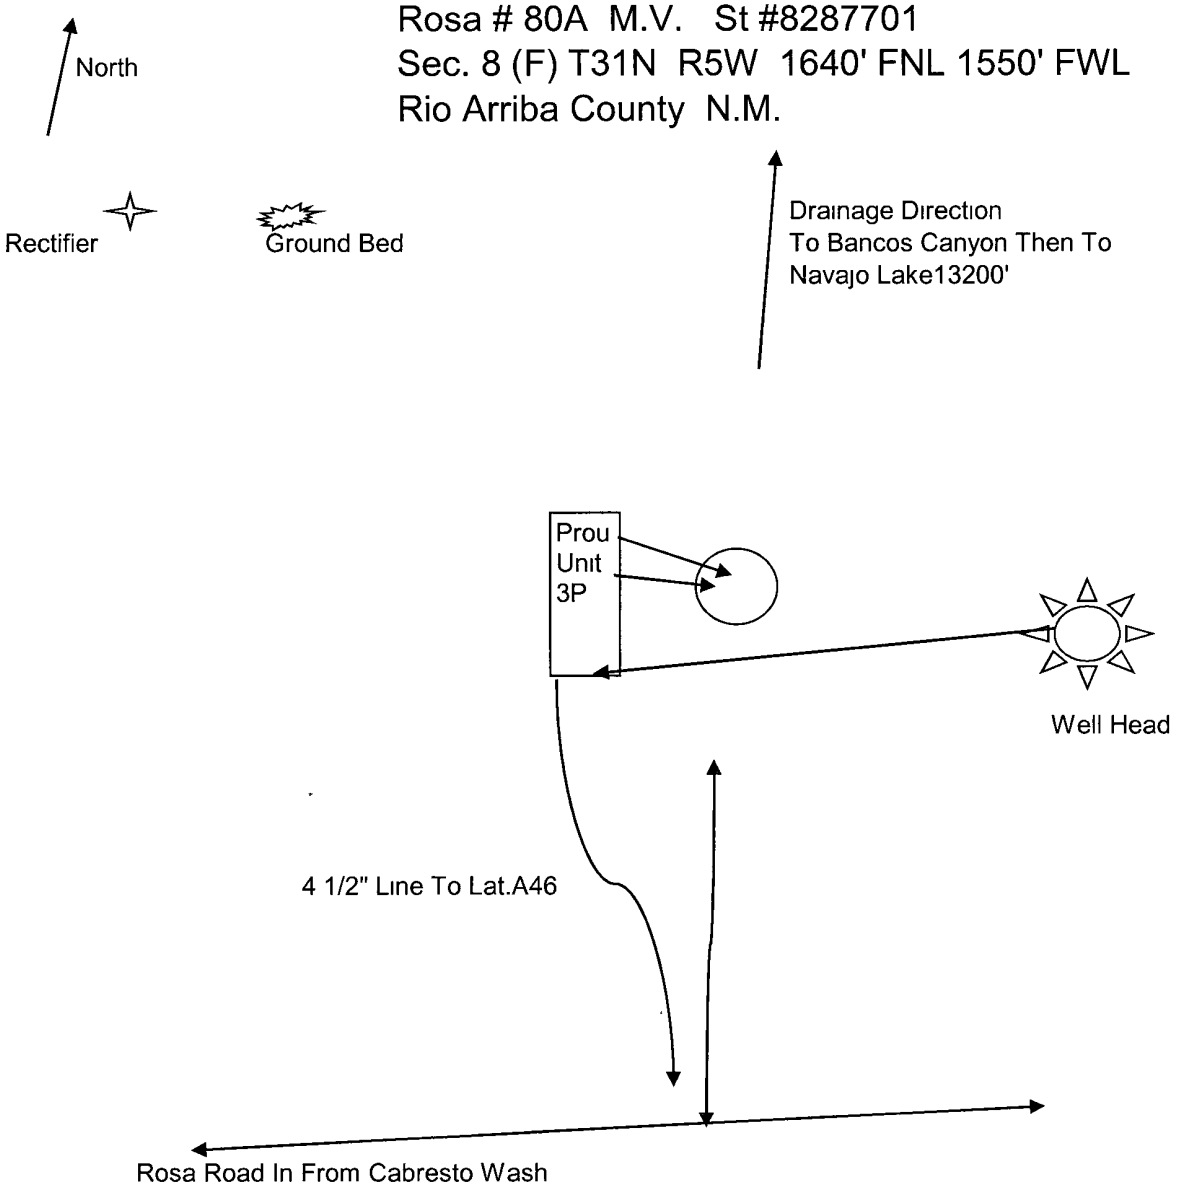
Williams Production Company
Rosa # 80A M.V. St #8287701
Sec. 8 (F) T31N R5W 1640' FNL 1550' FWL
Rio Arriba County N.M.

Sep. Pesco 3 Ph. Ser #203971 Year 2001
Pit 120 Bbl Fiberglass Lined & leak Detection
Rectifier A J. Electronic 180/240 Volts Ser # 99167
