HUNGRY HORSE, LLC

To: Mike Bratcher, New Mexico Oil Conservation Division Crystal Weaver, New Mexico Oil Conservation Division Shelly Tucker, Bureau of Land Management **Reference: Remediation Work Plan Operator: Deveon Energy Production Company** Location: Spica 25 Fed 3H API: 30-015-40220 Legals: UL. L, Sec 25, T19S, R31E Eddy County, New Mexico GPS: 32.6288 -103. 8301 NMOCD-2RP 4278

Remediation Proposal

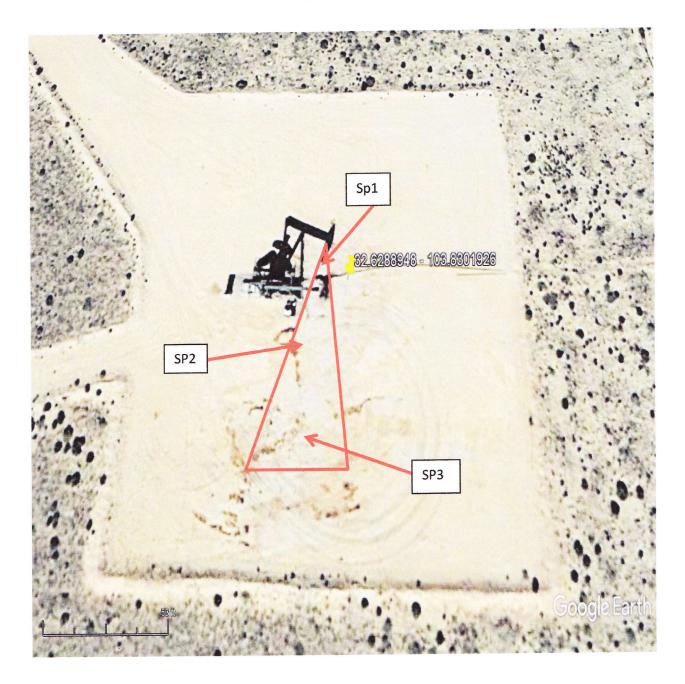
Devon Energy Company Spica 25 Fed 3H

The impacted area is in a cone shape extending from the well head to the southwest approximately 30'. At its widest point it is approximately 20' wide.

The malfunctioning equipment was repaired at the time of discovery and all free standing liquid was recovered by a vacuum truck. Delineation of the impacted area was conducted using a hand auger. Soil samples were collected at 1' intervals and field tested for chlorides (see field test results). Select samples based on field test were selected for lab analysis (see lab report).

Sp1	Sp2	Sp3
Surface	4,160	9,104	2,144
6 inches	4,160	3,226	902
1 ft	1,116	1,300	496
1ft 6 inches	1,302	1,204	198
2 ft	1,302	1,302	n/d
3ft	828	4,970	
4ft	198	4,970	
5ft	112	3,226	
6ft		2,736	
7ft		1,418	
8ft		240	
9ft		144
