Pit, Closed-Loop System, Below-Grade Tank, or Proposed Alternative Method Permit or Closure Plan Application

1.
Operator: BP AMERICA PRODUCTION COMPANY OGRID #: 778
Address: 200 Energy Court, Farmington, NM 87401
Facility or well name: GALLEGOS CANYON UNIT 579
API Number: 3004530672 OCD Permit Number:
U/L or Qtr/Qtr G Section 34.0 Township 29.0N Range 12W County: San Juan County
Center of Proposed Design: Latitude 36.68628 Longitude -108.08372 NAD: ☐ 1927 ☒ 1983
Surface Owner: ☐ Federal ☐ State ☒ Private ☐ Tribal Trust or Indian Allotment

FIELD REPORT:

SITE NAME: GCU # 579

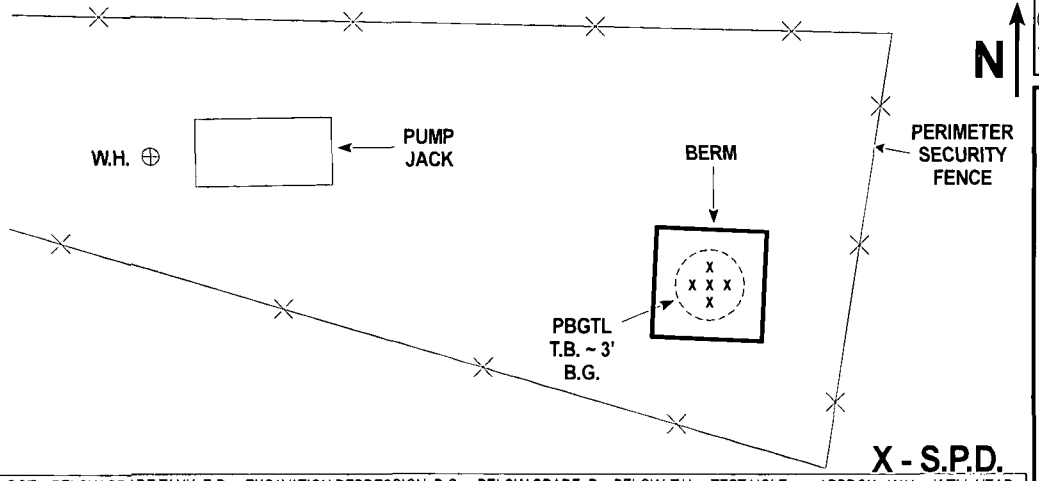
SITE SKETCH

ADDITIONAL COMMENTS: BGT - 15' DIAMETER LOW PROFILE.

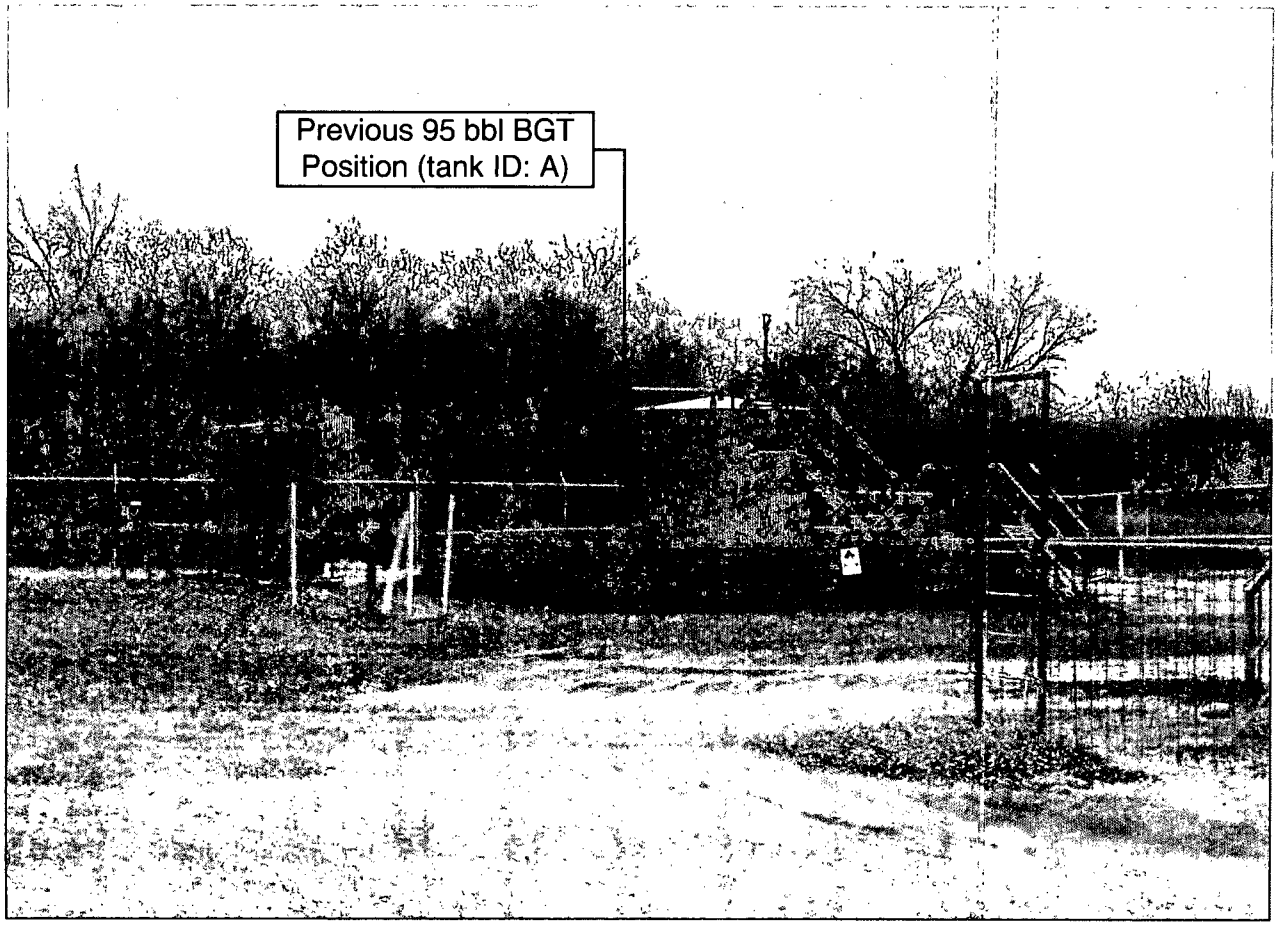
Previous 95 bbl BGT
Position (tank ID: A)

Describe Area Affected and Cleanup Action Taken.* BGT was removed and the area underneath the BGT was sampled. The excavated area was backfilled and compacted and the production tank was placed over the site.
