Pit, Closed-Loop System, Below-Grade Tank, or Proposed Alternative Method Permit or Closure Plan Application

1.
Operator: BP AMERICA PRODUCTION COMPANY OGRID #: 778
Address: 200 Energy Court, Farmington, NM 87401
Facility or well name: THURSTON COM A 001
API Number: 3004524042 OCD Permit Number:
U/L or Qtr/Qtr A Section 31.0 Township 31.0N Range 11W County: San Juan County
Center of Proposed Design: Latitude 36.860911 Longitude -108.02509 NAD: ☐1927 ☒ 1983
Surface Owner: ☐ Federal ☐ State ☒ Private ☐ Tribal Trust or Indian Allotment

BELOW-GRADE TANK CLOSURE PLAN

Thurston Com A 1
API No. 3004524042
Unit Letter A, Section 31, T31N, R11W

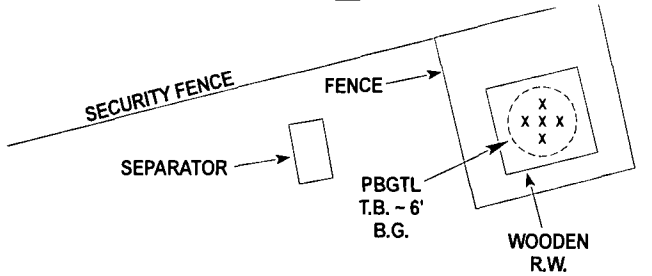
SITE SKETCH

BGT Located : off / on site

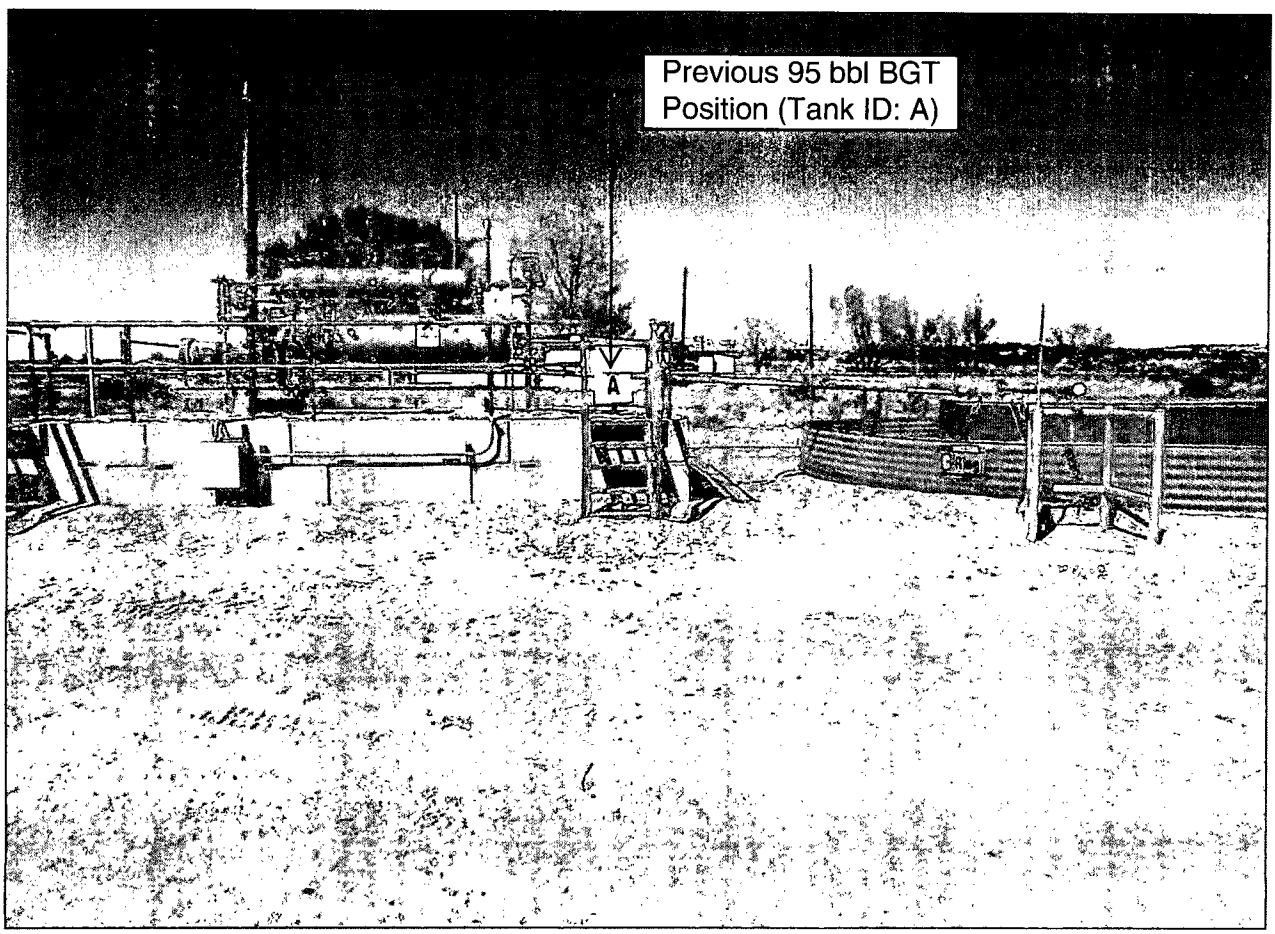
Previous 95 bbl BGT
Position (Tank ID: A)
A

All liquids and sludge in the BGT were removed and sent to one of the above NMOCD approved facilities for disposal.

4. BP shall remove the BGT and dispose of it in a NMOCD approved facility or recycle, reuse, or reclaim it in a manner that the NMOCD approves. If a liner is present and must be disposed of it will be cleaned by scraping any soils or other attached materials on the liner to a de minimus amount and disposed at a permitted solid waste facility, pursuant to Subparagraph (m) of Paragraph (1) of Subsection C of 19.15.35.8 NMAC. Documentation as to the final disposition of the removed BGT will be provided in the final closure report.
The BGT was transported to a storage area for sale and re-use.

5. BP shall remove any on-site equipment associated with a BGT unless the equipment is required for well production.
All equipment associated with the BGT has been removed.

Soil under the BGT was sampled and TPH, BTEX and chloride levels were below the stated limits. Sampling data is attached.

9. If the sampling demonstrates that a release has not occurred or that any release does not exceed the concentrations specified above, then BP shall backfill the excavation, with compacted, non-waste containing, earthen material; construct a division-prescribed soil cover, re-contour and re-vegetate the location. The location will be reclaimed if it is not with in the active process area
The area under the BGT was backfilled with clean soil and is covered by the raised separator pad.
