Chevron U.S.A. Inc. C-147 Registration Application Package Hayhurst New Mexico T26S R27E

- Section 2 Recycling Containment
- Section 2 Recycling Facility

Hayhurst New Mexico T26S R27E Section 2 U.S.A. Inc. | Recycling Containment and Facility

Report of Geotechnical Study Hayhurst Section 2 Hydraulic Fracturing Ponds

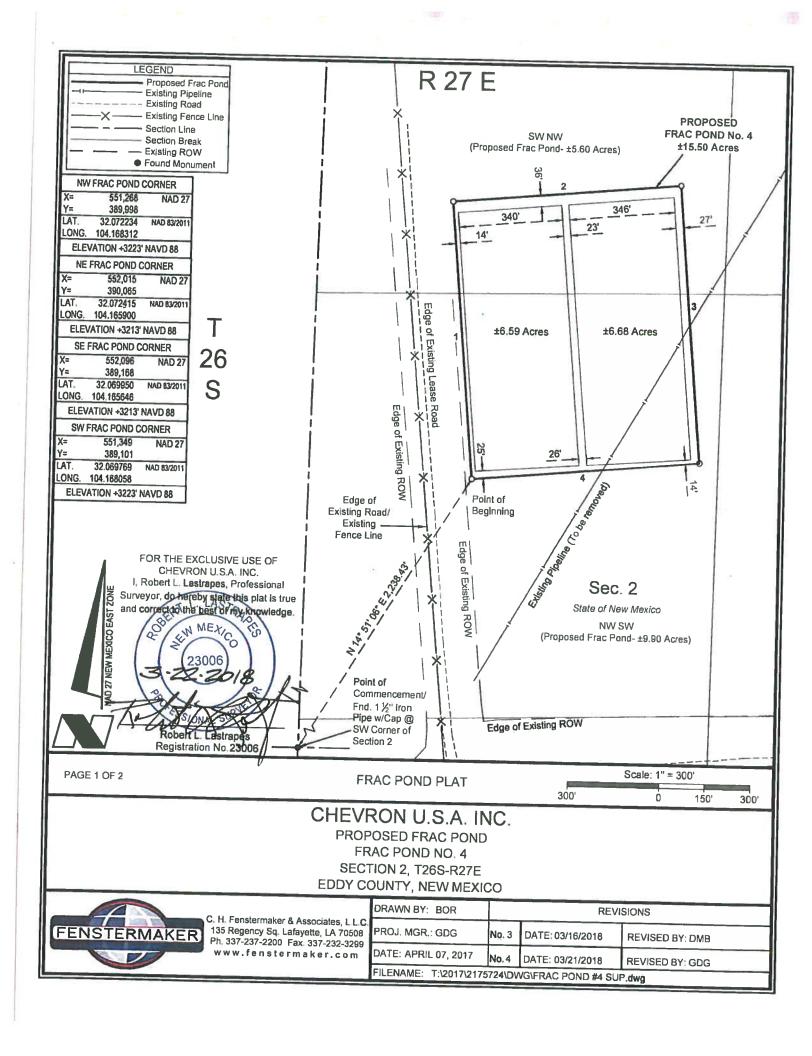
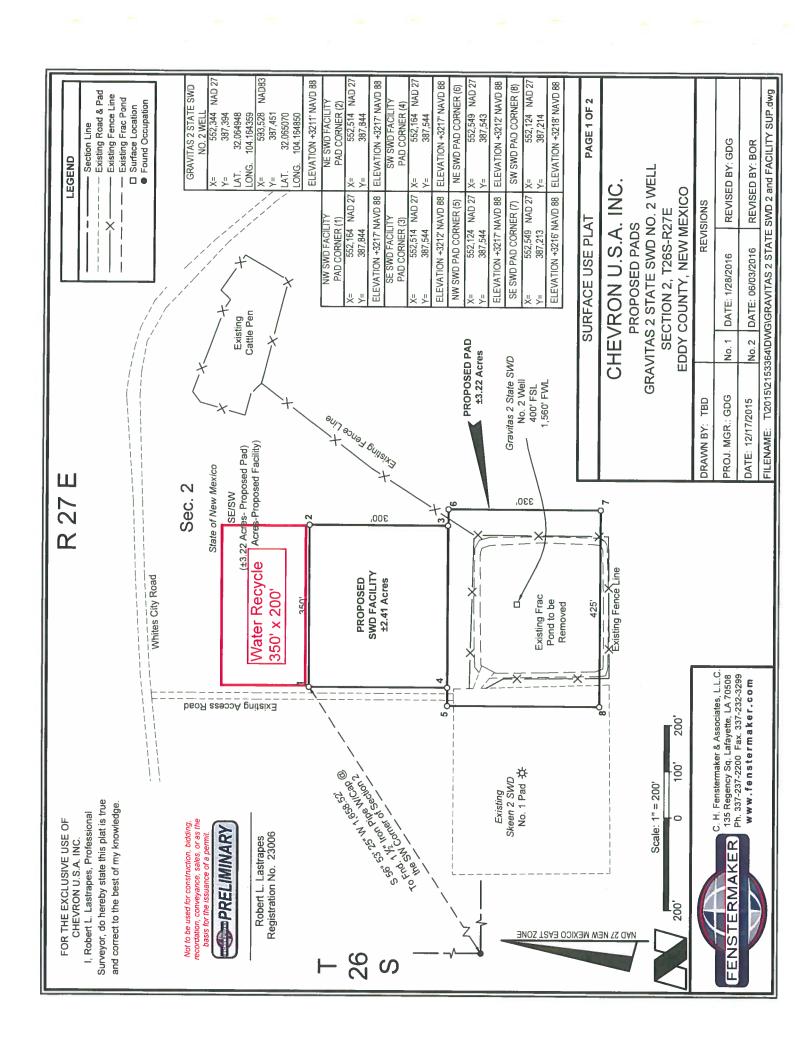
Appendix 1 – Survey Plat

Commencing at the Southwest corner of said Section 2, Township 26 South Range 27 East at a Found 1 1/2" Iron Pipe with cap; Thence North 14 degrees 51 minutes 06 seconds East 2,238,43 feet to the Point of Beginning. Said Point of Beginning having the following coordinates: X = 551,348.50 and Y = 389,101.47 (New Mexico State Plane Coordinate System, East Zone, NAD 27).

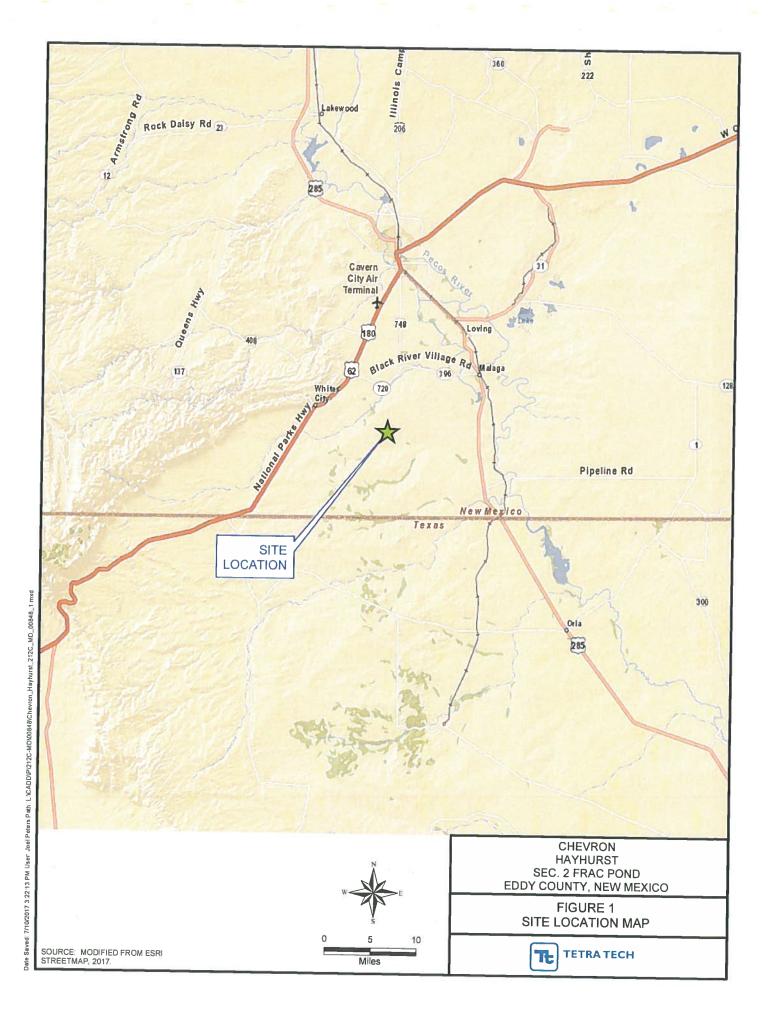
The general location of the site is shown on the Site Location Map, Figure 1 and Topographic Map, Figure 2.

The purposes of this study were to obtain information on subsurface conditions, and to provide geotechnical design criteria for the construction of the proposed ponds. The general site location is shown on the Site Location Map, Figure 1 and Topographic Map (Figure 2).

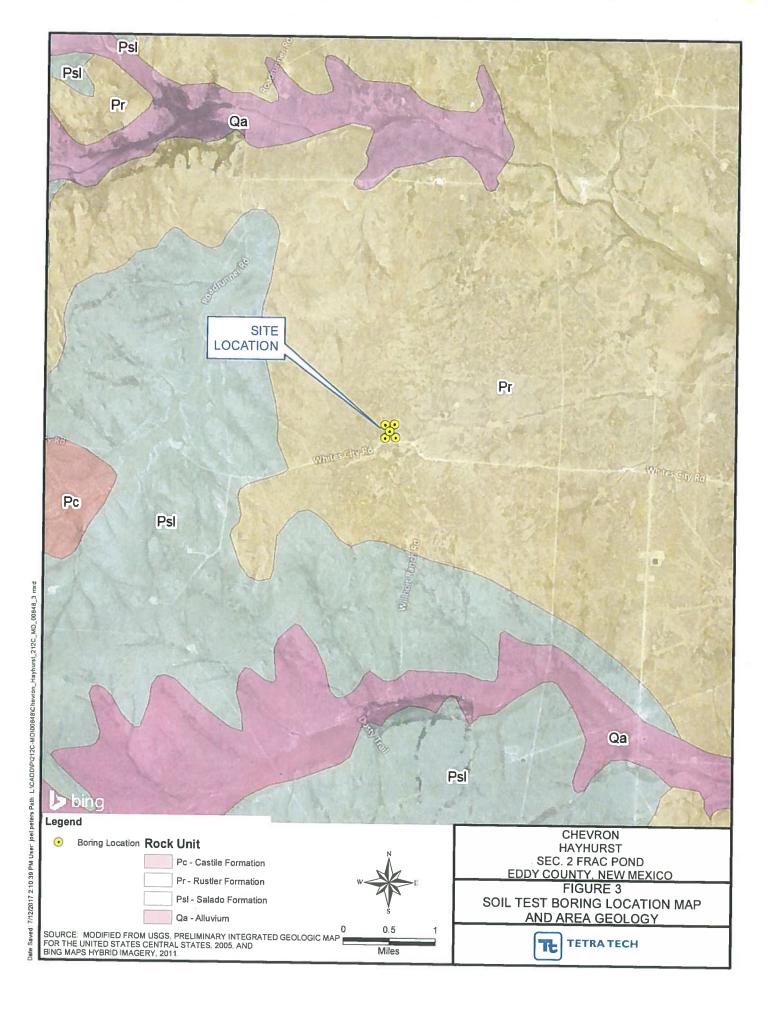
Geologic mapping by the U.S. Geological Survey (USGS, 2005 and 2014) indicates the Rustler Formation is the foundation bedrock at the site (Figure 3). This sedimentary rock is primarily composed of carbonate from the Permian Period with evaporites also present. The contact with sediments of the underlying Permian Salado Formation is mapped about one mile west of the subject site.

Review of mapping by the U.S. Geological Survey (Figure 3) indicates that the Rustler Formation, which is a carbonate based sedimentary rock with evaporates present, underlies the site, and can be prone to karst formation and dissolution leaving voids. No voids were encountered during our investigation, however this does not ensure that voids do not exist beneath the proposed site. Tetra Tech recommends that Chevron consider additional investigation to determine more conclusively if voids exist beneath the site.

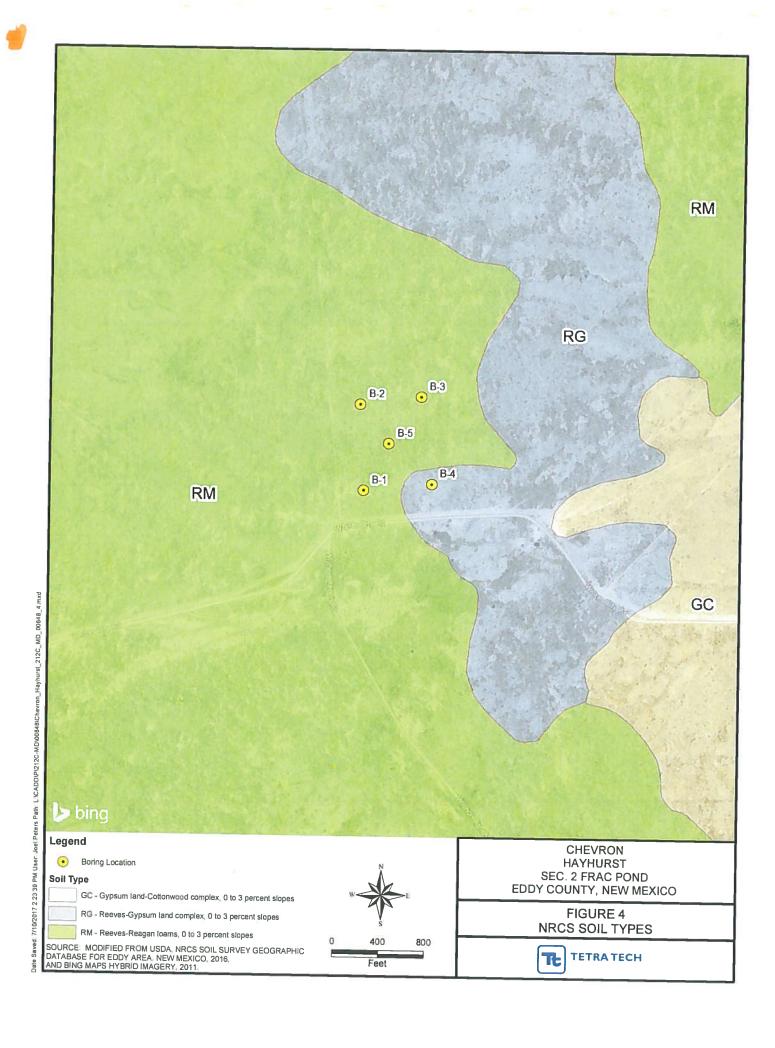
Mapping by the Natural Resources Conservation Service (NRCS, 2017) identifies the site soils as the Reeves-Gypsum and Reeves-Reagan mapping units (Figure 4). These soils are both described as loam or clay loam derived as residuum weathered from gypsum.

Soil samples were collected using a split-spoon sampler in borings B-1 through B-4 at 5-foot intervals. In boring B-5 samples were collected at 5-foot intervals to a depth of 30 feet bgs, then the spacing interval was increased to 10-feet. Standard Penetration Tests (SPT) were performed during sampling in accordance with ASTM D 1586 where a 140-pound automatic hammer is repeatedly dropped from a height of 30 inches. The number of blows for each 6-inch increment was recorded on the logs to categorize the consistency of the soil. After drilling and sampling activities were complete the borings were backfilled with soil cuttings. The soil boring logs are presented in Appendix A, and approximate locations of the borings are shown on Figure 4.

Between May 16th and 19th, 2017, Tetra Tech and a subcontractor mobilized to the site with a truck-mounted drilling rig to drill five (5) exploratory soil borings to identify subsurface conditions and collect samples. Borings B-1 and B-4 were drilled to a depth of approximately 45 feet below the existing ground surface (bgs). Borings B-2 and B-3 were drilled to a depth of approximately 40 feet bgs. Boring B-5 was drilled to a depth of approximately 73 feet. Water was encountered at approximate depths of 31, 28, and 31 feet (bgs) in B-1, B-4, and B-5 respectively, and rose to depths of 26, 26, and 29 feet when checked prior to backfilling the boreholes one to two days following the initial drilling. New Mexico Oil Conservation Division Rules published in the New Mexico Administrative Code (NMAC) have specific siting requirements for "pits" (ponds), associated with oil and gas exploration and production, which are within specified proximities to groundwater. A hydrogeological study to meet the requirements of the NMAC should be performed to determine whether the groundwater encountered is a perched layer or a continuous water bearing feature. Approximate locations of the borings are shown on Figure 4.

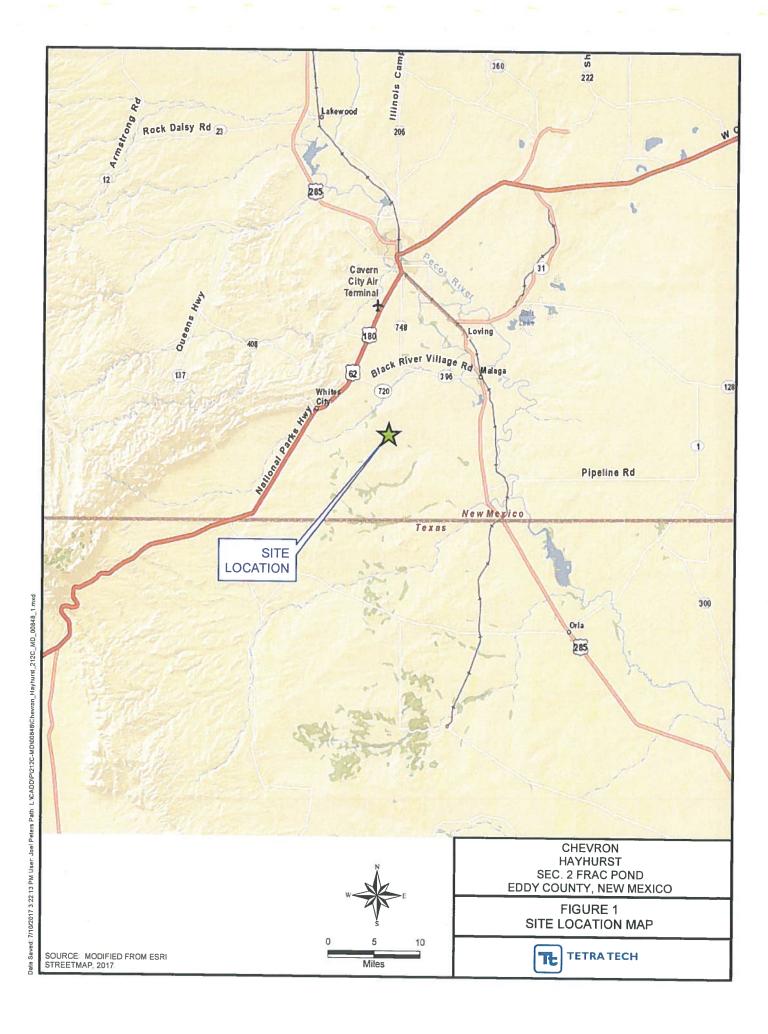
The general location of the site is shown on the Site Location Map, Figure 1 and Topographic Map, Figure 2.

The purposes of this study were to obtain information on subsurface conditions, and to provide geotechnical design criteria for the construction of the proposed ponds. The general site location is shown on the Site Location Map, Figure 1 and Topographic Map (Figure 2).
