#### **BRUINGTON GC B 001-DK**

Dakota API #: 300450841300 Unit A - Sec 15 - T29N - R12W San Juan County, NM

#### Well History

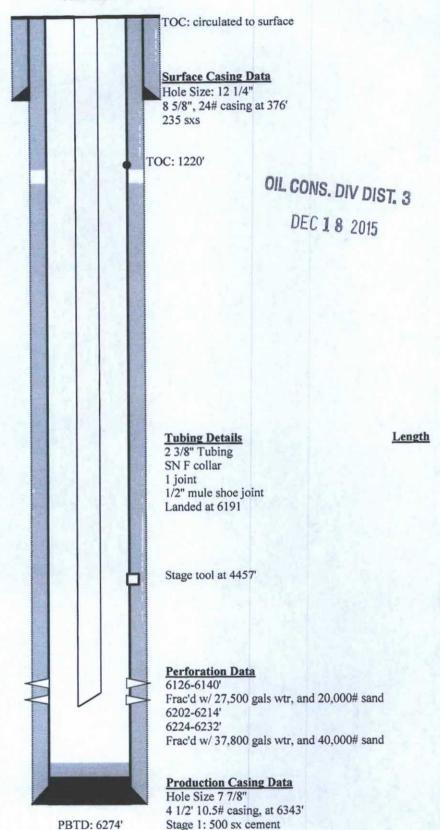
1/5/64 Spud date
2/3/64: Completion date
6/21/93: Reparied bradenhead
Tagged fill at 6237'
Ran CBL from 6012' -100'. TOC @ 1220'
Perf at 1200'. Pumped 301 sx cmt.
Pressure tested repair to 500 psi.
Cleaned out to 6237'
12/14/11: Changed master valve.
Tagged fluid at 5400'.
Tagged fishing neck at 6142'.
9/11/12: Braden head test
Casing pressuer = 499 psi
Bradenhead = 33 psi
Blew down to zero. Built to 14 psi in 5 min.

Pictured Clif	1670
Lewis Shale	1830
Mesaverde	3215
Mancos	4368
Gallup	5285
Lower Manc	5637
Greenhorn	6020
Graneros Sha	6082
Graneros DK	6,126
Main Dakota	6,195

SN F collar

Tubing Depth 6191'

#### Ground Eleveation 5700' 5625' KB

TD:6310'

Stage 2: 1000 sx cmt
