Pit, Below-Grade Tank, or
Proposed Alternative Method Permit or Closure Plan Application

Facility or well name: Riddle C 6 JUL 21 2014

BELOW-GRADE TANK CLOSURE PLAN

Riddle C 6, Tank B (21 bbl)
API No. 3004526787
Unit Letter K, Section 29, T31N, R9W

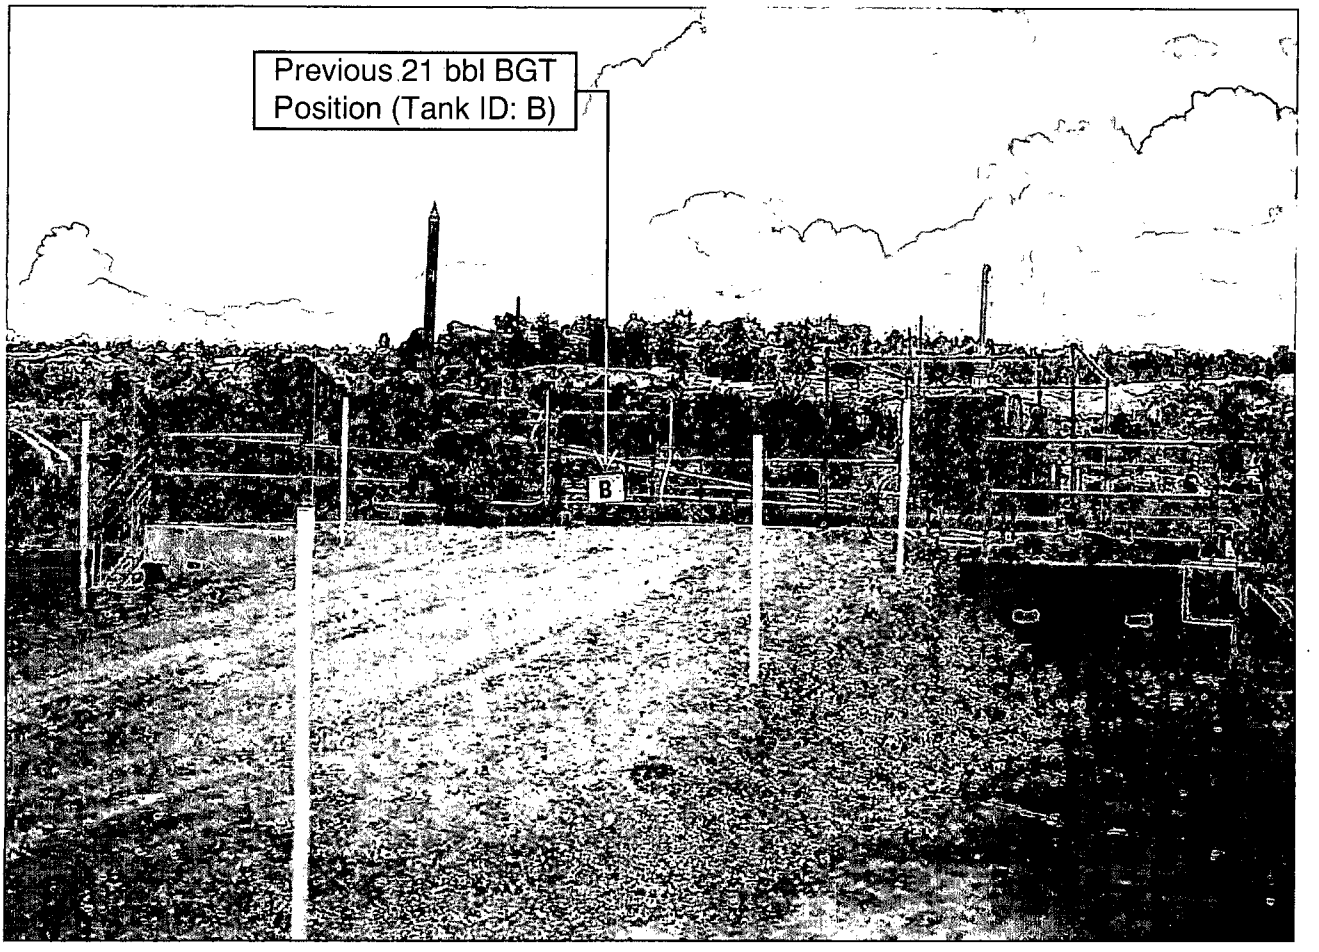
Previous 21 bbl BGT
Position (Tank ID: B)
B

9. If the sampling demonstrates that a release has not occurred or that any release does not exceed the concentrations specified above, then BP shall backfill the excavation, with compacted, non-waste containing, earthen material; construct a division-prescribed soil cover, re-contour and re-vegetate the location. The location will be reclaimed if it is not with in the active process area
The area under the BGT was backfilled with clean soil and is still within the active well area.
