Pit, Below-Grade Tank, or Proposed Alternative Method Permit or Closure Plan Application

BP AMERICA PRODUCTION COMPANY
SAN JUAN BASIN, NORTHWEST NEW MEXICO

BELOW-GRADE TANK CLOSURE PLAN

Florance 119
API No. 3004523976
Unit Letter A, Section 22, T29N, R9W

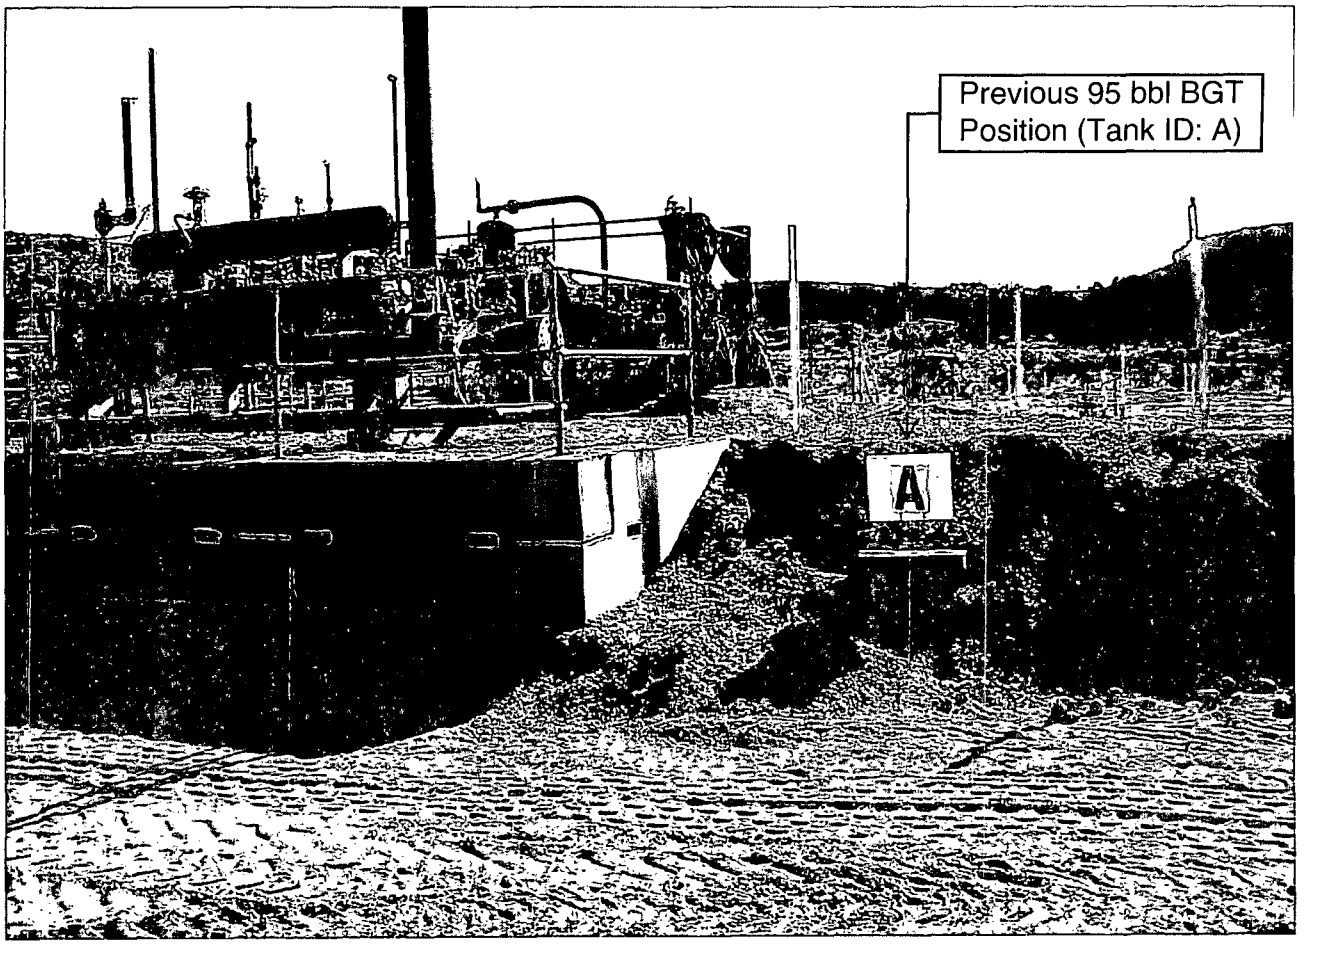
Previous 95 bbl BGT
Position (Tank ID: A)
A
