**Dudley Cornell A 001**

Dakota  
API # 30-045-08661  
T-29N, R-12-W, Sec. 1  
San Juan County, New Mexico

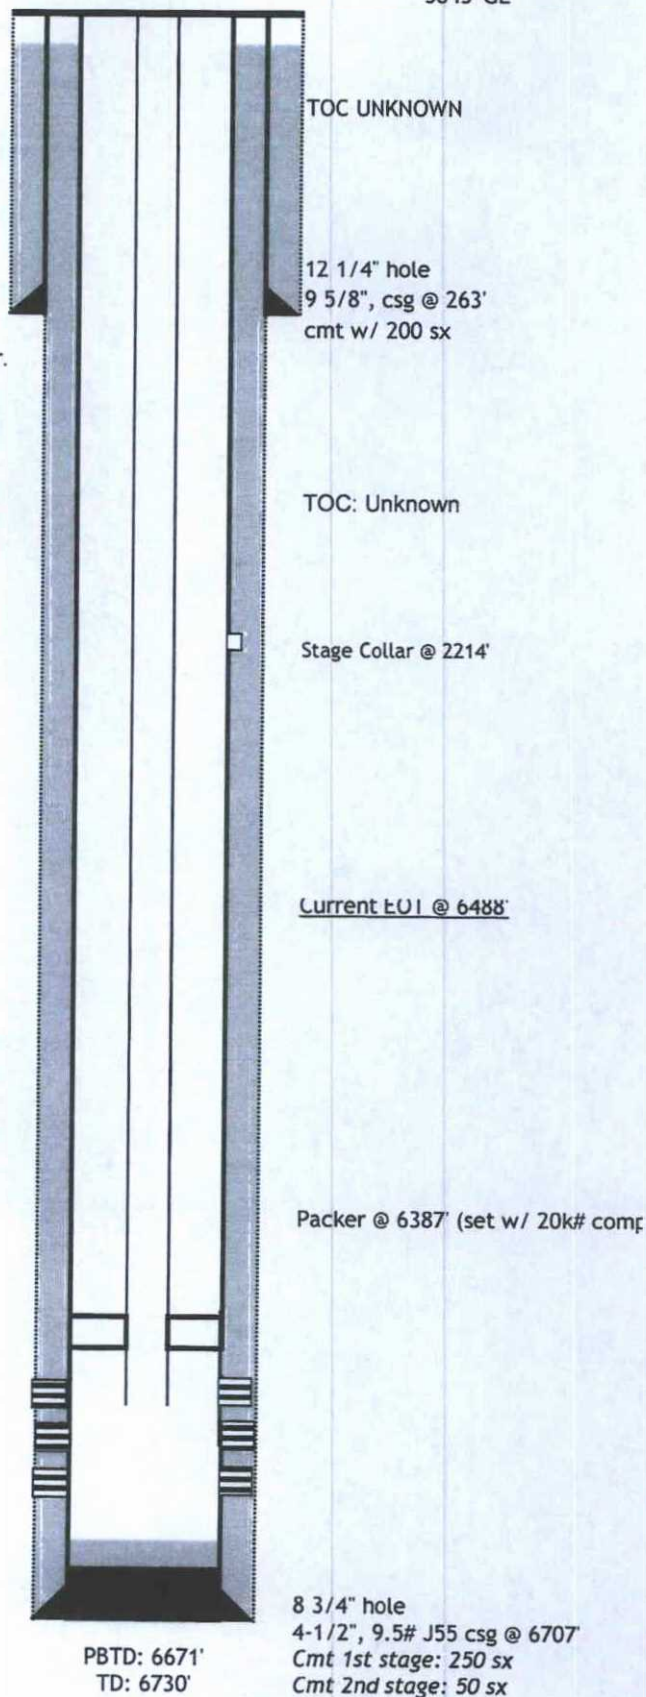
**Formation Tops**

Ojo Alamo  
Kirtland/Fruitland  
Pictured Cliffs  
Mesaverde  
Gallup  
Dakota

**Dakota Perforations**

6434-6438'	6446-6451'
6518-6534'	6564-6568'
6585-6587'	6601-6603'

Frac'd 135,000# 20/40 sand, & 90,000 gal wtr.

11/15/60: Spud Date  
12/12/60: Completion Date  
9/9/75: Repaired Casing leak and Installed tubing w/ pkr.  
No record or leak location (Procedure states that  
150 sx cement was planned to squeeze leak.)  
FDA comments: Casing leak @ 3996-4090'.  
2 3/8" tubing @ 6488'  
4/20/12: Changed master valve. Swabbed well  
for ~3 days. Treated for paraffin. Recovered ~18 bbls.
