Pit, Below-Grade Tank, or Proposed Alternative Method Permit or Closure Plan Application

Facility or well name: Bolack 3E

BELOW-GRADE TANK CLOSURE PLAN

Bolack 3E BGT Tank B (45 bbl)
API No. 3004525552
Unit Letter O, Section 20, T28N, R8W

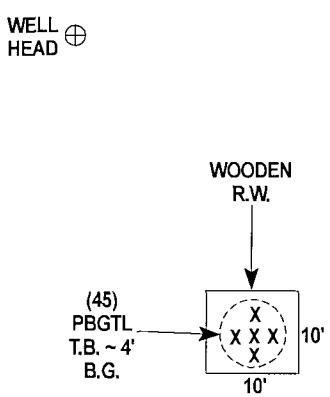
SITE SKETCH

DISCOLORATION/STAINING OBSERVED: YES / [NO] EXPLANATION -

APPARENT EVIDENCE OF A RELEASE OBSERVED AND/OR OCCURRED : YES / [NO] EXPLANATION :

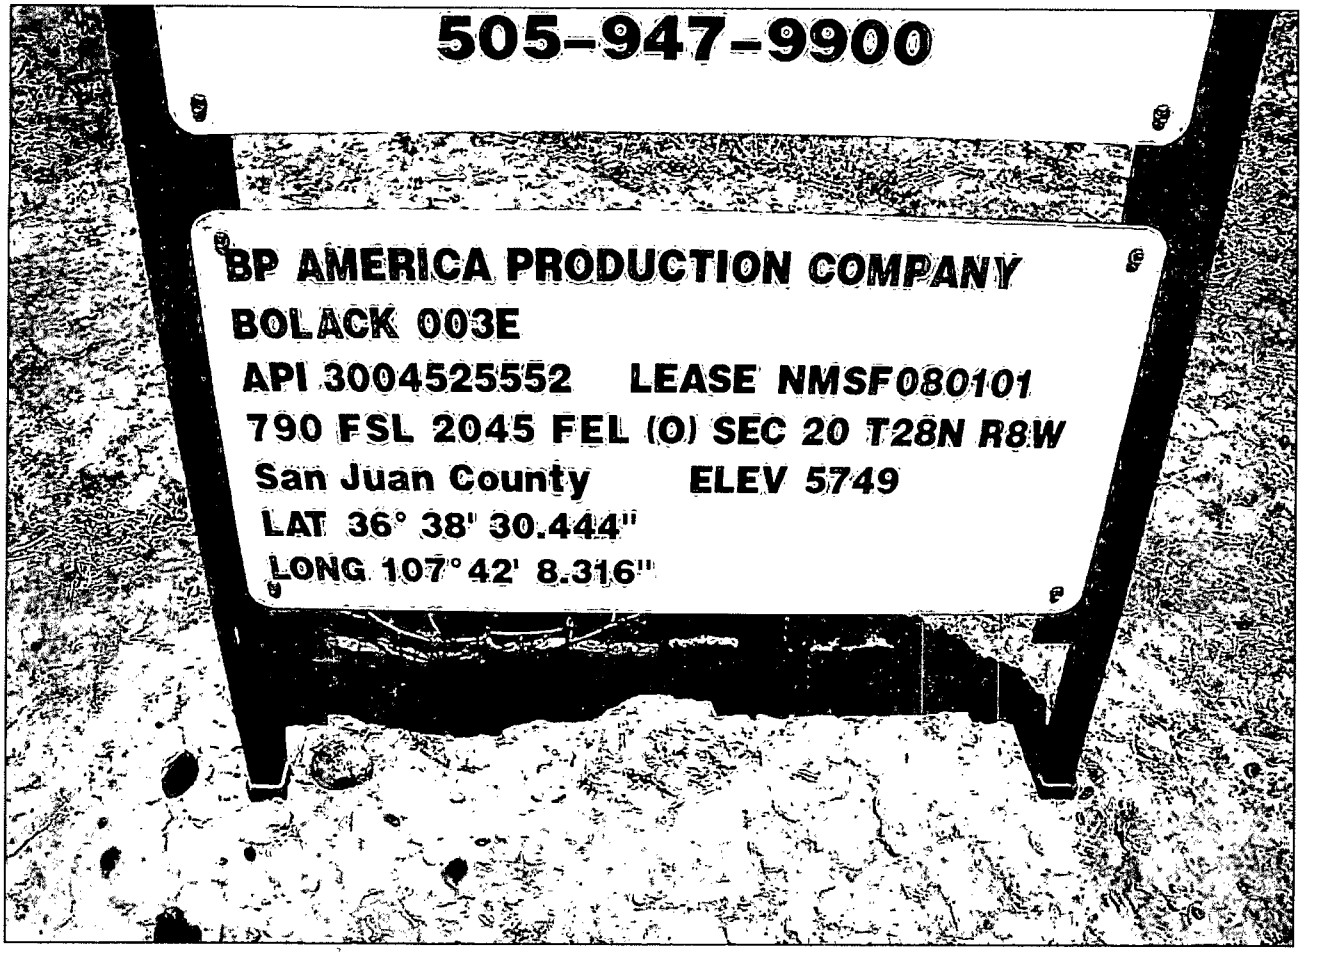
505-947-9900
BP AMERICA PRODUCTION COMPANY
BOLACK 003E
API 3004525552 LEASE NMSF080101
790 FSL 2045 FEL (O) SEC 20 T28N R8W
San Juan County ELEV 5749
LAT 36° 38' 30.444"
LONG 107° 42' 8.316"

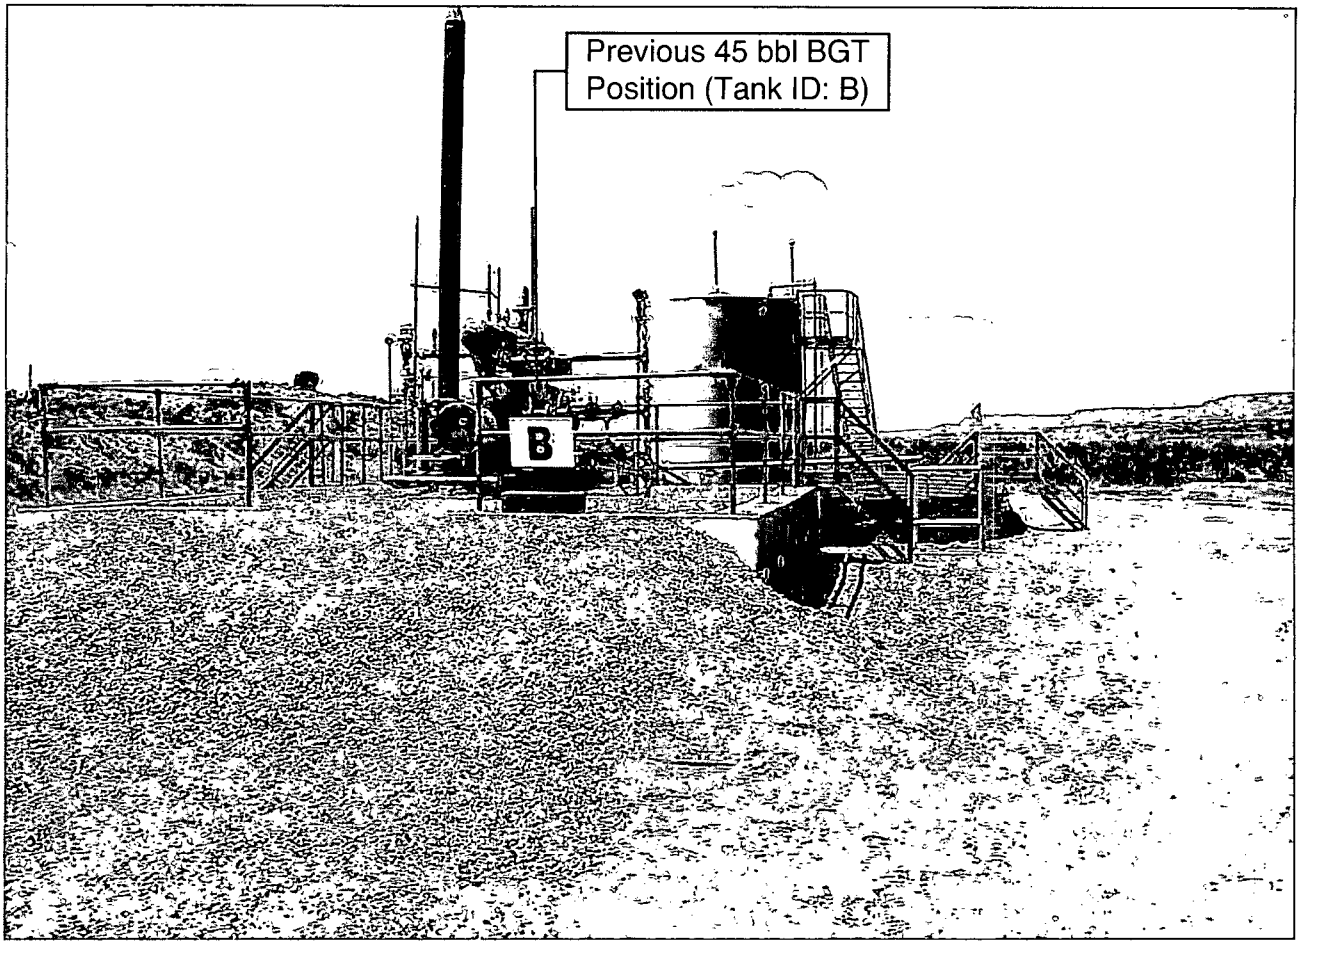
Previous 45 bbl BGT
Position (Tank ID: B)
B
