Sundry Notices and Reports on Wells

Canyon Largo Unit
8. Well Name & Number
Canyon Largo U #190
9. API Well No.
30-039-20715
10. Field and Pool
Ballard Pictured Cliffs
11. County and State
Rio Arriba Co, NM

It is intended to plug and abandon the subject well according to the attached procedure and wellbore diagram.

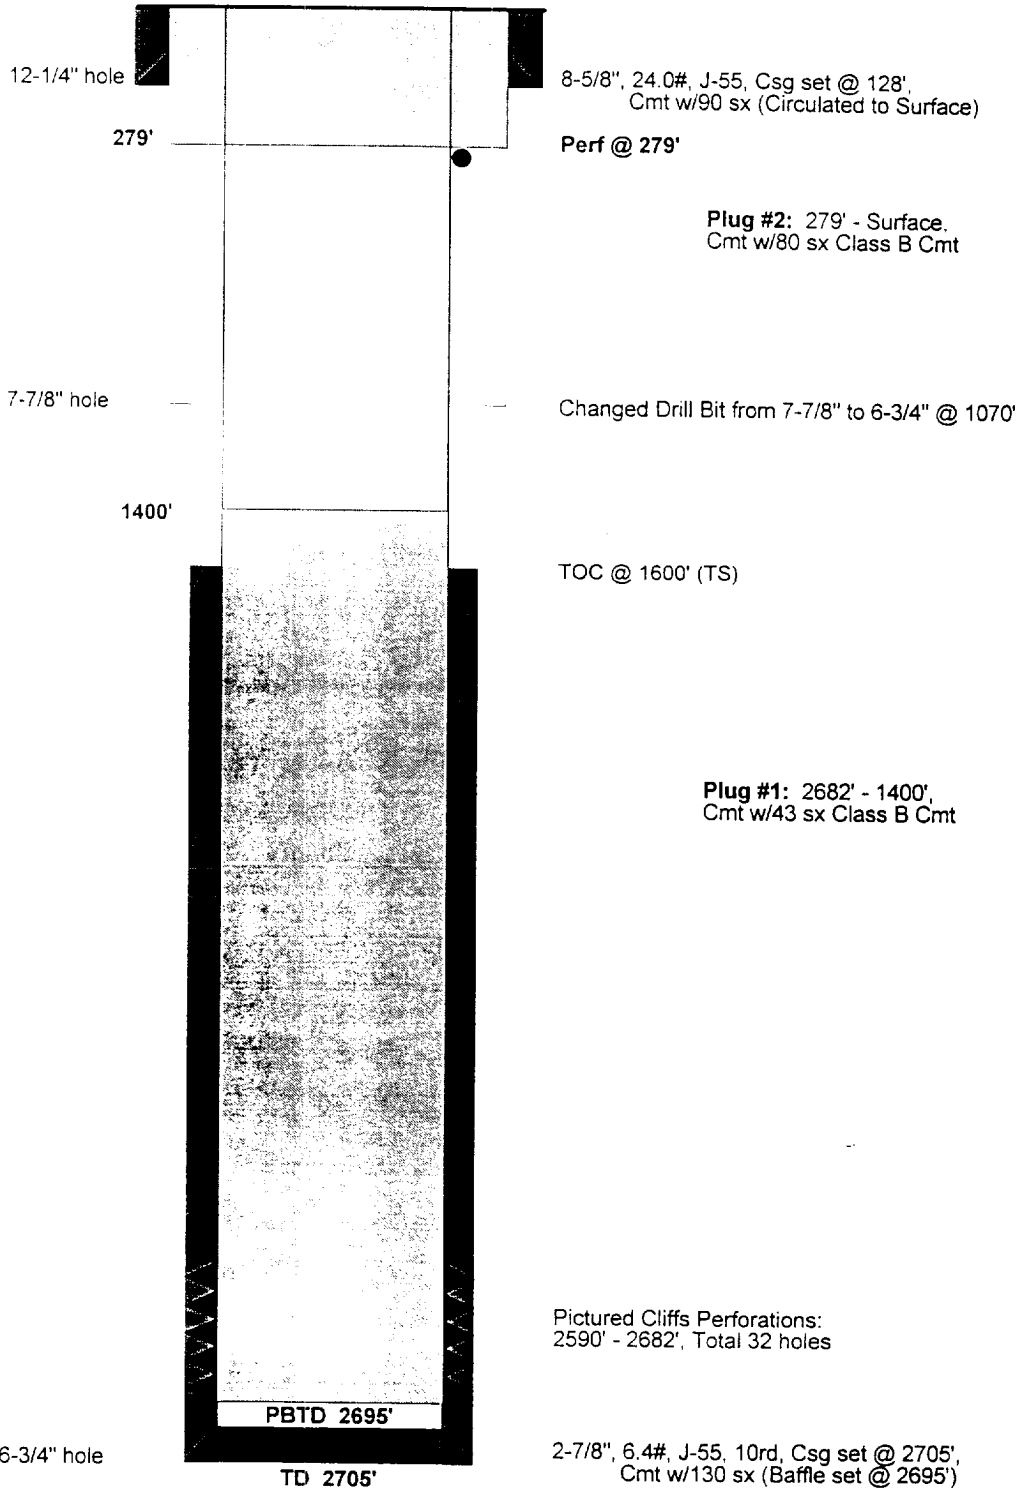
Today's Date: 9/1/95
Spud: 10/8/73
Completed: 11/26/73
Elevation: GL 6751'
KB 6762'

Nacimiento @ 229'
