Pit, Below-Grade Tank, or Proposed Alternative Method Permit or Closure Plan Application

1.
Operator: BP America Production Company OGRID #: 778
Address: 200 Energy Court, Farmington, NM 87401
Facility or well name: Gallegos Canyon Unit 283
API Number: 3004523793 OCD Permit Number:
U/L or Qtr/Qtr B Section 29 Township 29N Range 12W County: San Juan
Center of Proposed Design: Latitude 36.70218 Longitude -108.12190 NAD: ☐ 1927 ☒ 1983
Surface Owner: ☐ Federal ☐ State ☒ Private ☐ Tribal Trust or Indian Allotment

BELOW-GRADE TANK CLOSURE PLAN

Gallegos Canyon Unit 283
API No. 3004523793
Unit Letter B, Section 29, T29N, R12W

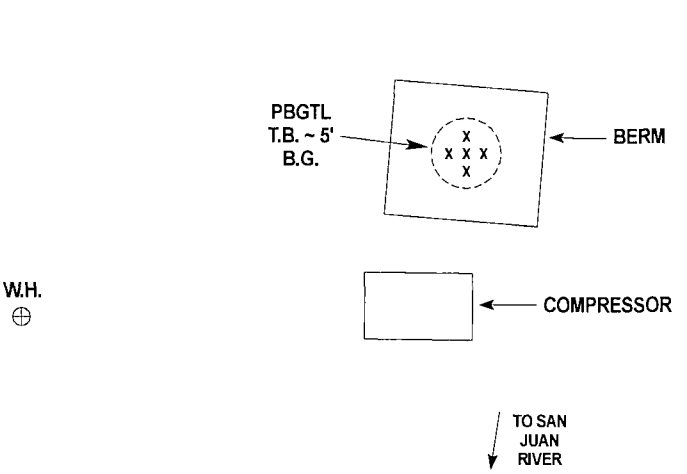
PLOT PLAN circle: attached

BGT Located : off / [on] site

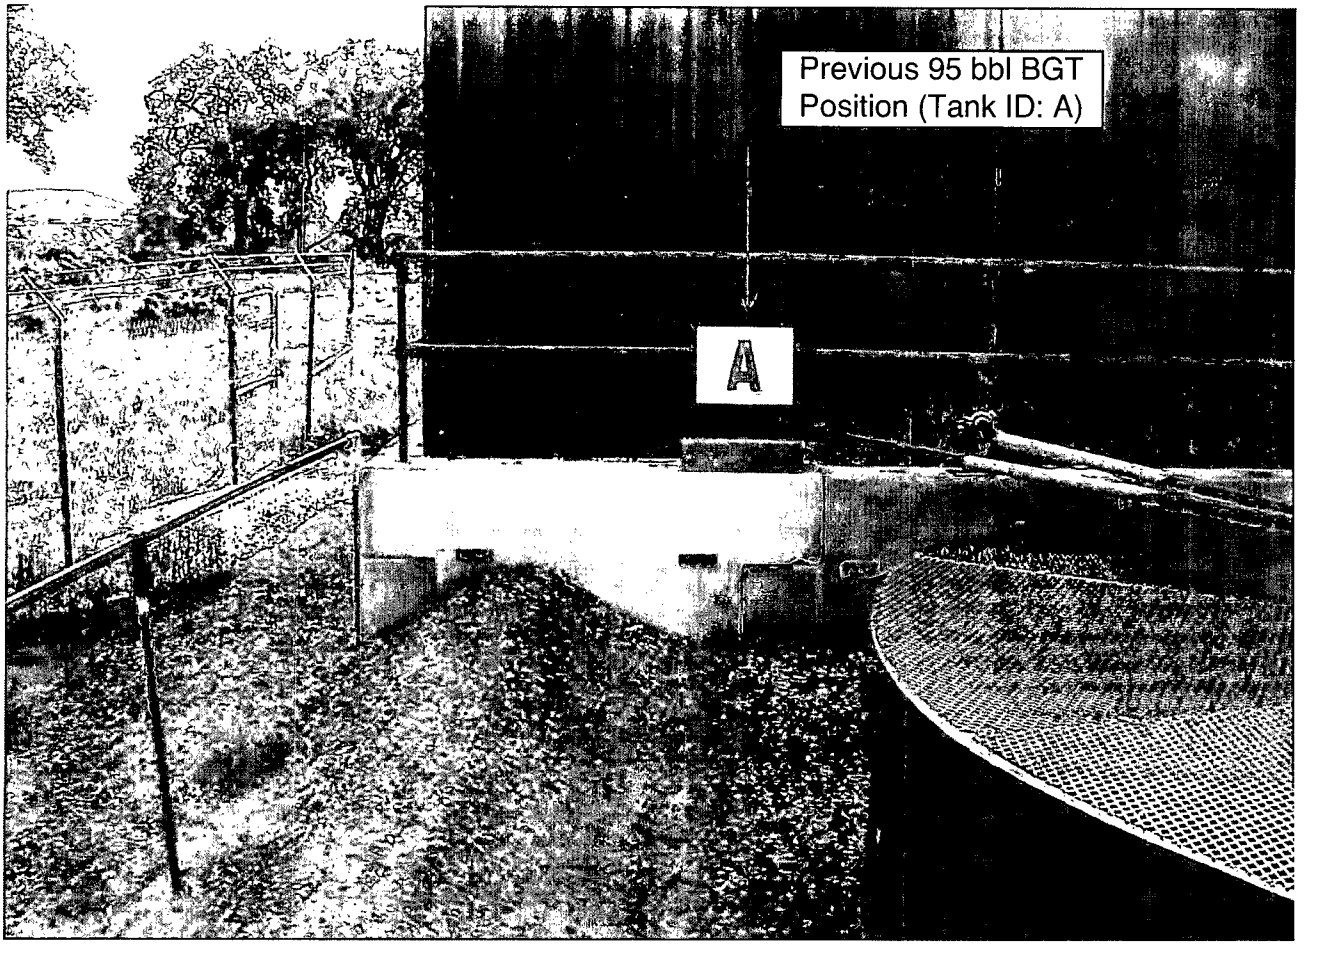
BP AMERICA PRODUCTION COMPANY
GALLEGOS CANYON UNIT 283
API 3004523793 LEASE NMNM78391A
990 FNL 2500 FEL (B) SEC 29 T29N R12W
San Juan County ELEV 5317
LAT 36° 42' 7.776"
LONG 108° 7' 19.452"

Previous 95 bbl BGT
Position (Tank ID: A)
A
