Sundry Notices and Reports on Wells 99007-2 AM 7:49

San Juan 27-5 Unit

San Juan 27-5 U #47

It is intended to add pay to the Mesaverde formation of the subject well by setting a cast iron bridge plug above the Point Lookout, perforating and fracture treating the Cliff House/Menefee. The well will be down-hole commingled after the workover and returned to production. Application is being made for down-hole commingling from the New Mexico Oil Conservation Division.

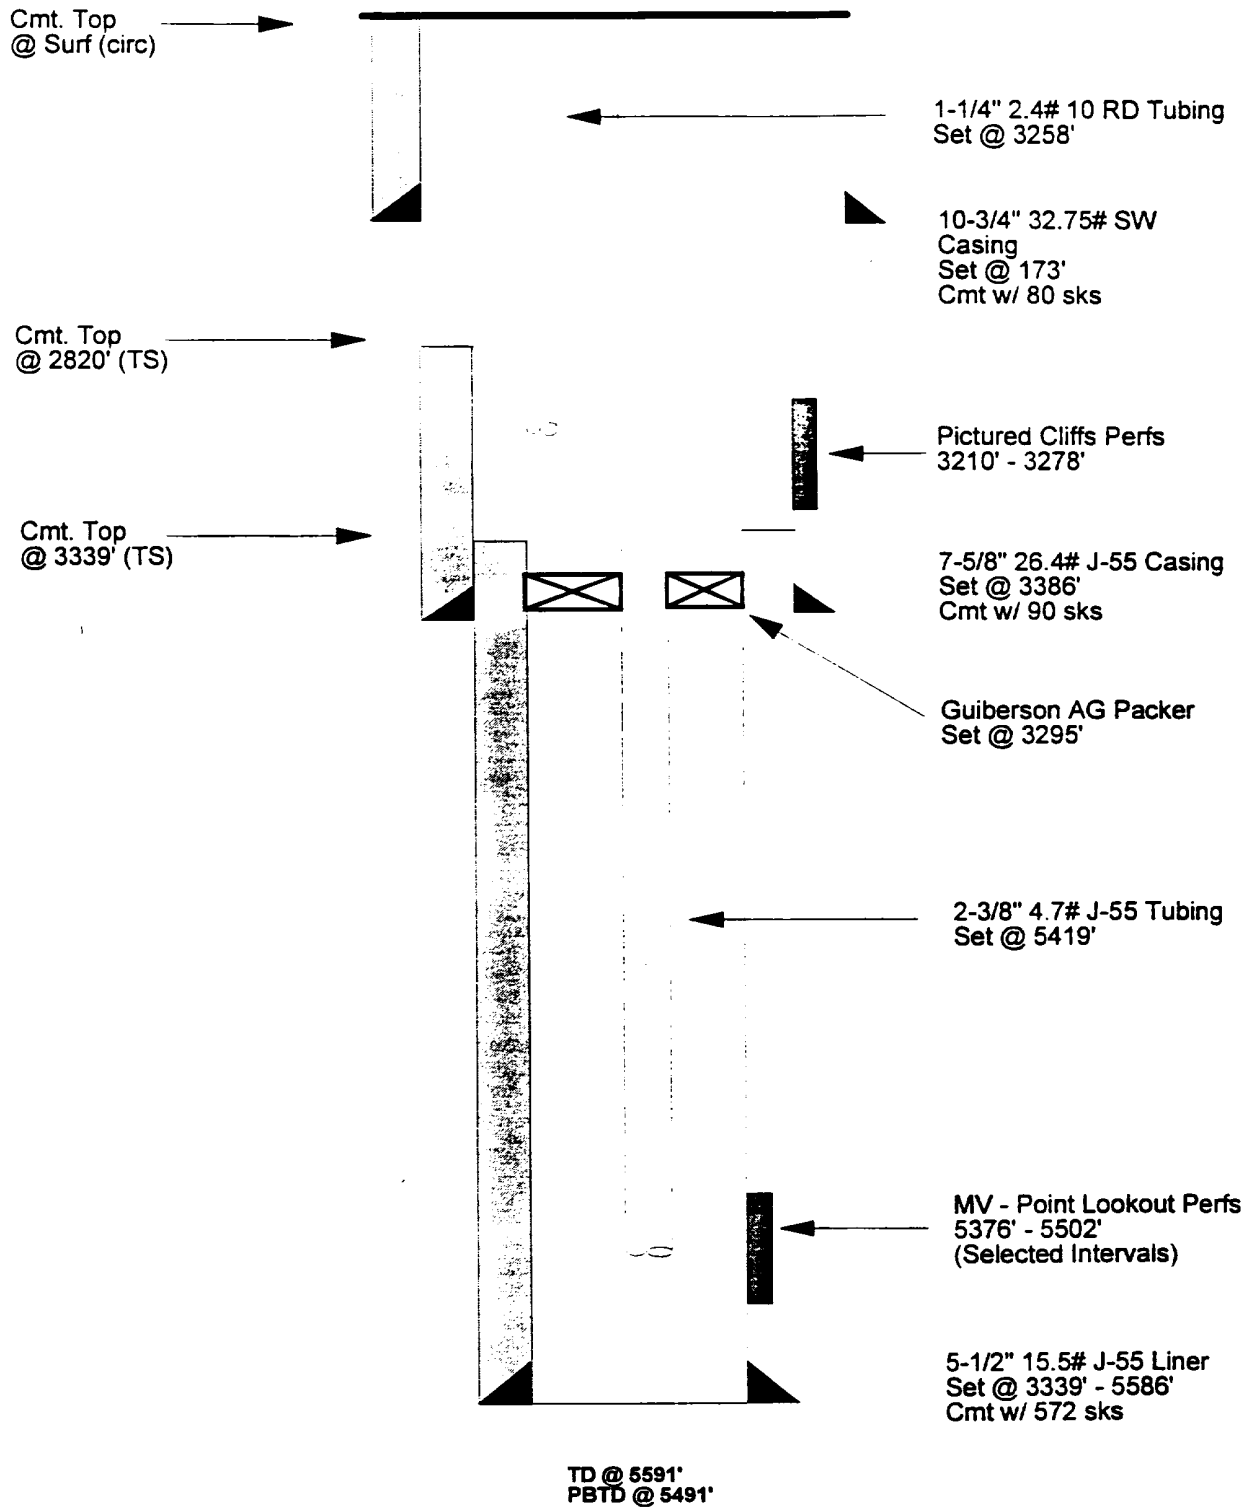
CURRENT WELLBORE SCHEMATIC

Unit K, Section 18, T-27-N, R-5-W
Lat. 36-34-15, Long. 107-24-11

5/15/59 While attempting to repair leaking packer, fish was left in hole (2-3/8" tubing and packer). Top of fish 5491'.
