Pit, Below-Grade Tank, or
Proposed Alternative Method Permit or Closure Plan Application

1.
Operator: BP America Production Company OGRID #: 778
Address: 200 Energy Court, Farmington, NM 87401
Facility or well name: Atlantic LS 2A
API Number: 3004522992 OCD Permit Number: 4033
U/L or Qtr/Qtr I Section 24 Township 31N Range 10W County: San Juan
Center of Proposed Design: Latitude 36.88095 Longitude -107.83035 NAD: ☐1927 ☒ 1983
Surface Owner: ☒ Federal ☐ State ☐ Private ☐ Tribal Trust or Indian Allotment

BELOW-GRADE TANK CLOSURE PLAN

Atlantic LS 2A
API No. 3004522992
Unit Letter I, Section 24, T31N, R10W

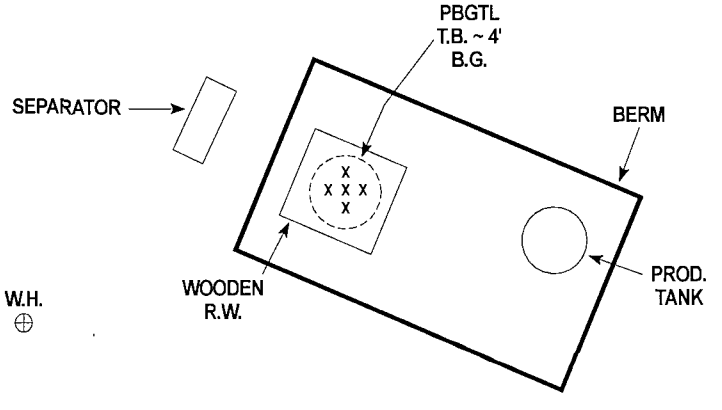
PLOT PLAN circle: attached

DISCOLORATION/STAINING OBSERVED: YES NO EXPLANATION - GRAY/BLACK

APPARENT EVIDENCE OF A RELEASE OBSERVED AND/OR OCCURRED : YES NO EXPLANATION:

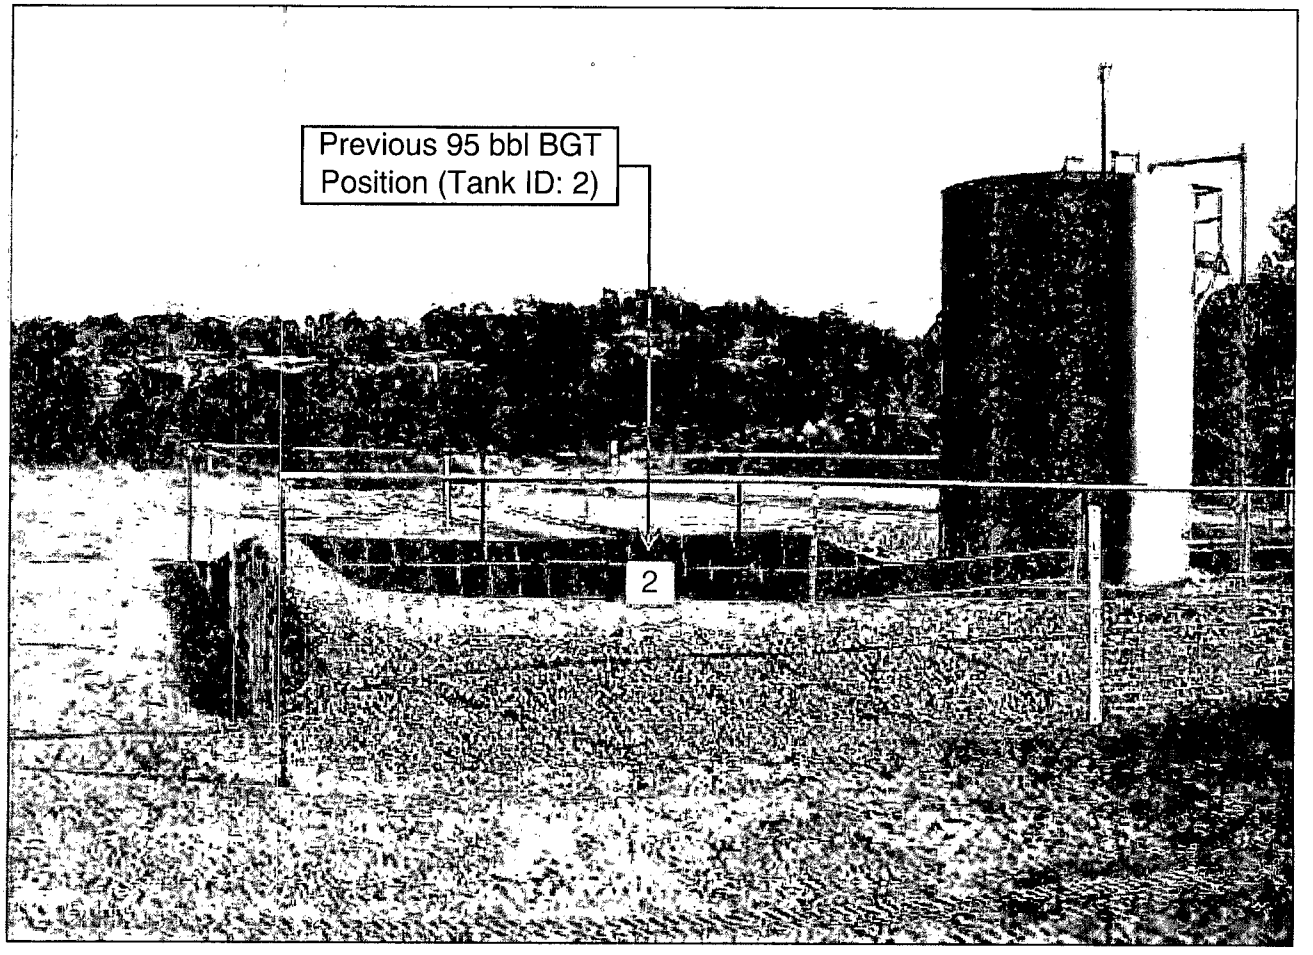
Previous 95 bbl BGT
Position (Tank ID: 2)
2

10. BP shall reclaim the BGT location and all areas associated with the BGT including associated access roads to a safe and stable condition that blends with the surrounding undisturbed area. BP shall substantially restore the impacted surface area to the condition that existed prior to oil and gas operations by placement of the soil cover as provided in Subsection H of 19.15.17.13 NMAC, re-contour the location and associated areas to a contour that approximates the original contour and blends with the surrounding topography and re-vegetate according to Subsection I of 19.15.17.13 NMAC.
The area over the BGT is still within the active well area. This area will be reclaimed when the well is plugged and abandoned as part of final reclamation.
