Pit, Below-Grade Tank, or Proposed Alternative Method Permit or Closure Plan Application

1.
Operator: ConocoPhillips Company OGRID #: 217817
Address: PO BOX 4289, Farmington, NM 87499
Facility or well name: AXI Apache N 13
API Number: 30-039-21428 OCD Permit Number: _____
U/L or Qtr/Qtr G Section 2 Township 25N Range 4W County: Rio Arriba
Center of Proposed Design: Latitude 36.43111 °N Longitude -107.21916 °W NAD: ☐ 1927 ☒ 1983
Surface Owner: ☐ Federal ☐ State ☐ Private ☒ Tribal Trust or Indian Allotment

ConocoPhillips Company
San Juan Basin
Below Grade Tank Closure Report

Lease Name: AXI Apache N 13
API No.: 30-039-21428

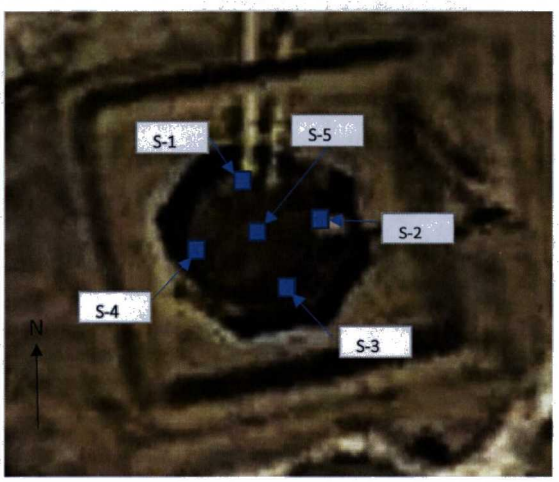
Objective:	Closure sampling for BGT
Tank Size:	120 barrels, removed during closure activities
Liner:	Liner present, removed during closure activities
Observations:	No staining or excess moisture was observed below the tank.
Notes:

SC-1 is a 5-point composite of S-1 through S-5, collected 0.5 ft below BGT.
Sample SC-1 was laboratory analyzed for TPH (8015 and 418.1), BTEX (8021) and chlorides (300.0).
