Su	ndry Notices	and Reports on Wel	ls		
					5.	Lease Number SF-078388
1. Ту	pe of Well GAS				6.	If Indian, All. or Tribe Name
			(C)		7.	Unit Agreement Nam
	ame of Operator					
3	RESOURCES		COMPANY			Therefore to The
		OIL & GAS	COMPANI		8.	Huerfanito Unit Well Name & Number
. Ac	dress & Phone No.	of Operator				Huerfanito U #67
I	PO Box 4289, Farmir	gton, NM 874	99 (505) 326-9700		9.	API Well No. 30-045-05905
	ocation of Well, Fo				10.	Field and Pool
99	90'FSL, 1550'FEL, S	Sec ^C 12, T-26-N	, R-9-W, NMPM			Ballard Pict.Clif

Huerfanito Unit # 67 Pertinent Data Sheet

Ballard Pictured Cliffs Wellbore Schematic

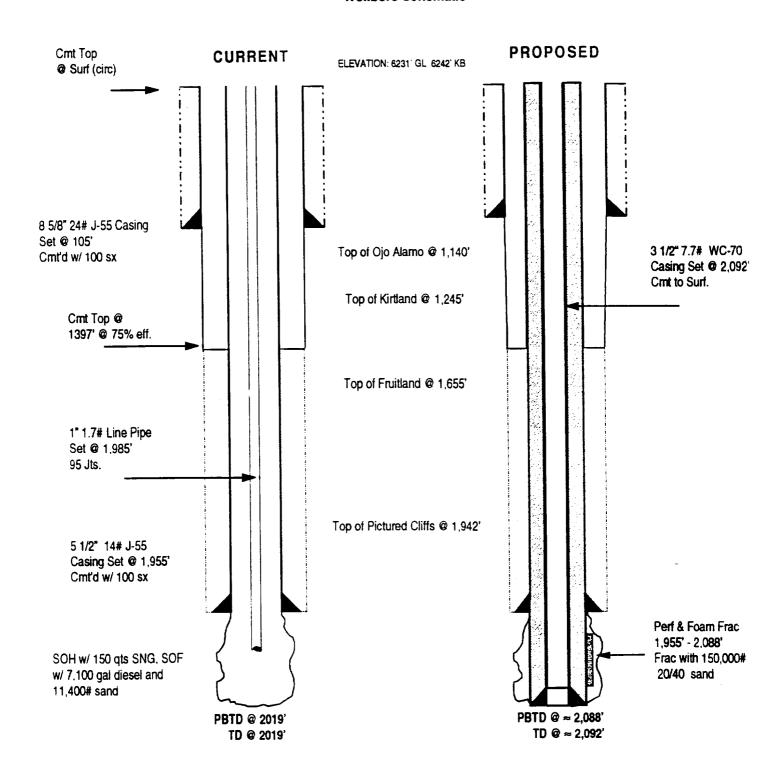
Section 12 O, T-26-N R-09-W San Juan, New Mexico

11.	County and State San Juan Co, NM
.3.		_X_d or Completed	Altering Casing _ Other - Restimula Operations the Pictured Cliff wing procedure:	te		
		n open hole lo	ean out open hole togs. Run 3 1/2" cas		_	th at approximatel
	to surfac Gilsonite	, 0.4% fluid	cks Class "B" 50/50 loss, 3% Kcl. Perfo	poz w/2% prate, acid	gel, lize a	0.3% CFR-3, 5 pps
	to surfac Gilsonite	, 0.4% fluid	cks Class "B" 50/50 loss, 3% Kcl. Perfo	poz w/2% prate, acid	gel, lize a	0.3% CFR-3, 5 pps nd foam fracture
	to surfac Gilsonite	, 0.4% fluid	cks Class "B" 50/50 loss, 3% Kcl. Perfo	poz w/2% prate, acid	gel, lize a	0.3% CFR-3, 5 pps nd foam fracture
	to surfac Gilsonite	, 0.4% fluid	cks Class "B" 50/50 loss, 3% Kcl. Perfo	poz w/2% prate, acid	gel, lize a	0.3% CFR-3, 5 pps nd foam fracture
