### DEPARTMENT OF THE INTERIOR BUREAU OF LAND MANAGEMENT

| | | 5. | Lease Number |
|--|--|--|--|
| RESOURCES OIL & GAS COMPANY | | 8. | Huerfano Unit Well Name & Number |
| . Address & Phone No. of Operator | <del></del> | ٥. | Huerfano Unit #21 |
| It is intended to restimulate the Picture according to the following procedu | | ation of ( | the subject well |

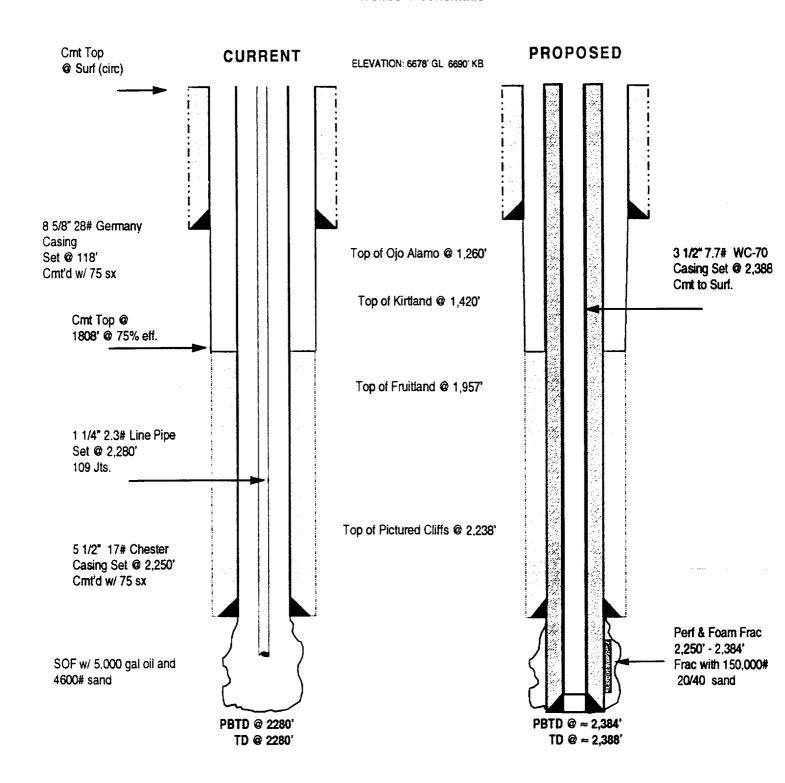
#### West Kutz Pictured Cliffs Wellbore Schematic

Section 9 B, T-26-N R-10-W San Juan, New Mexico

| | | 5. | Lease Number |
|--|--|--|--|
| according to the following procedu<br>Pull the 1 1/4" tubing. Clean out<br>2388'. Run open hole logs. Run 3 1<br>to surface w/155 sacks Class "B" 5<br>Gilsonite, 0.4% fluid loss, 3% Kcl | open hole to<br>1/2" casing to<br>50/50 poz w/2%<br>L. Perforate, | new total de gel, 0.3 acidize a and retur | depth at approximate<br>pth. Cement casing<br>% CFR-3, 5 pps<br>nd foam fracture |
