# Pit, Below-Grade Tank, or Proposed Alternative Method Permit or Closure Plan Application

1.
Operator: BP America Production Company OGRID #: 778
Address: 200 Energy Court, Farmington, NM 87401
Facility or well name: Jacquez LS 001R
API Number: 3004523587 OCD Permit Number:
U/L or Qtr/Qtr B Section 29 Township 31N Range 09W County: San Juan
Center of Proposed Design: Latitude 36.873895 Longitude -107.799648 NAD: ☐1927 ☒1983
Surface Owner: ☐ Federal ☐ State ☒ Private ☐ Tribal Trust or Indian Allotment

BELOW-GRADE TANK CLOSURE PLAN

**Jacquez LS 001R**
**API No. 3004523587**
**Unit Letter B, Section 29, T31N, R09W**

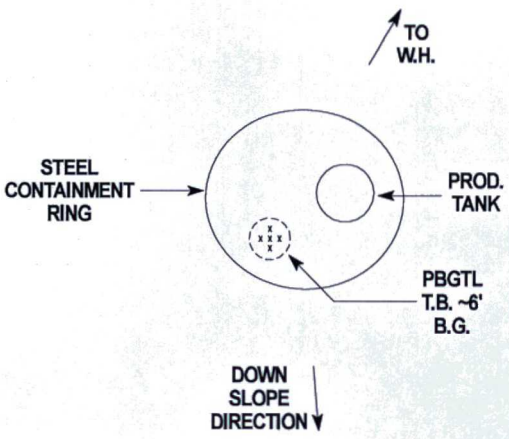
PLOT PLAN circle: attached

DISCOLORATION/STAINING OBSERVED: YES / [NO] EXPLANATION -

APPARENT EVIDENCE OF A RELEASE OBSERVED AND/OR OCCURRED : YES / [NO] EXPLANATION:

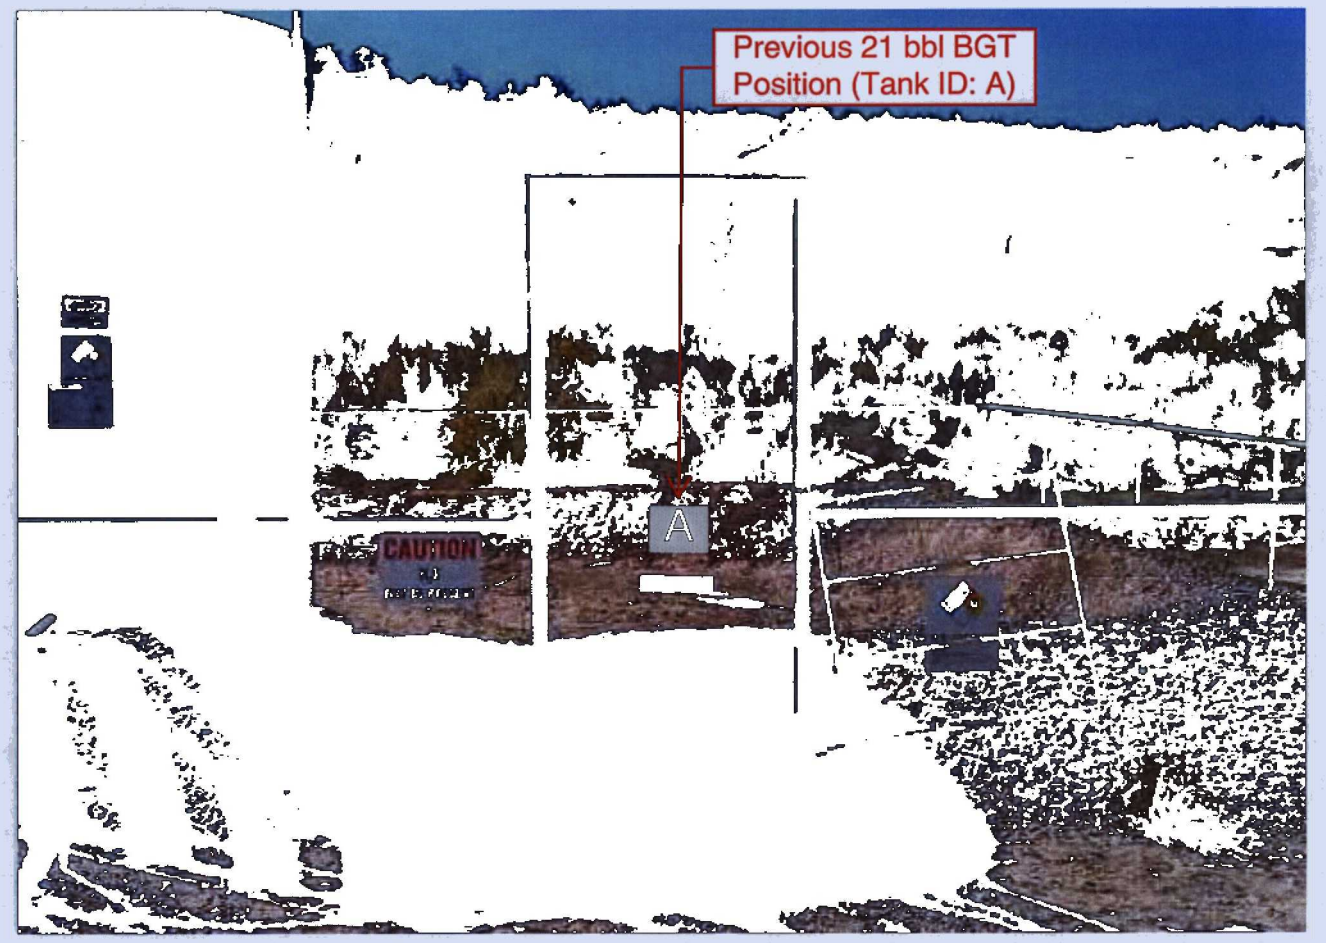
Previous 21 bbl BGT
Position (Tank ID: A)
A
CAUTION

10. BP shall reclaim the BGT location and all areas associated with the BGT including associated access roads to a safe and stable condition that blends with the surrounding undisturbed area. BP shall substantially restore the impacted surface area to the condition that existed prior to oil and gas operations by placement of the soil cover as provided in Subsection H of 19.15.17.13 NMAC, re-contour the location and associated areas to a contour that approximates the original contour and blends with the surrounding topography and re-vegetate according to Subsection I of 19.15.17.13 NMAC.
**The area has been backfilled and will be reclaimed once the well has been plugged and abandoned.**
