Sundry Notices and Reports on Wells

2. Name of Operator  
**BURLINGTON  
RESOURCES** OIL & GAS COMPANY

7. Lease Name/Unit Name  
Huerfanito Unit

8. Well No.  
15

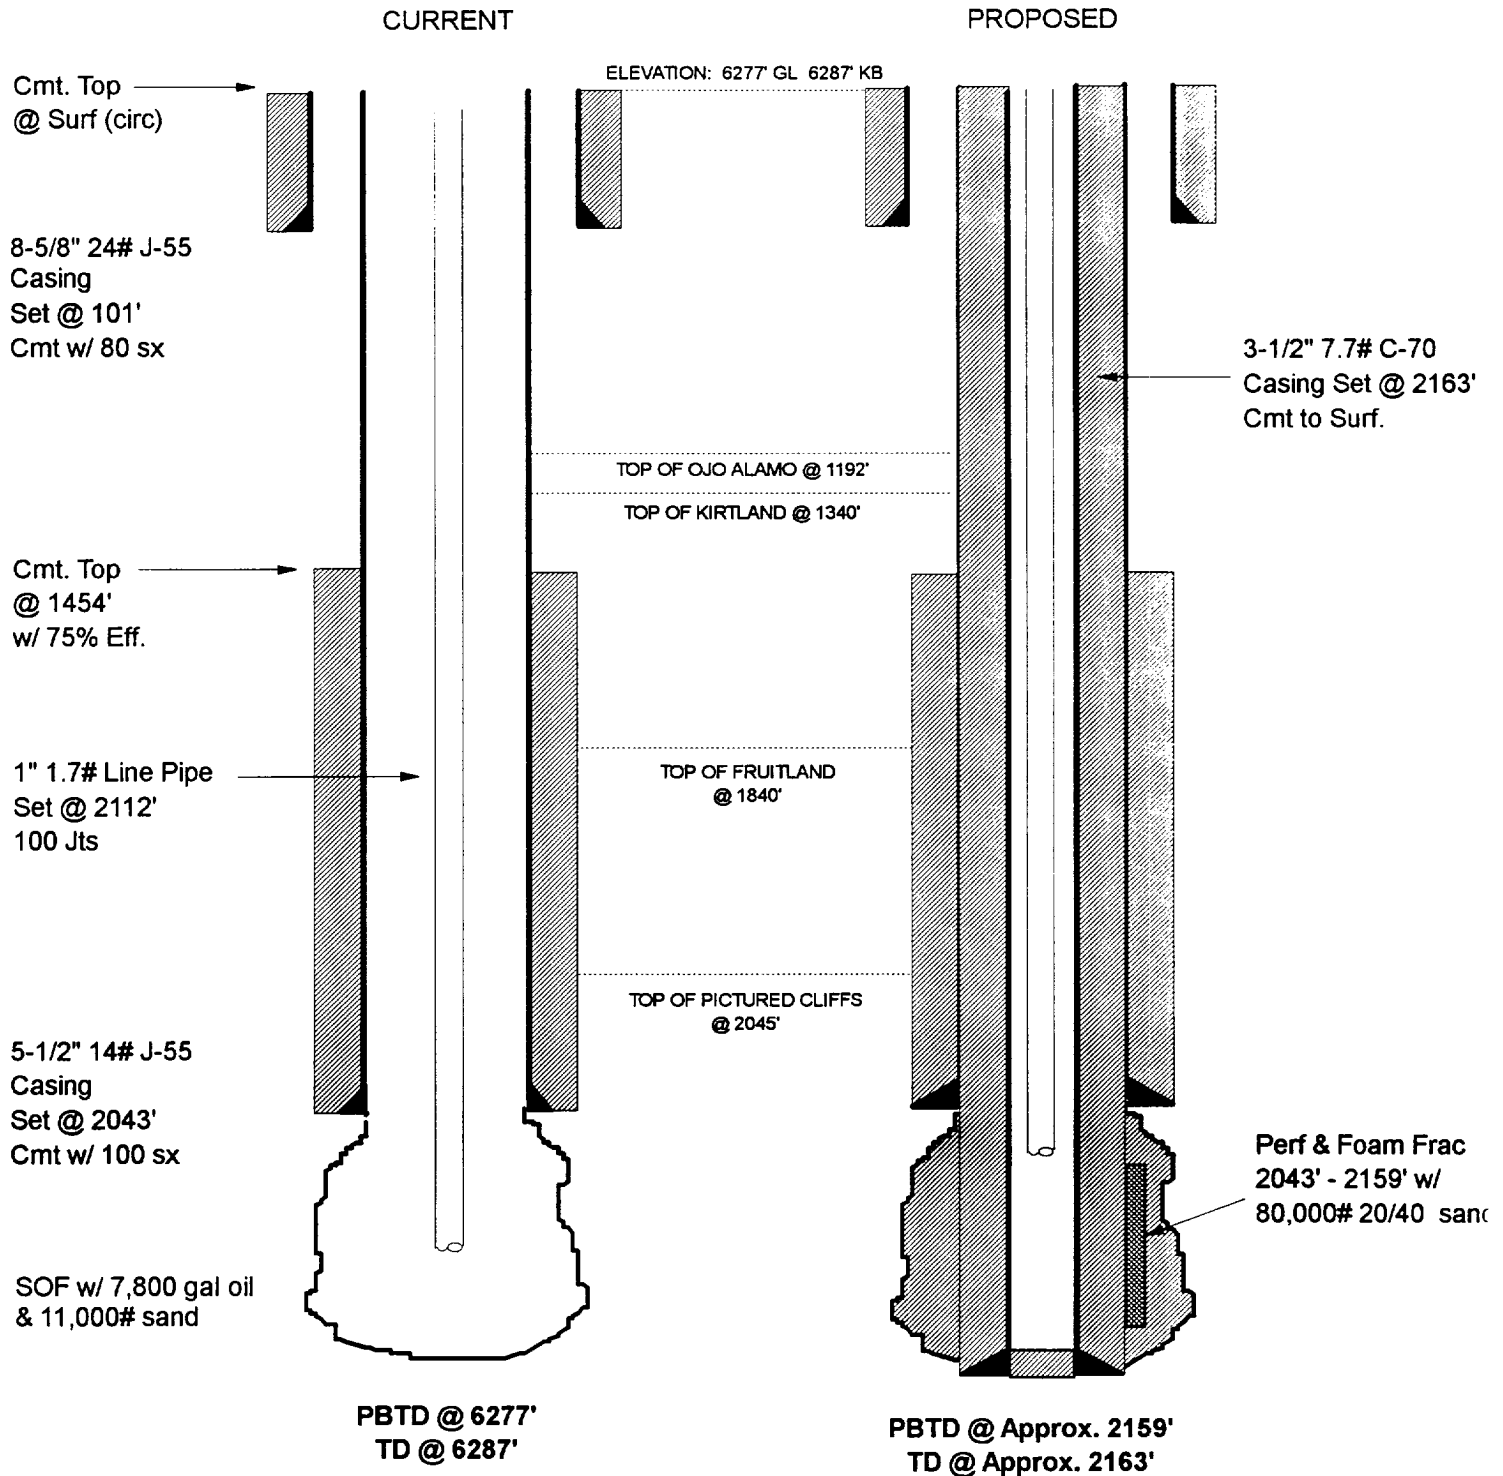
## BALLARD PICTURED CLIFFS WELLBORE SCHEMATIC

Section 2A, T-26-N, R-9-W  
San Juan County, NM

NU BOP. Pull 1" tubing. Drill new open hole from 2043-2163'. Run open hole logs. Run 3 1/2" casing to new total depth and cement to surface with 140 sx Class "B" 50/50 poz with 2% gel, 0.3% CFR-3, 5 pps Gilsonite 0.4% Halad-344, 3% Kcl. Perforate, acidize and foam fracture treat the Pictured Cliffs zone. Clean out. Rerun tubing and return the well to production.
