Pit, Below-Grade Tank, or Proposed Alternative Method Permit or Closure Plan Application

ConocoPhillips Company
San Juan Basin
Below Grade Tank Closure Report

Lease Name: Trieb Federal Com 2B
API No.: 30-045-30140

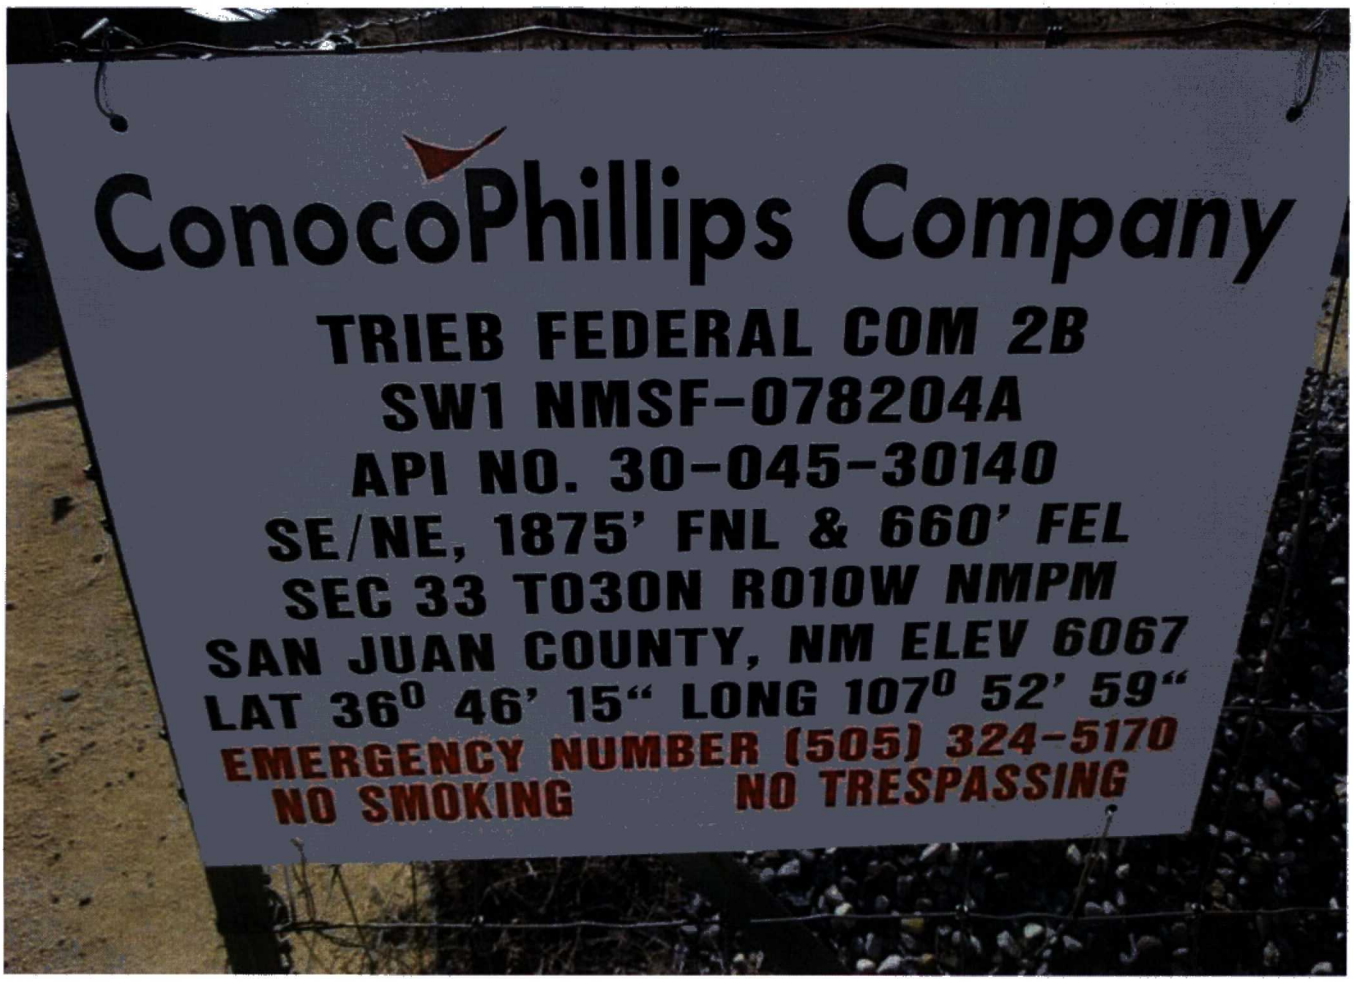
ConocoPhillips Company
TRIEB FEDERAL COM 2B
SW1 NMSF-078204A
API NO. 30-045-30140
SE/NE, 1875' FNL & 660' FEL
SEC 33 T030N R010W NMPM
SAN JUAN COUNTY, NM ELEV 6067
LAT 36° 46' 15" LONG 107° 52' 59"
EMERGENCY NUMBER (505) 324-5170
NO SMOKING
NO TRESPASSING
