Pit, Below-Grade Tank, or Proposed Alternative Method Permit or Closure Plan Application

1.
Operator: BP America Production Company OGRID #: 778
Address: 200 Energy Court, Farmington, NM 87401
Facility or well name: Fields A 002A
API Number: 3004522399 OCD Permit Number:
U/L or Qtr/Qtr I Section 25 Township 32N Range 11W County: San Juan
Center of Proposed Design: Latitude 36.953210 Longitude -107.935641 NAD: ☐1927 ☒1983
Surface Owner: ☒ Federal ☐ State ☐ Private ☐ Tribal Trust or Indian Allotment

BELOW-GRADE TANK CLOSURE PLAN

Fields A 002A
API No. 3004522399
Unit Letter I, Section 25, T32N, R11W

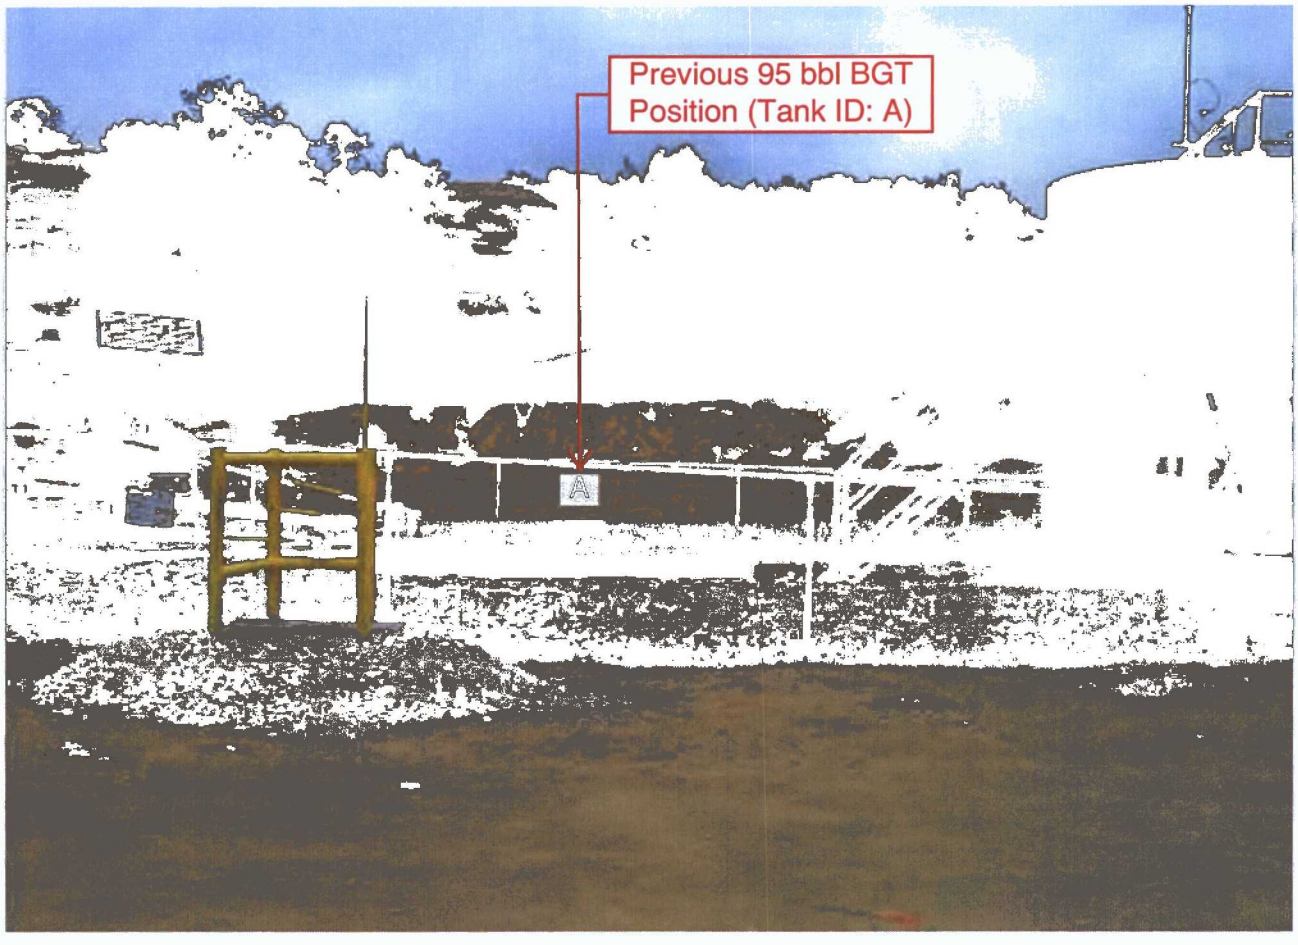
Previous 95 bbl BGT
Position (Tank ID: A)
A

5. BP shall remove any on-site equipment associated with a BGT unless the equipment is required for well production.
All equipment associated with the BGT has been removed.

9. If the sampling demonstrates that a release has not occurred or that any release does not exceed the concentrations specified above, then BP shall backfill the excavation, with compacted, non-waste containing, earthen material; construct a division-prescribed soil cover, re-contour and re-vegetate the location. The location will be reclaimed if it is not with in the active process area
Sampling results indicates no release had occurred. Attached is a laboratory report and field report. The location will be reclaimed when the well is plugged and abandoned.
