BUREAU OF LAND MANAGEMENT	BLM /	
Sundry Notices and Reports on Well	G-1 PM 3:18	
	5. ARMINGTON, NM	Lease Number SF-077315 If Indian, All. or Tribe Name
	7.	Unit Agreement Name

2. Name of Operator MERIDIAN OIL	8.	Well Name & Number
3. Address & Phone No. of Operator PO Box 4289, Farmington, NM 87499 (505) 326-9700	9.	Martin #5 API Well No. 30-045-07064

PLUG AND ABANDONMENT PROCEDURE

Martin #5

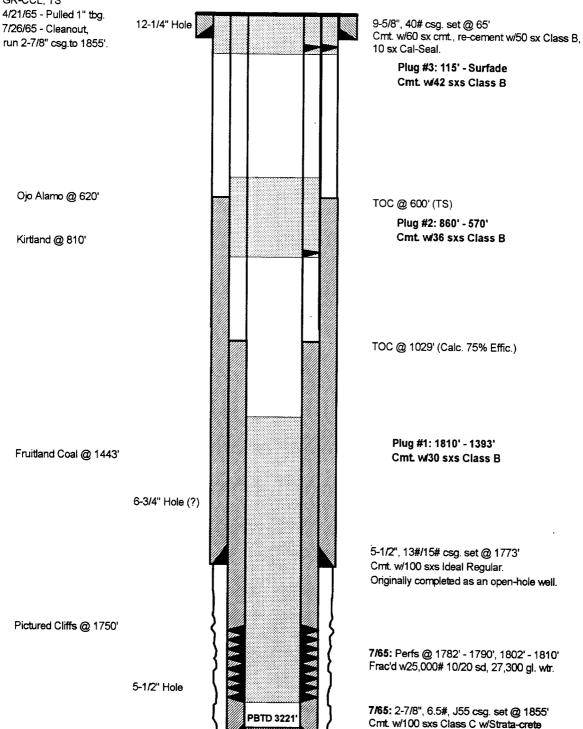
Unit A, Sec 31, T28N, R10W, San Juan County, NM

Long./Lat.: 107.930710 - 36.623230

TD 3260

13. Describe Proposed or Completed Operations It is intended to plug and abandon the subject we procedure and wellbore diagram.		to the attached
		ICESVED U6 1 2 1996 D
	OH!	COM. DIV. DISI. 3
