Sundry Notices and Re	ports on Wells		
		API	# (assigned by OCD) 30-039-07737	
1. Type of Well GAS		5.	Lease Number	
		6.	State Oil&Gas Lease	
2. Name of Operator		7.	E-347 Lease Name/Unit Name	
BURLINGTON				
RESOURCES OIL &	GAS COMPANY	_	San Juan 30-6 Unit

San Juan 30-6 Unit #13 Blanco Mesaverde

Latitude / Longitude: 36° 46.32936' / 107° 28.94076' Recommended Tubing Repair Procedure 2/16/99

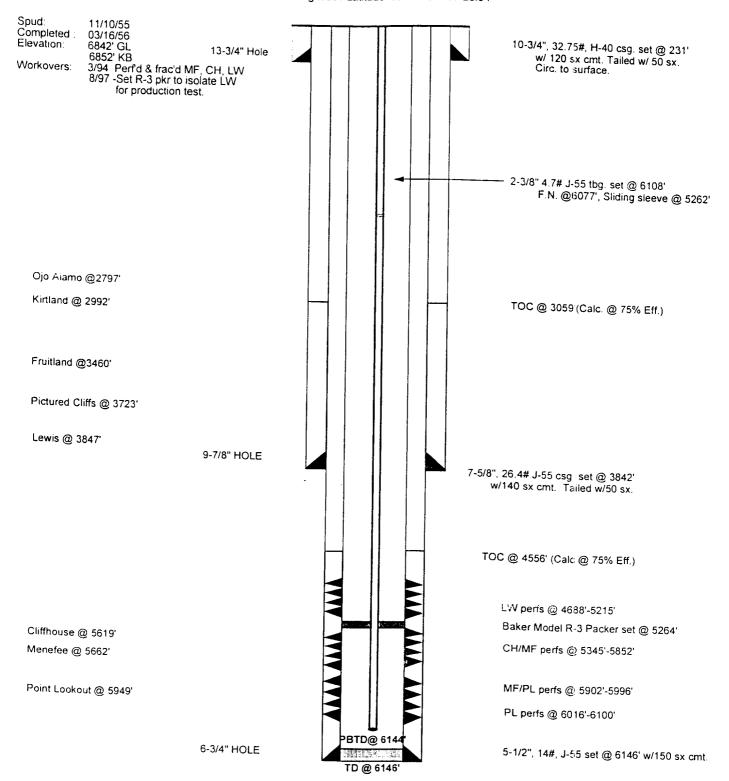
Blanco Mesaverde

1500' FNL,1600' FEL Sec. 32, T30N, R6W, Rio Arriba County, NM Longitude / Latitude: 36-46.33' /107-28.94'
