Pit, Below-Grade Tank, or Proposed Alternative Method Permit or Closure Plan Application

BP AMERICA PRODUCTION COMPANY
SAN JUAN BASIN, NORTHWEST NEW MEXICO

BELOW-GRADE TANK CLOSURE PLAN

FLORANCE GAS COM D 004A
API No. 3004522147
Unit Letter C, Section 10, T30N, R09W

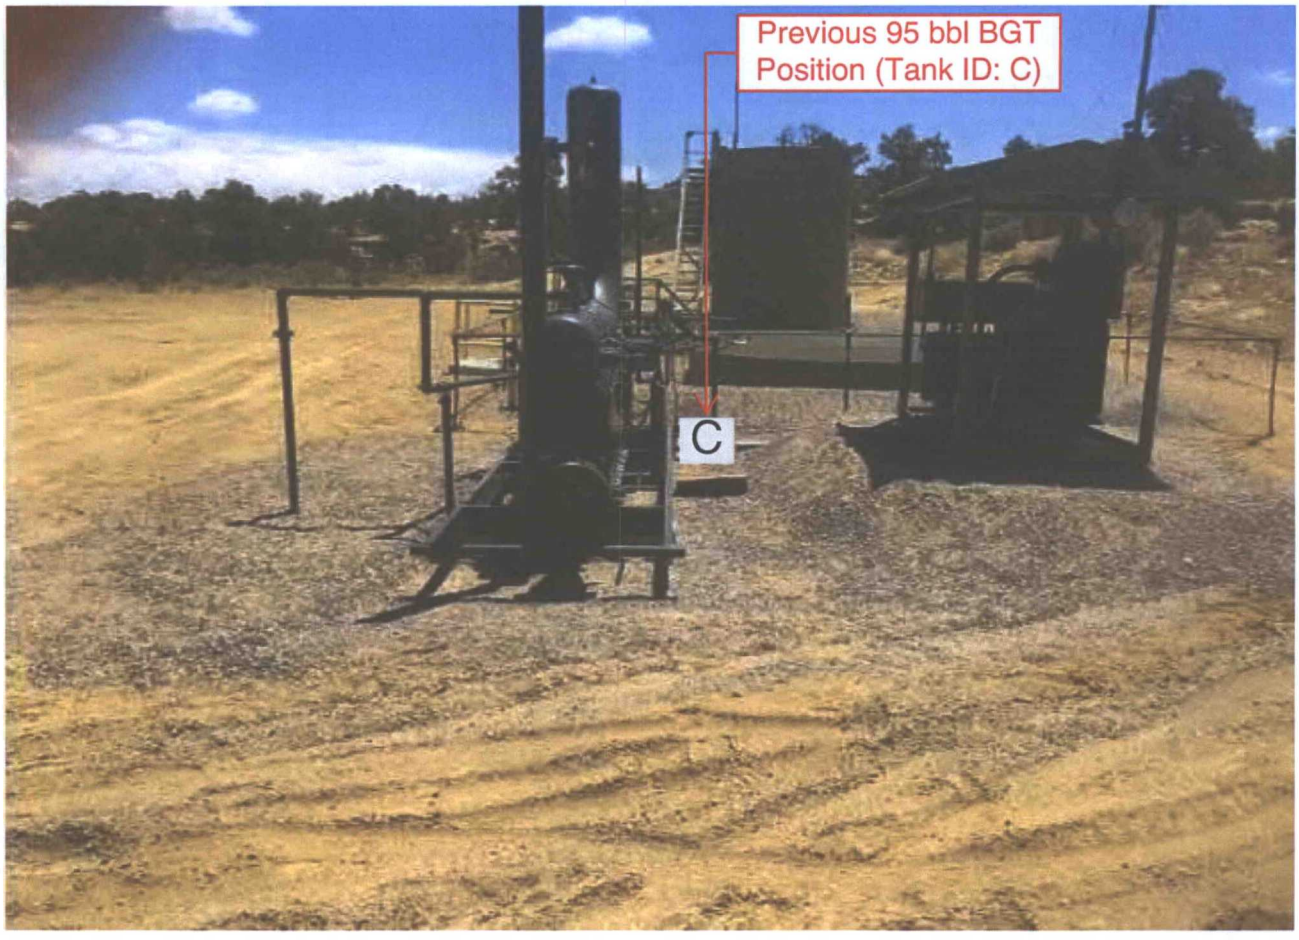
Previous 95 bbl BGT
Position (Tank ID: C)
C

Soil under the BGT was sampled for TPH, BTEX and chloride. TPH exceeded the BGT closure standard with all other concentrations below the stated limits. The site was remediated via soil shredding following the spill and release guidelines. The field report and laboratory reports are attached.
