State of New Mexico Energy, Minerals and Natural Resources Department Oil Conservation Division

Kattler #1 **Pertinent Data Sheet**

Location: 990 'FNL & 1650 'FWL, Unit C, Section 2, T29N, R12W, San Juan County, New Mexico

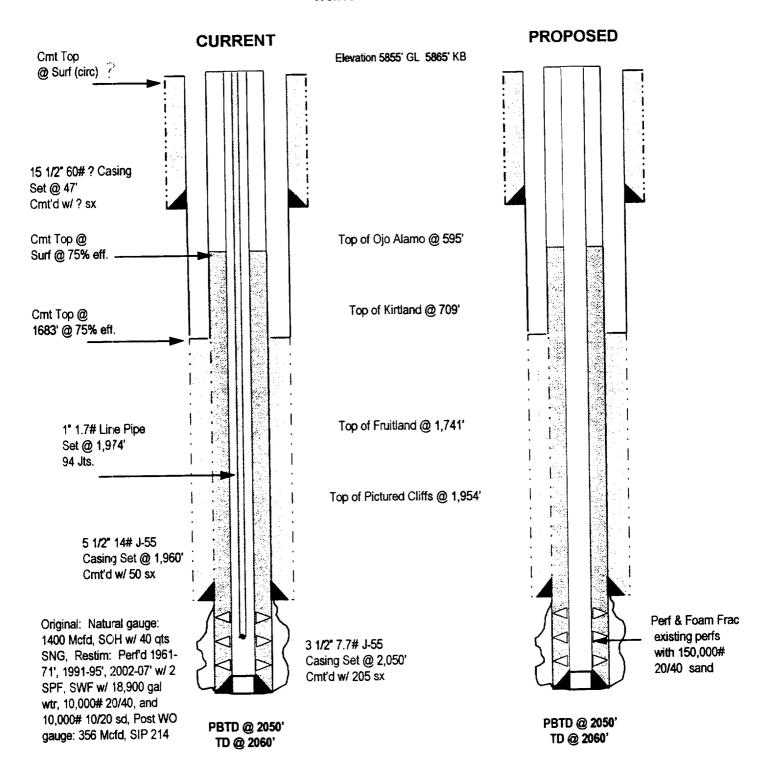
Section 2 C, T-29 -N R-12 -W San Juan, New Mexico

Fulcher Kutz Pictured Cliffs Field Wellbore Schematic
