Pit, Below-Grade Tank, or Proposed Alternative Method Permit or Closure Plan Application

BP AMERICA PRODUCTION COMPANY
SAN JUAN BASIN, NORTHWEST NEW MEXICO

BELOW-GRADE TANK CLOSURE PLAN

Fields Com LS #5A
API No. 3004522461
Unit Letter F, Section 28, T32N, R11W

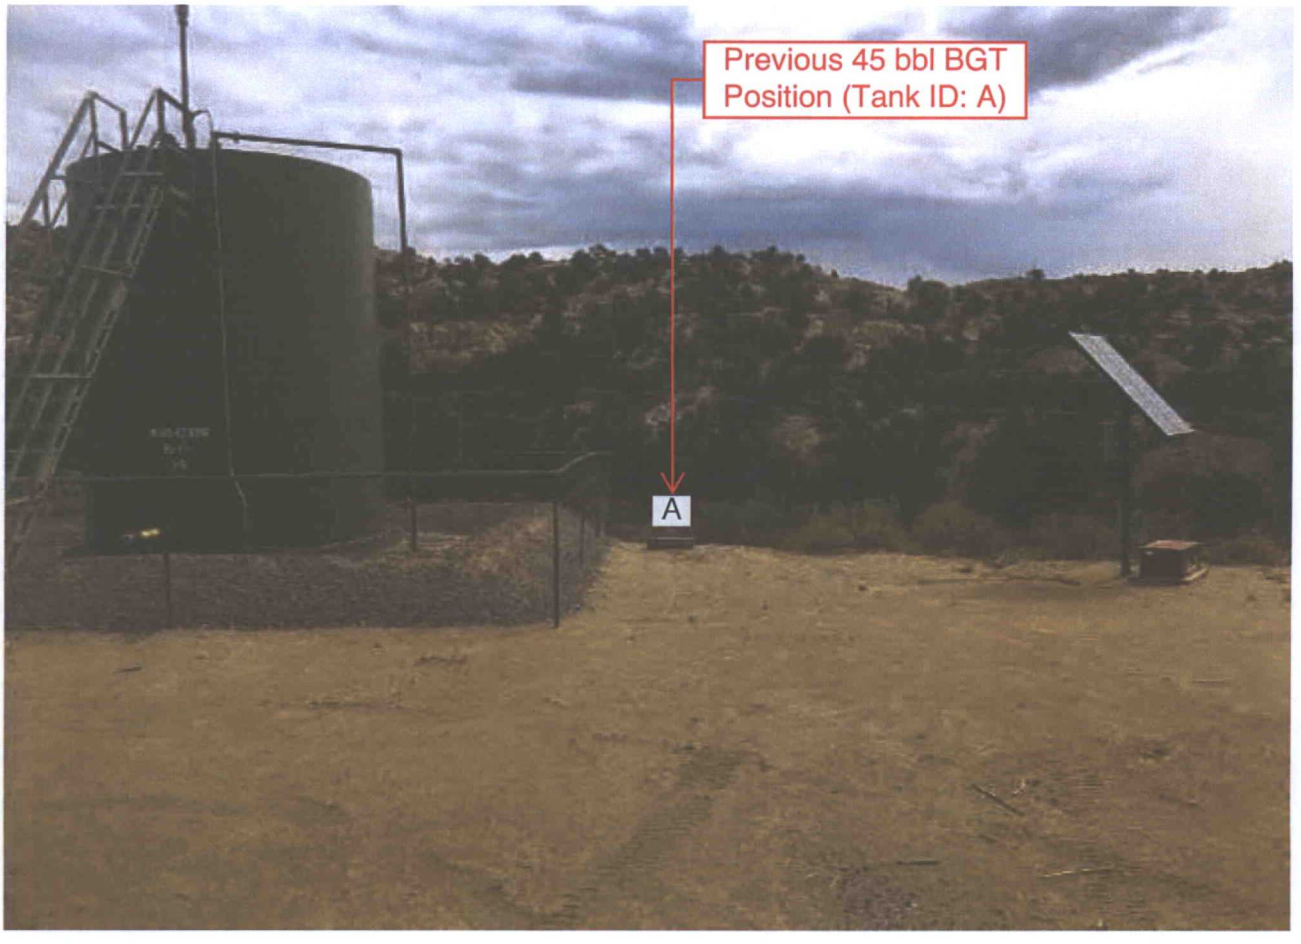
Previous 45 bbl BGT
Position (Tank ID: A)
A

10. BP shall reclaim the BGT location and all areas associated with the BGT including associated access roads to a safe and stable condition that blends with the surrounding undisturbed area. BP shall substantially restore the impacted surface area to the condition that existed prior to oil and gas operations by placement of the soil cover as provided in Subsection H of 19.15.17.13 NMAC, re-contour the location and associated areas to a contour that approximates the original contour and blends with the surrounding topography and re-vegetate according to Subsection I of 19.15.17.13 NMAC.
    The area has been backfilled. The location will be reclaimed once the well is plugged and abandoned.
