Pit, Below-Grade Tank, or Proposed Alternative Method Permit or Closure Plan Application

BP AMERICA PRODUCTION COMPANY
SAN JUAN BASIN, NORTHWEST NEW MEXICO

BELOW-GRADE TANK CLOSURE PLAN

GARTNER A 005R

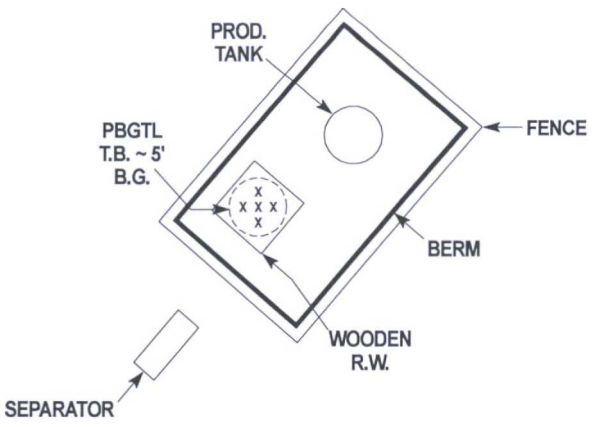
PLOT PLAN circle: attached

DISCOLORATION/STAINING OBSERVED: [YES] NO EXPLANATION - VARYING GRAY

APPARENT EVIDENCE OF A RELEASE OBSERVED AND/OR OCCURRED : [YES] NO EXPLANATION: DISCOLORED SOILS WITH STRONG APPARENT HYDROCARBON ODOR

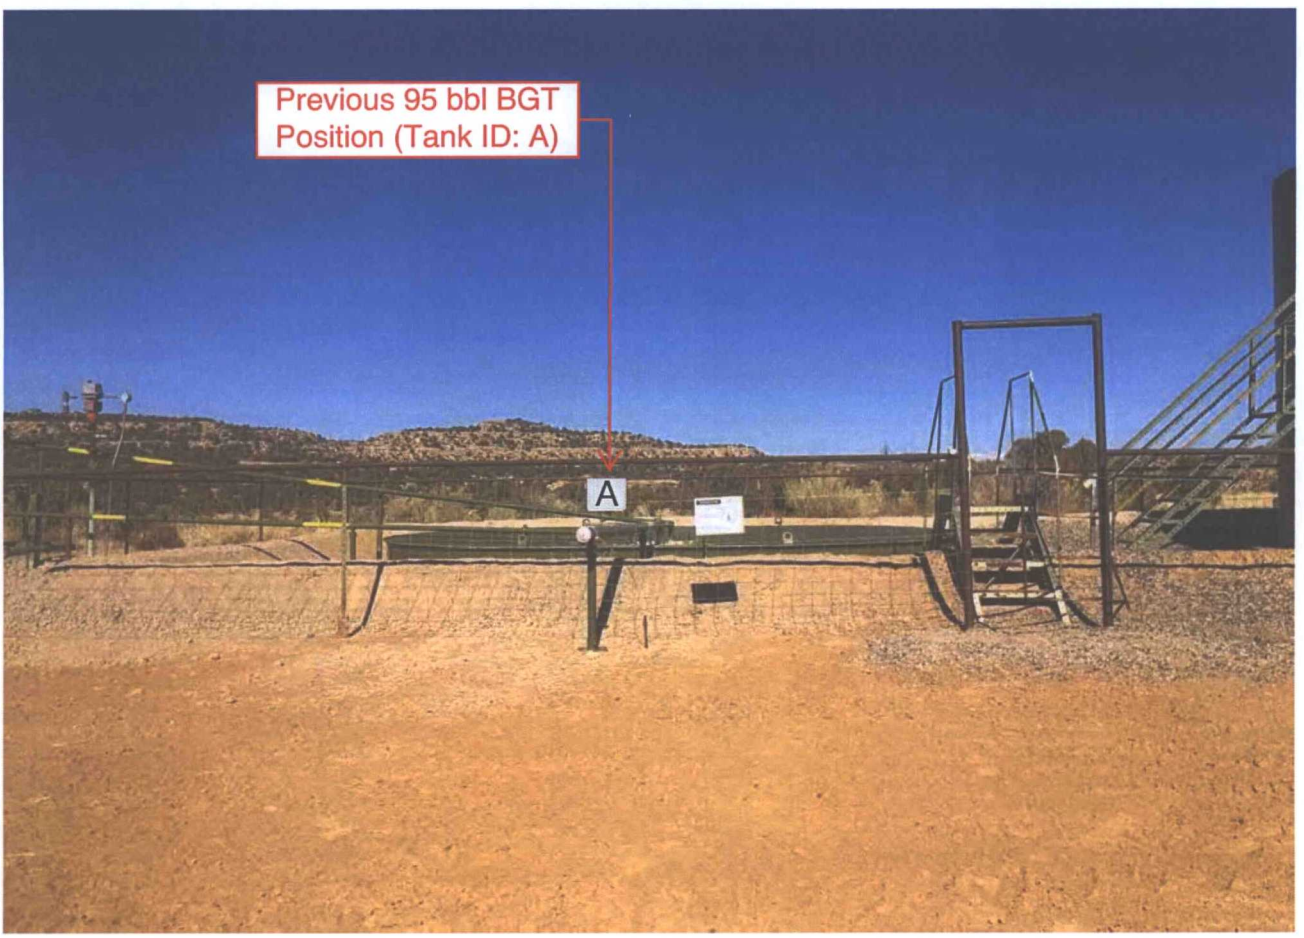
Previous 95 bbl BGT
Position (Tank ID: A)
A

The area has been backfilled and a 105 BBL shallow low profile above-grade tank set atop BGT location. The location will be reclaimed once the well is plugged and abandoned.
