PLUG & ABANDONMENT PROCEDURE

Texaco State #2 DPNO 73785

Pictured Cliffs 824' FNL, 1795' FEL

Sec. 19, T29N, R13W, San Juan County, NM Longitude / Latitude: 108240677 - 36716799

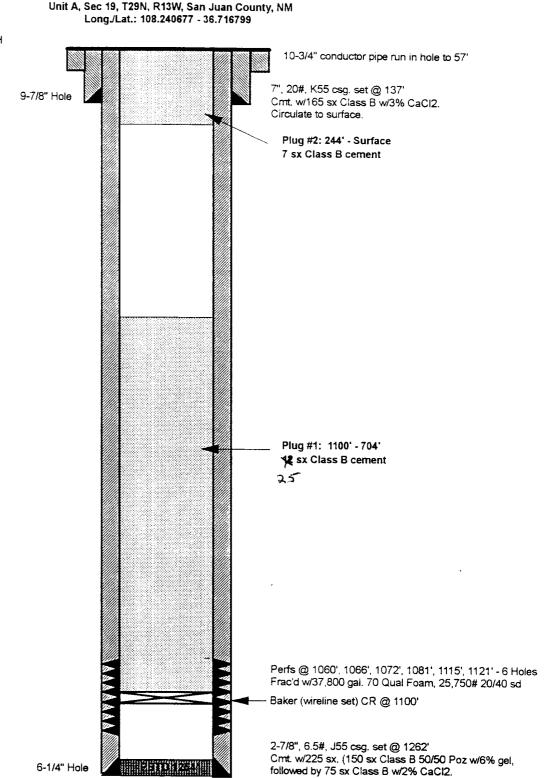
Fruitland @ 754'

Pictured Cliffs @ 1058'

(Calculated @ 75% Effic. Rate, circulated to surface.)
