Pit, Below-Grade Tank, or Proposed Alternative Method Permit or Closure Plan Application

BELOW-GRADE TANK CLOSURE PLAN

W D HEATH A 008

API No. 3004508409

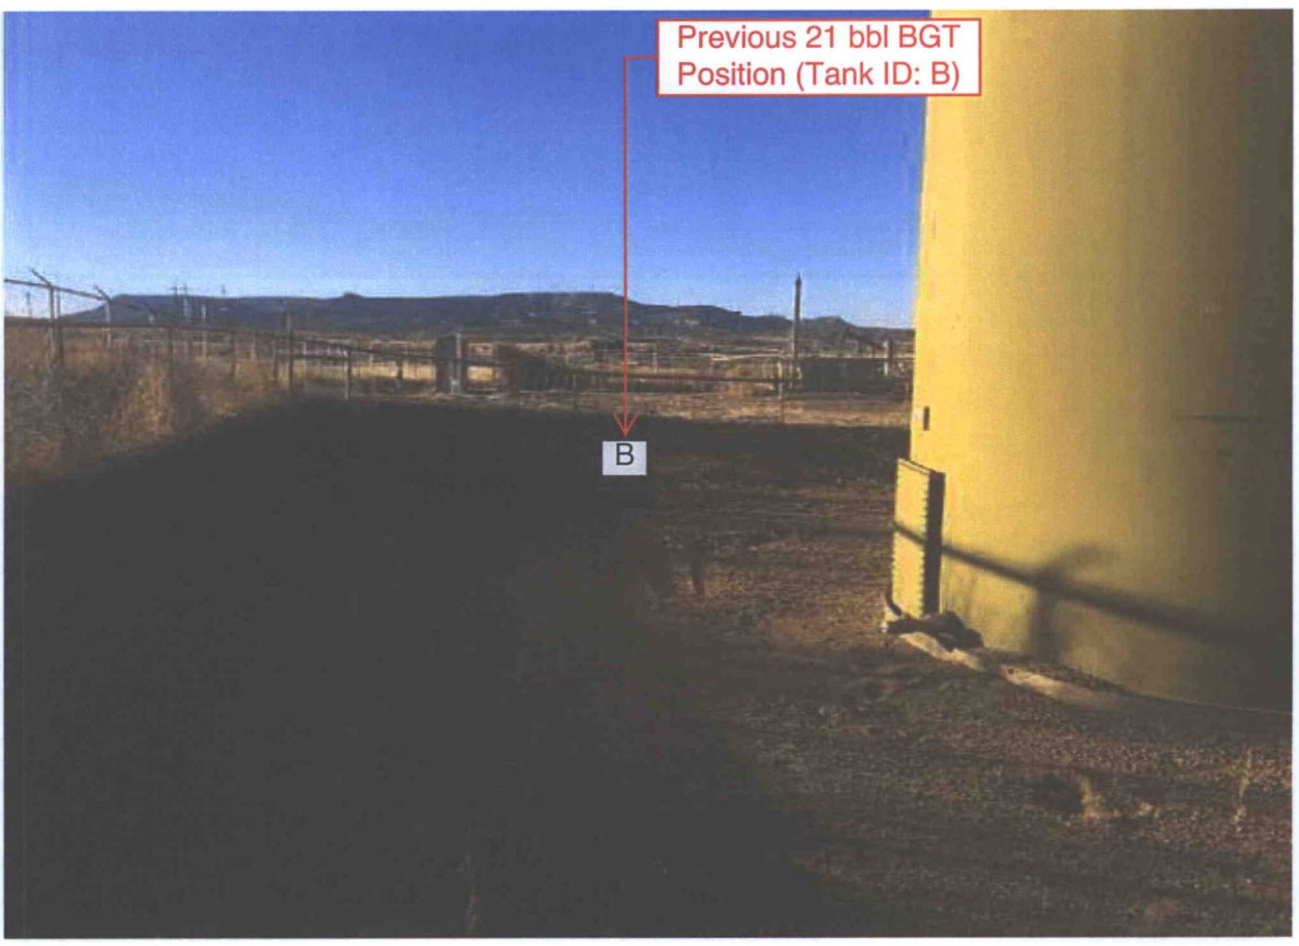
Previous 21 bbl BGT
Position (Tank ID: B)
B

The area has been backfilled but is still within the operational area of the location. The location will be reclaimed once the well is plugged and abandoned.
