#### San Juan 32-9 Unit NP #8

Mesaverde NE, Section 20, T-32-N, R-9-W San Juan Co., New Mexico

## PERTINENT DATA SHEET

## San Juan 32-9 Unit NP #8

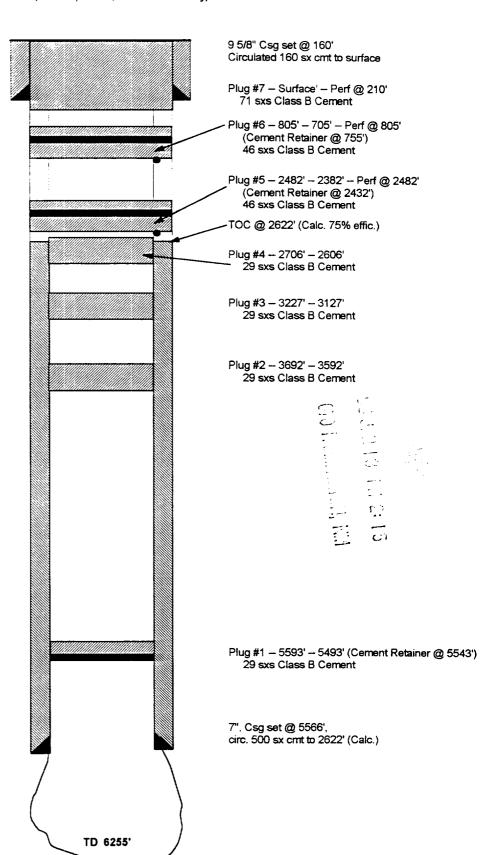
Cliff House @ 5543' Menefee @ 5652'

Point Lookout @ 5932'

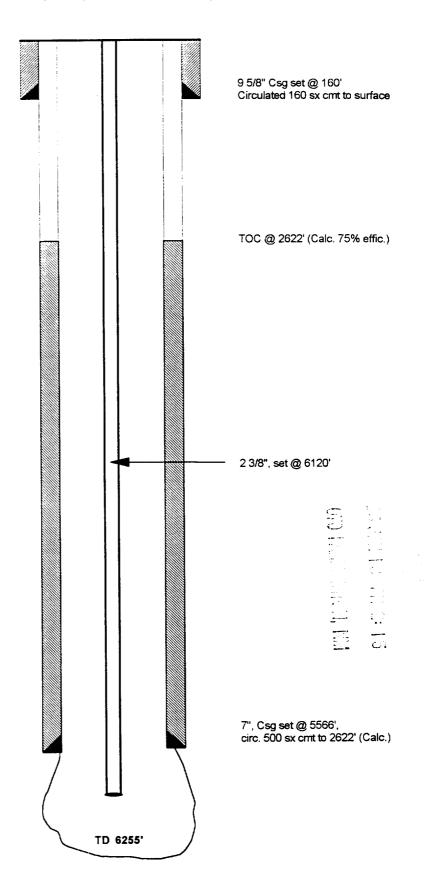
**CURRENT -- 12-29-94**

Mesa Verde DPNO 69973

929' FNL, 986' FEL, Section 20, T-32-N, R-9-W, San Juan County, NM

Spud: 11-10-53

Completed: 12-30-53

Nacimiento @ 755'

Ojo Alamo @ 2432'

Kirtland @ 2656'

Fruitland @ 3177'

Pictured Cliffs @ 3642'

Cliff House @ 5543' Menefee @ 5652'

Point Lookout @ 5932'
