Pit, Below-Grade Tank, or Proposed Alternative Method Permit or Closure Plan Application

BELOW-GRADE TANK CLOSURE PLAN

GCU 061

API No. 3004506939

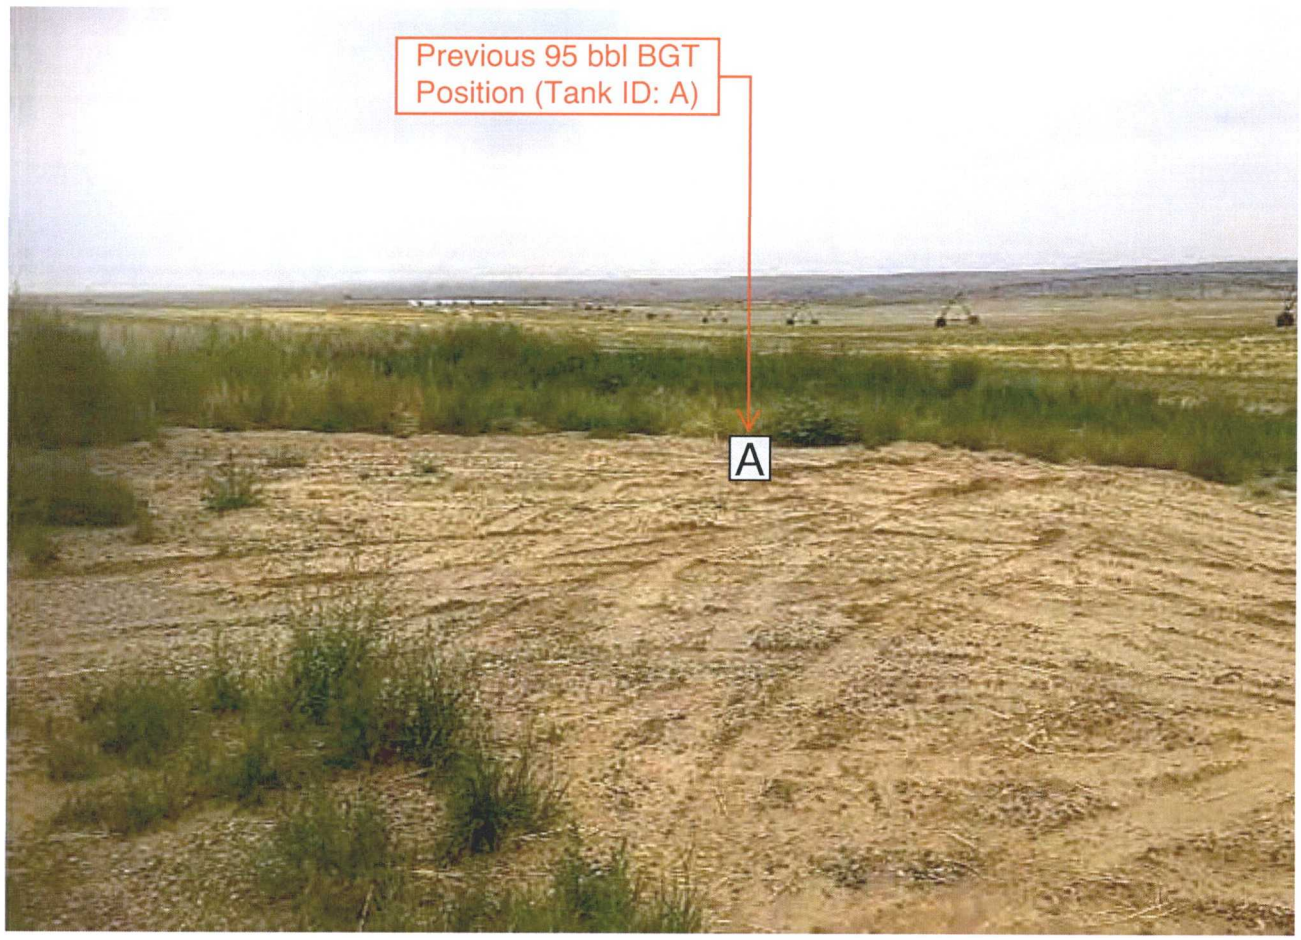
The area has been backfilled and BGT location's surface condition is clear, but within the site's operational area. The location will be reclaimed once the well is plugged and abandoned.

Previous 95 bbl BGT
Position (Tank ID: A)
A
