Pit, Closed-Loop System, Below-Grade Tank, or Proposed Alternative Method Permit or Closure Plan Application

BELOW-GRADE TANK CLOSURE PLAN

Warren LS # 4B – Tank ID: A
API #: 3004532423
Unit Letter I, Section 14, T28N, R09W

From: Patti Campbell
Sent: Wednesday, August 12, 2020 2:53 PM
To: Smith, Cory, EMNRD <Cory.Smith@state.nm.us>
Cc: Steven Moskal, Don Buller, Kyle Siesser, Jake Harter, Nelson Velez <blagg_njv@yahoo.com>
Subject: BGT Closure Notification – Warren LS 004B

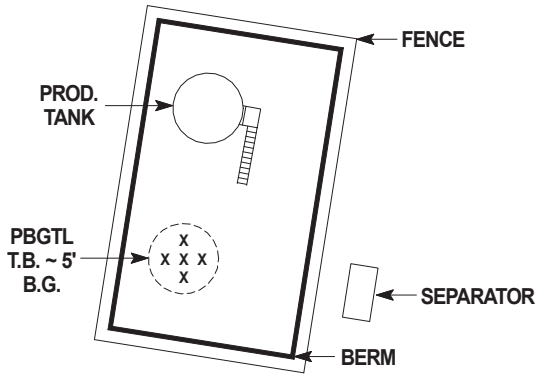
APPARENT EVIDENCE OF A RELEASE OBSERVED AND/OR OCCURRED : YES / NO EXPLANATION:

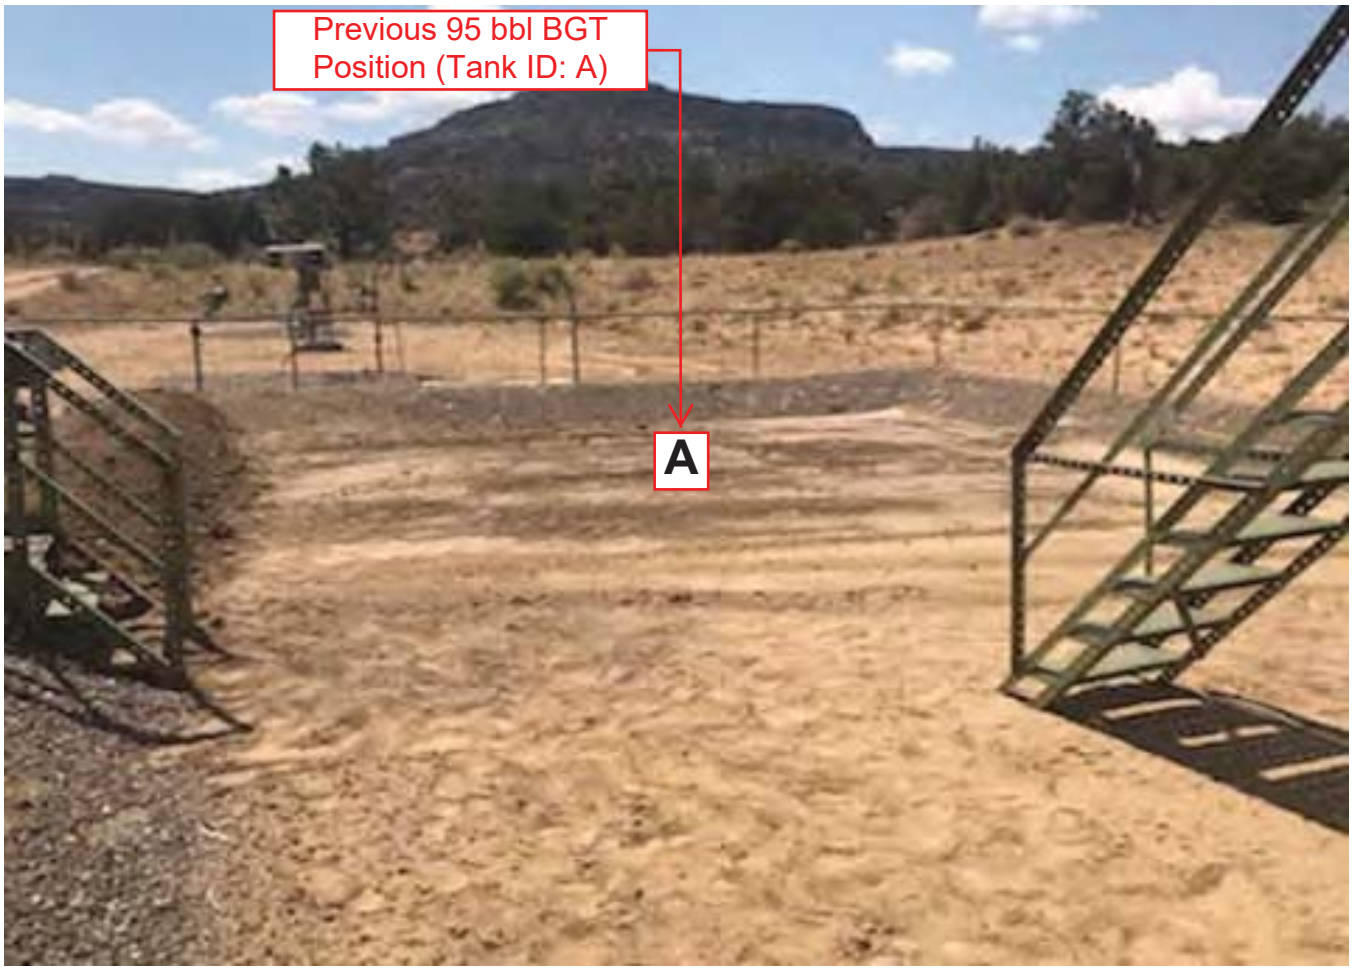
Previous 95 bbl BGT
Position (Tank ID: A)
A

Closure report on C-144 form is included & contains a photo of the current reclamation requirements completed.
