BUREAU OF	LAND MANAGEMENT		
Sundry Notic	es and Reports on Wells		
		5.	Lease Number
1. <b>Type of Well</b> GAS		6.	SF-077652  If Indian, All. or  Tribe Name
0/10		7.	Unit Agreement Name

2. Name of Operator		•	
SOUTHLAND ROYALTY COMPAN	Y	8.	Well Name & Number
3. Address & Phone No. of Operato	r	0.	East #13
PO Box 4289, Farmington, NM	87499 (505) 326-9700	9.	<b>API Well No.</b> 30-045-20447

4. Location of Well, Footage, Sec	, T, R, M	10.	Field and Pool
1160'FSL, 1560'FWL, Sec.24, T-			Basin Fruitland Coal/ Aztec Pictured Cliffs
		11.	County and State
			San Juan Co, NM

13. Describe Proposed or Comple	eted Operations		
	abandon the subject well ac	cording to	o the attached procedur
and wellbore diagra	am.		
		7	Wilder angles day is described by the service of th
		F	)Eachtain
		וח	)eceiven
		Ш	MAR 2 0 1995

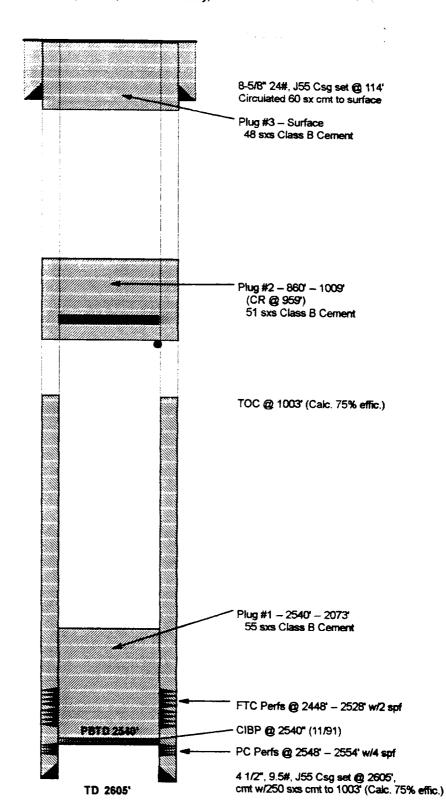
Spud: 5-7-69

Completed: 6-4-69

Ojo Alamo @ 910

Kirtland @ 959

Fruitland @ 2123\*

Pictured Cliffs @ 2547

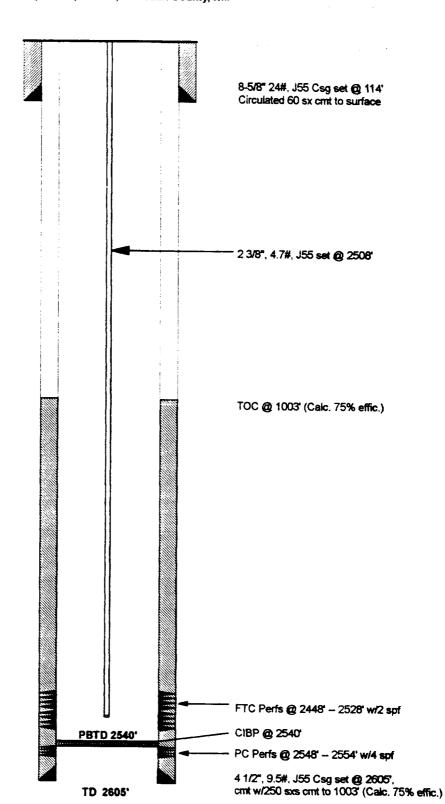
#### **CURRENT -- 2-21-95**

## East #13

Basin Fruitiand Coal — DPNO 15404B Pictured Cliffs — DPNO 15404A

1160' FSL, 1560' FWL, Section 24, T-31-N, R-12-W, San Juan County, NM

Spud: 5-7-69

Completed: 6-4-69

Ojo Alamo @ 910'

Kirtland @ 959
