Sundry Not	ices and Reports on Wells	7	
1. Type of Well GAS	070 7741C.1, N	5.	SF-078604
		7.	Unit Agreement Name
2. Name of Operator BITRIINGTON	•		
アンア・アンプ・アナンア・ア・ア・ア・ア・ア・ア・ア・ア・ア・ア・ア・ア・ア・ア・ア・ア・ア・	& GAS COMPANY	•	Mall Mana & Mumban

3. Address & Phone No. of Opera		8.	Well Name & Number Scott #2A API Well No.
PO Box 4289, Farmington, NM	1 8/499 (505) 326-9/00	۶.	30-045-21994
4. Location of Well, Footage, S 1650'FSL, 980'FEL, Sec.31, T			Field and Pool Blanco Pictured Cliffs Blanco Mesaverde

Scott 2A

Mesaverde / Pictured Cliffs Unit I, Section 31, T32N, R10W Lat. 36-56.35', Long. 107-55.73' Commingle Workover Procedure 01/06/97

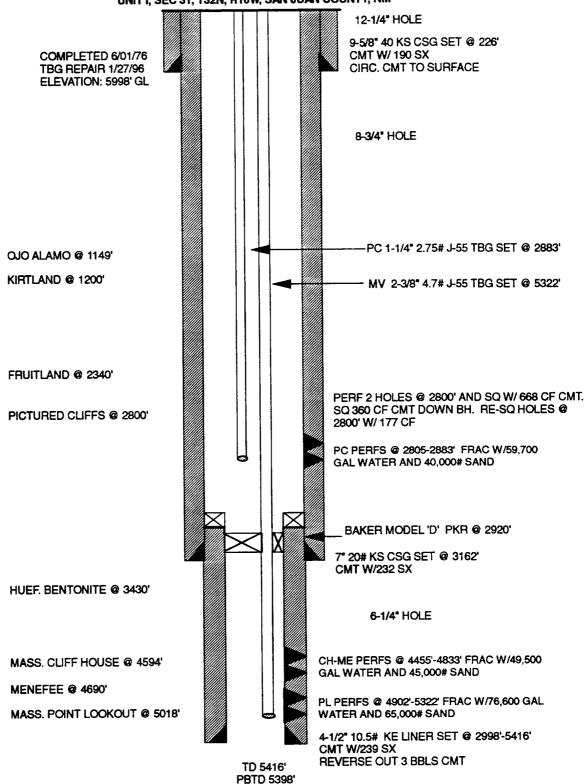
AS OF 1/10/97 BLANCO PICTURED CLIFFS/MESAVERDE

1650' FSL, 980' FEL UNIT I, SEC 31, T32N, R10W, SAN JUAN COUNTY, NM
