Pit, Below-Grade Tank, or Proposed Alternative Method Permit or Closure Plan Application

BGT1 Closure Report

Well Name: NEBU #049M
Well API# 30-045-33305
Unit Letter H, Section 30, T31N, R7W

NEBU #049M
Photographic Log
Simcoe LLC

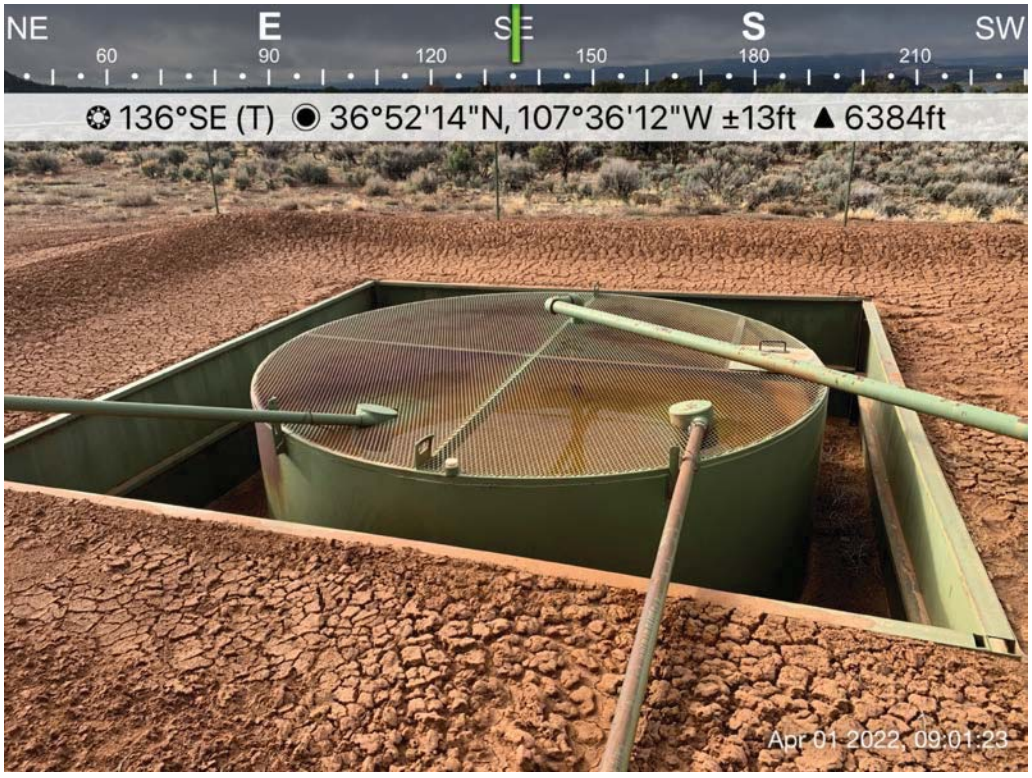
Photo 2: 80 bbls steel tank prior to removal, 4/1/2022.
