Sundry Notices and Reports on Wells

**BURLINGTON
RESOURCES**

8. Well Name & Number
Scott #19

☒ Abandonment

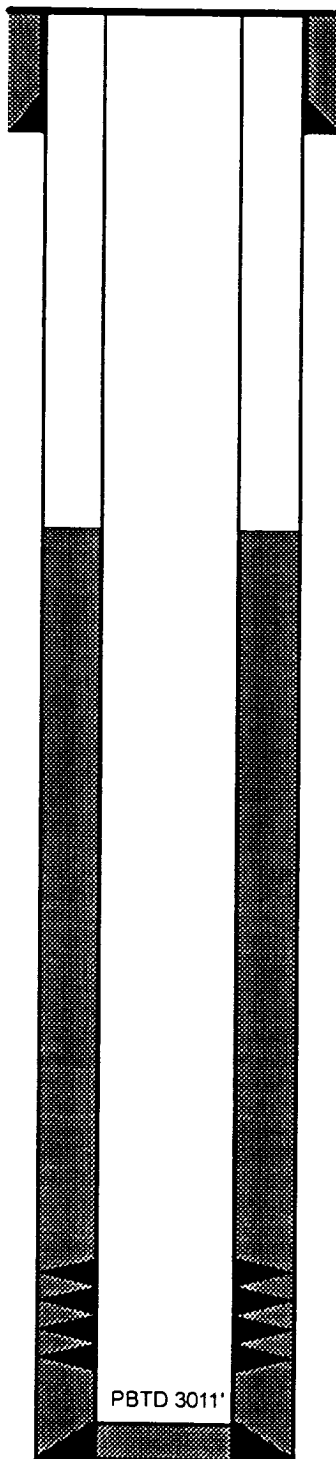
Current

8-5/8" 24# K-55 Csg set @ 134'
Cmt w/148 cf (Circulated to Surface)

12-1/4" hole

TOC @ 1075' (T.S.)

7-7/8" hole to
unknown depth

Pictured Cliffs Perforations:
2882' - 2946' (9 holes)

PBTD 3011'

2-7/8" 6.4# J-55 Csg set @ 3022'
Cmt w/ 676 cf

TD 3022'
