Pit, Below-Grade Tank, or Proposed Alternative Method Permit or Closure Plan Application

Hilcorp Energy Company
San Juan Basin
Below Grade Tank Closure Report

Lease Name: San Juan 27-4 Unit 59
API No.: 30-039-20369

SJ 27-4 Unit 59 - BGT Closure
API 30-039-20369

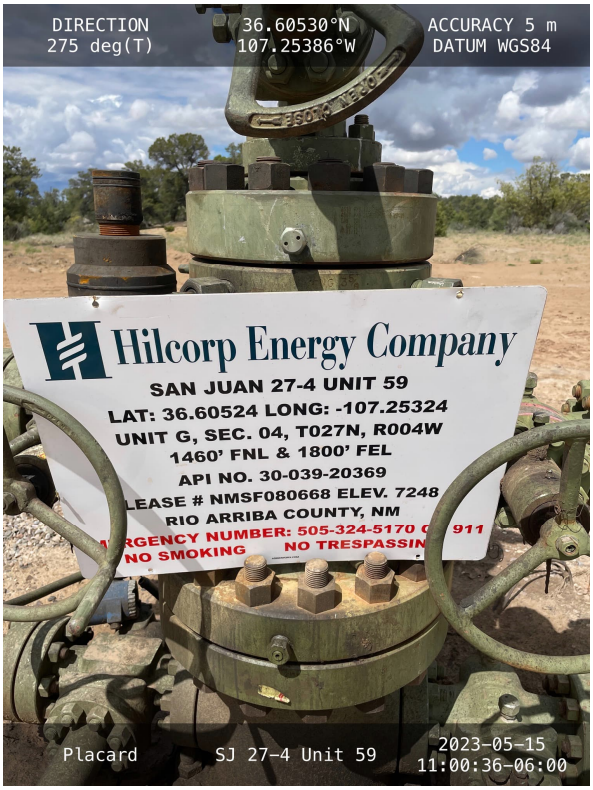
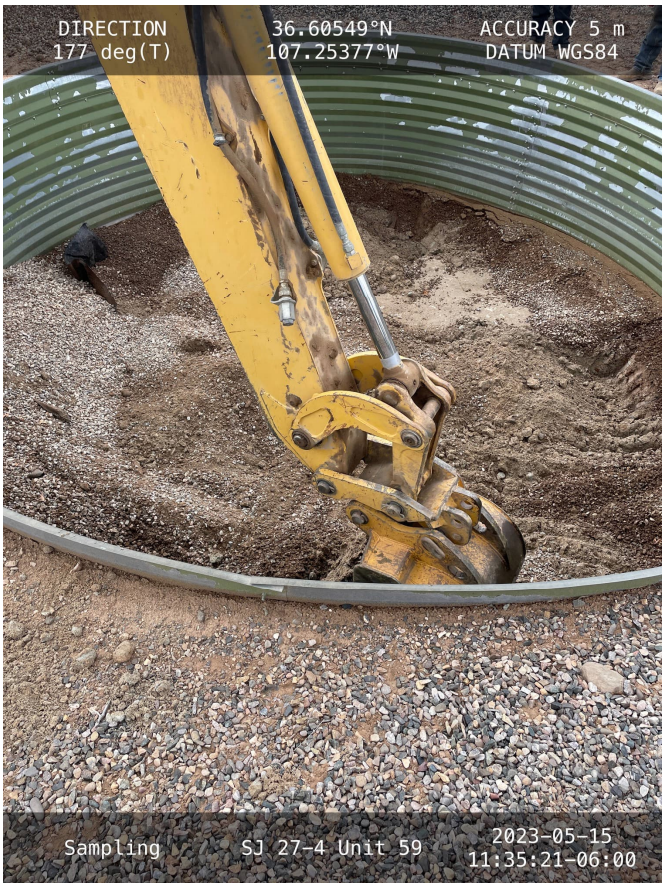
DIRECTION
177 deg(T)
36.60549°N
107.25377°W
ACCURACY 5 m
DATUM WGS84
Sampling
SJ 27-4 Unit 59
2023-05-15
11:35:21-06:00
