ENSOLUM

January 16, 2026

Re: Closure Request
Golden 8 Federal #001
Incident Numbers nKMW1035646177, nKMW1106629393, nJMW1333053660, nAB1422637219, nAB1607837012, nAB1633656856, nAB1803638613, and nAB1929041495
Eddy County, New Mexico

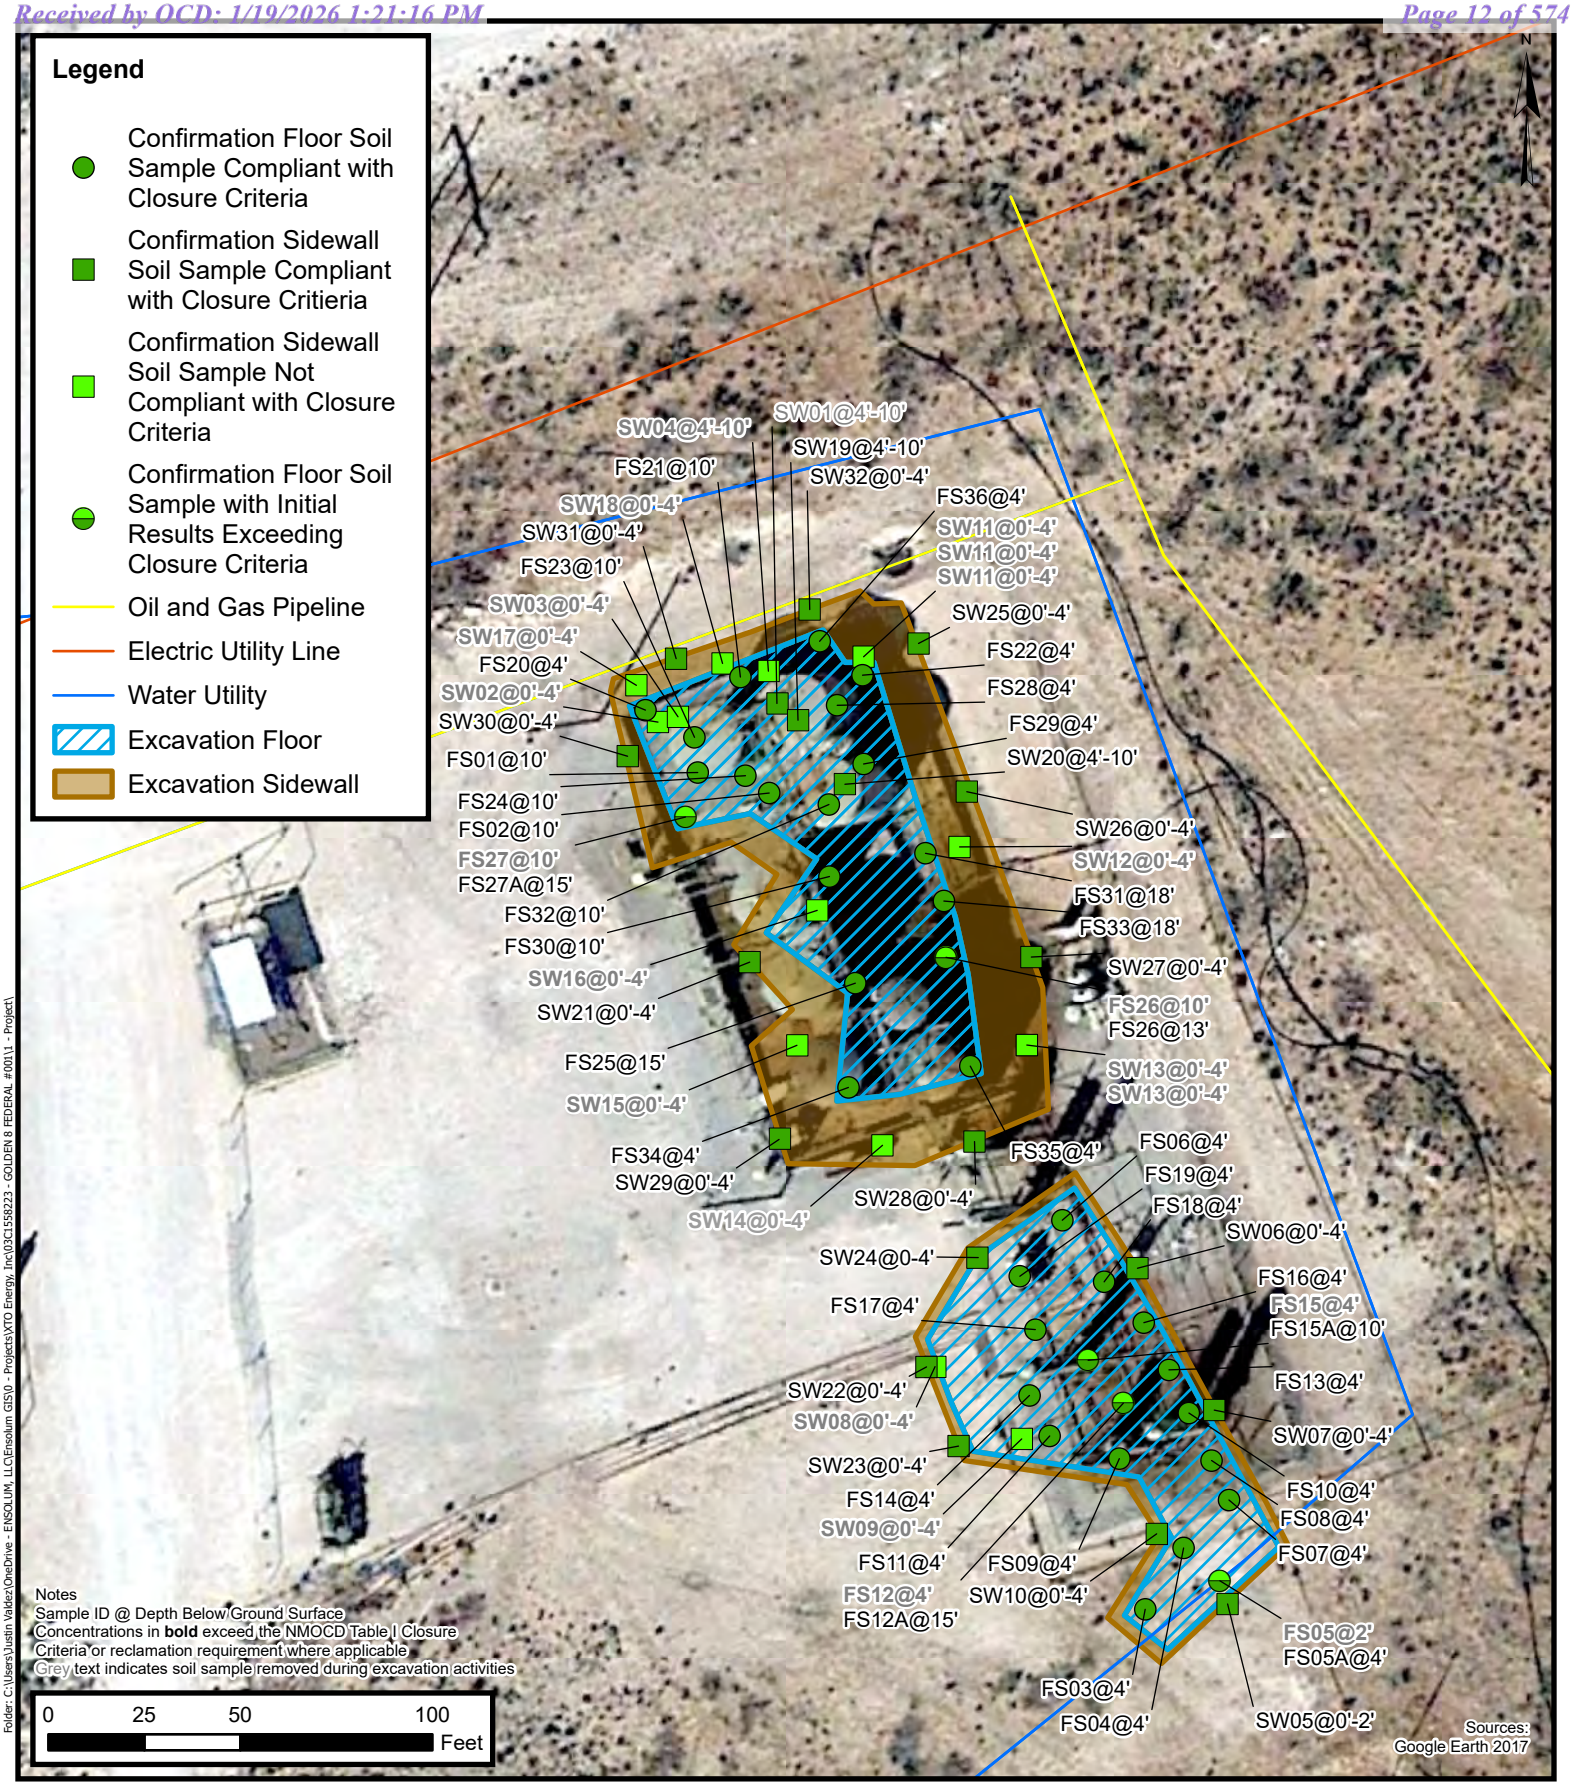
FIGURE 2

Deferral Locations

XTO Energy, Inc
GOLDEN 8 FEDERAL #001
Incident Numbers: nKMW1035646177, nKMW1106629393, nJMW1333053660, nAB1422637219, and nAB1929041495
Unit K, Section 8, T 21S, R 29E
Eddy County, New Mexico
