UNITED STATES DEPARTMENT OF THE INTERIOR BUREAU OF LAND MANAGEMENT

Sundry Notices and Reports on Wells		
	5.	Lease Number SF-078504
1. Type of Well GAS	6.	
	7.	Unit Agreement Name
2. Name of Operator		
BURLINGTON RESOURCES		
OIL & GAS COMPANY	0	San Juan 32-9 Unit Well Name & Number

San Juan 32-9 Unit #119

Blanco Pictured Cliffs SE Sec. 14, T32N, R10W San Juan County, New Mexico

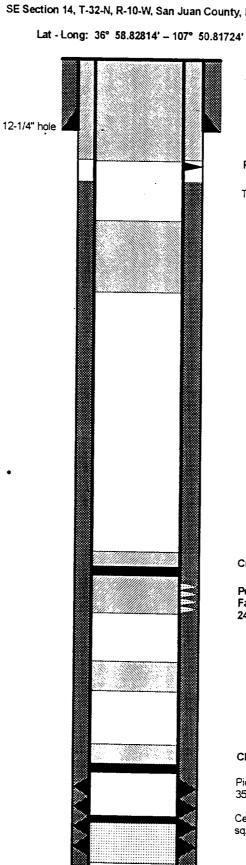
Pictured Cliffs @ 3522

7-7/8" hole

TD 3795'

8-5/8" 24# K-55 Csg set @ 228' 242 cf (Circulated to Surface)

During completion swab test found lower perfs wet. Set CR @ 3598' and squeezed below with 50 sxs cement.
